Stability Assessment of Coastal Cliffs Incorporating Laser Scanning Technology and a Numerical Analysis

Faculty of Civil and Environmental Engineering, Gdansk University of Technology, 80-233 Gdansk, Poland

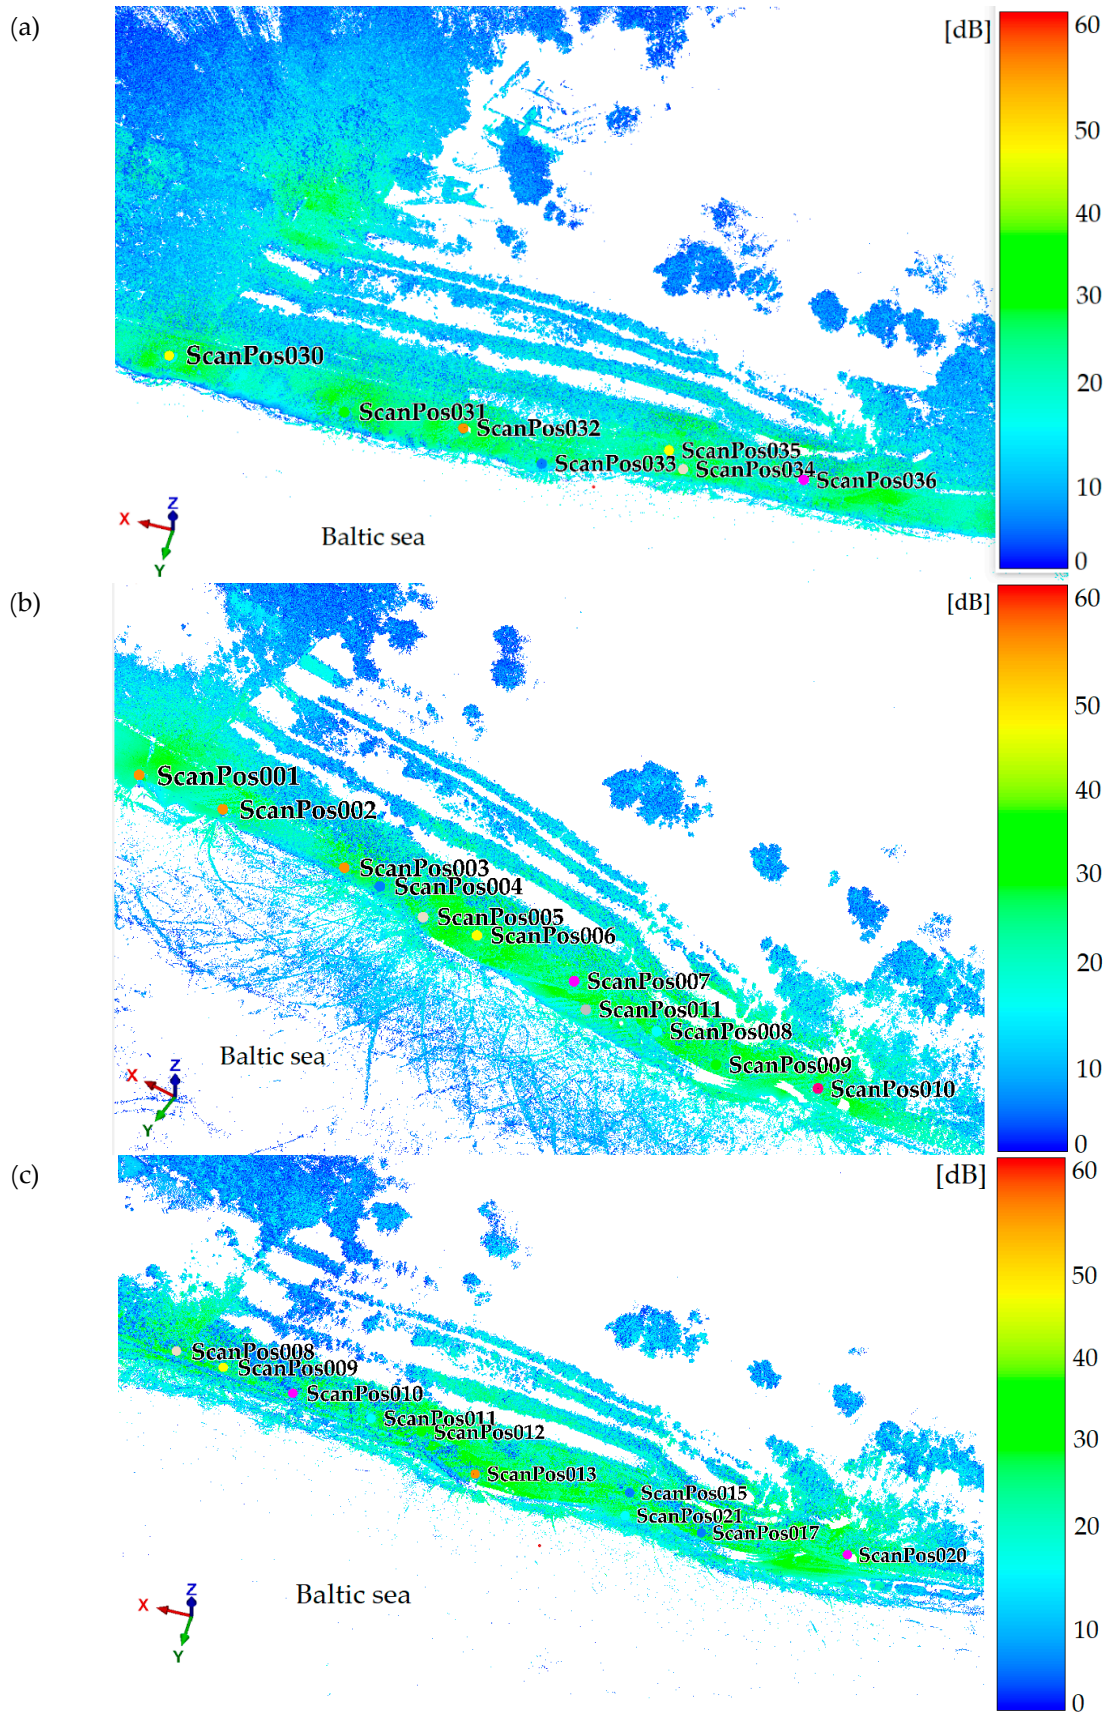
Figure 8. The scanner locations for the (a) February 2015, (b) March 2017, (c) July 2017, (d) November 2018, and (e) March 2018 measurement missions.

Figure 8 presents the location of the scan positions for each of the February 2015, March 2017, and July 2017 measurement missions and the deployment of positions in the local system in November 2017 and March 2018. The point density for each measurement mission was equal 4200 pts/m². In Figure 8a–c,e respectively, colours are presented as a function of light reflection amplitude, while Figure 8d shows the fragment of the upper part of the cliff in RGB (Red-Green-Blue) colours.
