Experimental investigations of damage evolution in concrete during bending by continuous micro-CT scanning

Ł. Skarżyński and J. Tejchman

Faculty of Civil and Environmental Engineering, Gdańsk University of Technology, Poland

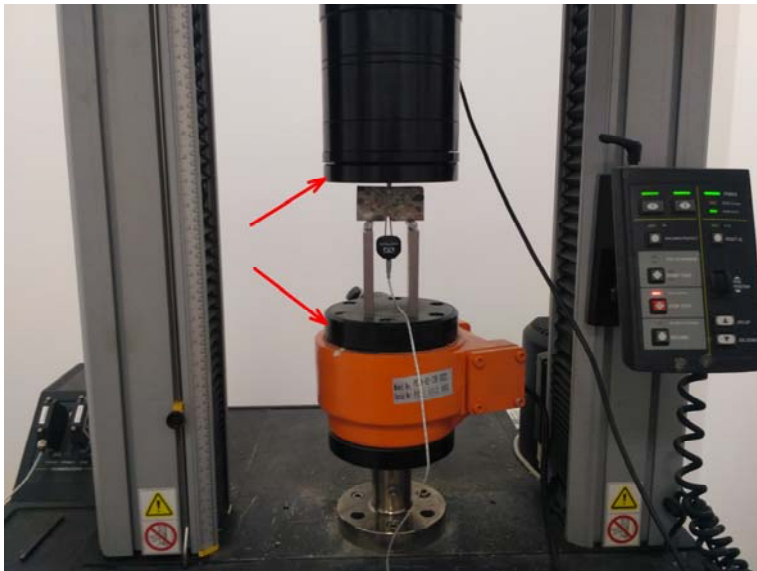
Fig.2: Views on micro-CT tomography system Skyscan 1173 mounted to loading machine Instron 5569: a) general view, b) rotating frame (marked with arrows) with concrete specimen prepared for bending and c) stepper motor

102 In the current paper, the scanning process was continuously performed during deformation without
103 any unloading phases for concrete. The same tomography system SkyScan 1173 was used.
104 However, it was directly connected now to the loading machine Instron 5569 (with the maximum
105 loading capacity of 50 kN). The micro-CT scanner was mounted on the loading machine (Fig.2a).
106 To rotate the specimen for scanning, a rotating frame was built and a stepper motor was used
107 (Figs.2b and 2c) that were both fully controlled by the micro-CT software. Thus, the micro-CT
108 scans might be shot during a very slow quasi-static deformation process without any breaks. The
109 disadvantages of our extended prototype micro-CT system were two: 1) reduced scanning
110 resolution (the pixel size was now between 39 μm and 46 μm) and 2) reduced maximum size of the
111 scanned concrete specimen (now down to 80 mm).
