Finite element modelling of a historic church structure in the context of a masonry damage analysis

The paper includes a case study of modelling a real historic church using the finite element method (FEM) based on laser scans of its geometry. The main goal of the study was the analysis of the causes of cracking and crushing of masonry walls. An FEM model of the structure has been defined in ABAQUS. A non-linear dynamic explicit analysis with material model including damage plasticity has been performed. A homogenization procedure has been applied to obtain the material parameters used in the modelling of masonry. In the numerical analysis, the interactions between the church structure, the foundations and the ground were taken into account.

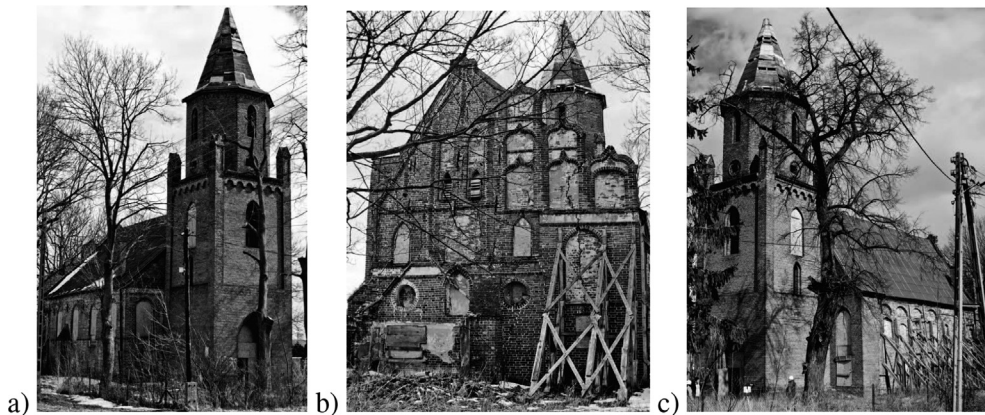
Fig. 2. Views of the church (a) north-west, (b) east, (c) west-south.

In the XIX century, two brick buttresses were built in the western corner of the south wall and in the east wall (see Fig. 4). In 2009, during the renovation, three columns of concrete were built into the southern inner wall (see Figs. 3 and 4). These three pillars are not founded on any foundation. The eastern wall is also comprised of two layers, and some vertical cracks of significant width are observed on it (see Figs. 2 and 15).

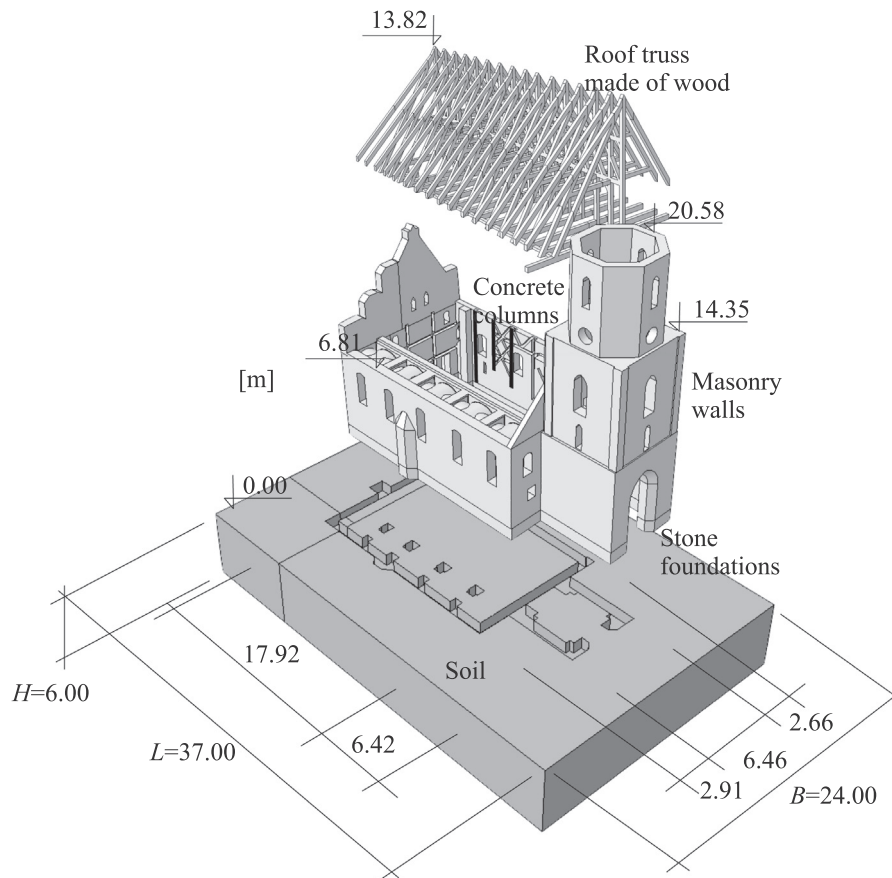
Fig. 3. Main parts and dimensions of the structure.

The analysed church is a brick nogged timber wall frame construction on a stone foundation of boulders. After 1323, the church was rebuilt several times. The main parts of structure and phases of the church reconstruction are shown in Figs. 3 and 4. In the first phase of redevelopment at the end of the fourteenth century, the church was reinforced by an outside solid brick wall. In the second phase, in the fifteenth century, the church was enlarged by an additional five chapels, which have been roofed vaulted using bricks. In the Baroque period after the year 1708, the windows were enlarged, and some doorways were bricked up. Finally, in the fourth phase, after 1819, a brick tower was built. At that time, the new owner tore down the walls between the main nave and chapels located on the north wall, creating a new second nave. The church was used for its intended purpose until 1945. Currently, the church is not in use, but it is included in the register of monuments.

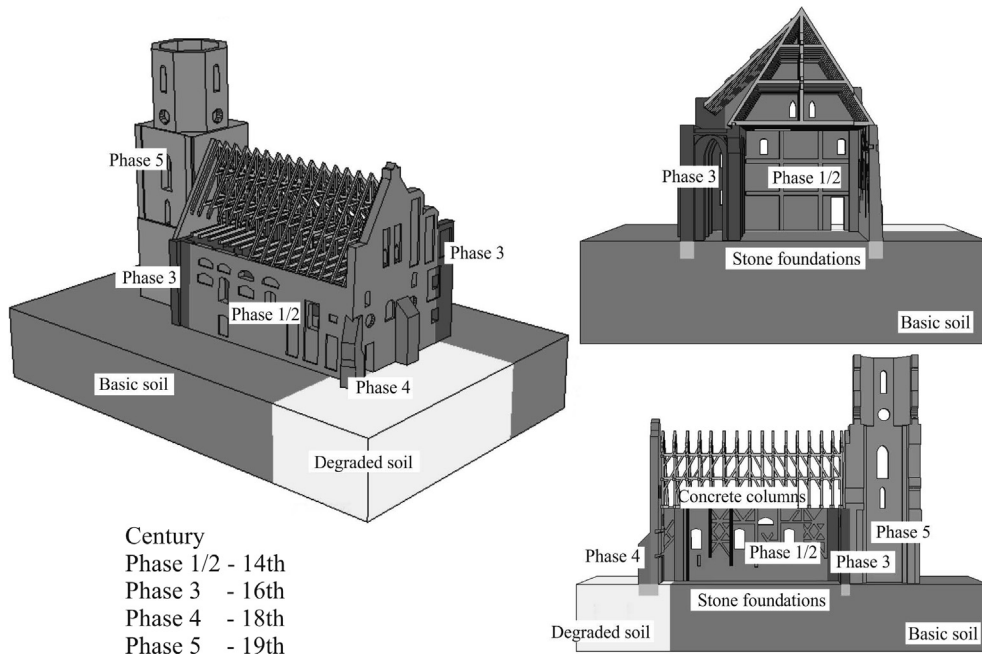
Fig. 4. Phases of the church reconstruction.

- The second but also very important cause of the masonry cracking is varied settlement of soil under the church structure (see Fig. 4). The numerical study results clearly indicate that the soil conditions, although seemingly good enough for supporting the structure, unfortunately are the cause of cracks in masonry. The geotechnical investigation carried out did not show problems with the bearing capacity of the soil merely because of the inadequate number of geotechnical test drillings (see Fig. 9). An additional geotechnical drilling should be conducted at the south-east corner of the church, where the soil seems to be weaker. The soil weakness can be confirmed by the reconstruction of the church in the 18th century (see Figs. 4 and 15 - phase 4) because the buttresses probably built in at that time were supposed to prevent the structure from collapsing. Moreover, a sacristy built later at the same corner made the situation even worse because it caused the overloading of the soil and the east masonry wall cracking (see Fig. 15).

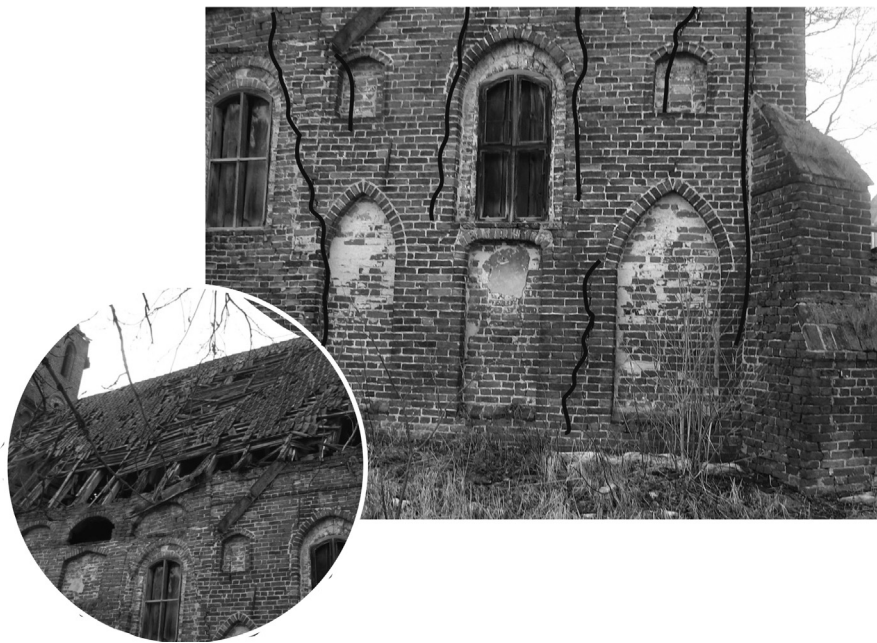
Fig. 5. View of the south wall and roof over the wall.

The roof of the church is made of wood (see Figs. 5–7). The main destroyed roof timber truss is considered in analysis here (see Fig. 7). The roof of the tower is omitted. The material of the truss is modelled in a simplified manner as elastic and isotropic even if wood is known as an anisotropic material. Because the church is a structure that was built centuries ago, the material may also have

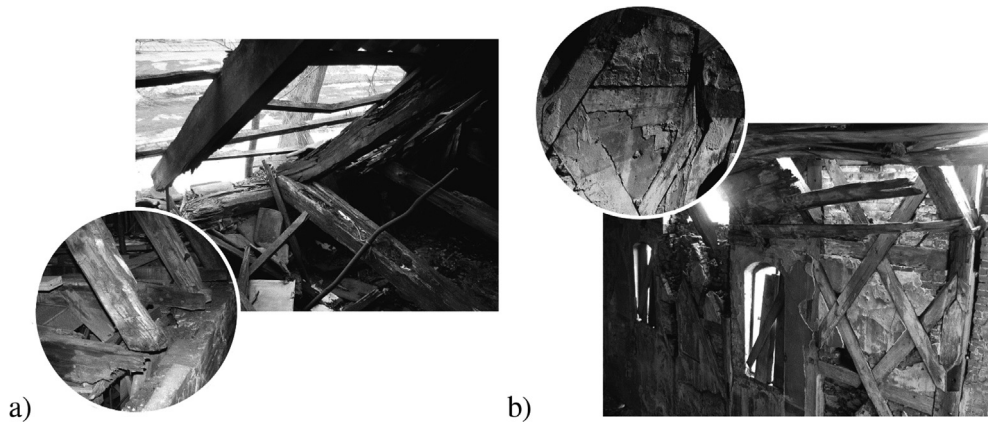
Fig. 6. Damage to (a) ceiling, rafter, wall beams and (b) timber wall frames (inner view of the south wall).

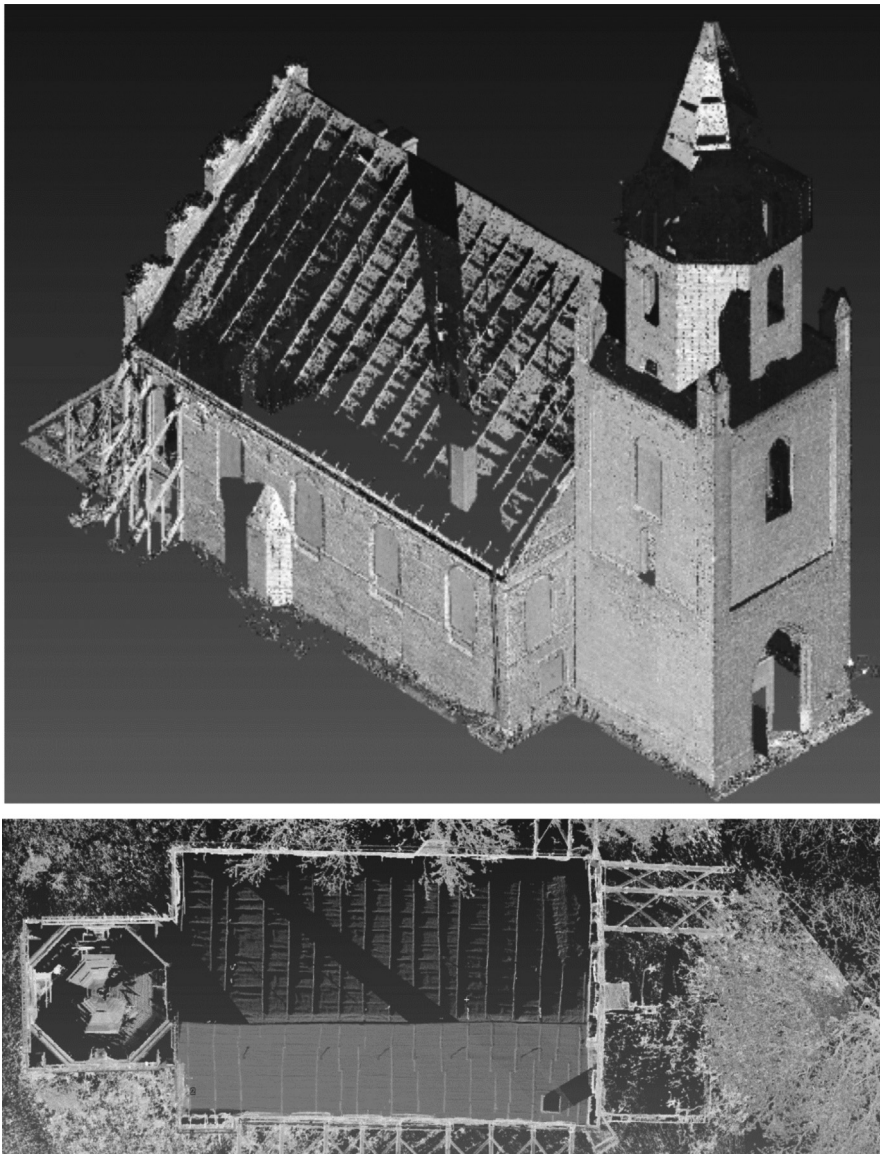
Fig. 8. View of the cloud of points.

The numerical models of the structures were created based on a standard architectural inventory with support from laser scanning (see Fig. 8). This technique and other similar techniques are not new and have been used for similar purposes, as presented in detail in [9,21]. A Leica ScanStation P20 3D laser scanner was used for the inventory. The data acquisition was based on the resolution

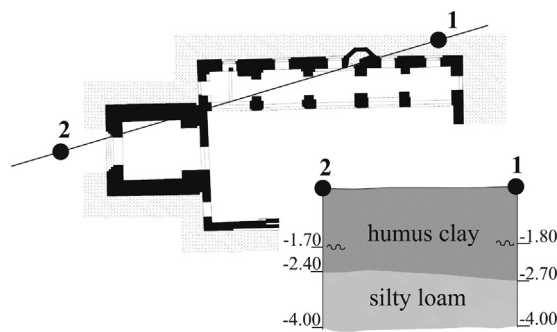
Fig. 9. Geotechnical research map.

structure [22] (see Fig. 9). In this paper, the support substrate on which the structure rests is treated in a simplified manner as a homogeneous and elastic material, without modelling the details of the support. The constrained modulus from oedometer testing is $E_{ode} = 29700 \text{ kPa}$ [22]. Assuming that the Poisson's ratio of the tested soil substrate is $\nu = 0.25$, we can determine the Young's modulus of the soil according to the formula $E = E_{ode} [(1 + \nu)(1 - 2\nu)] / (1 - \nu) = 24750 \text{ kPa}$ [23]. Furthermore, it is assumed that the average value of the soil mass is 1775 kg/m^3 .

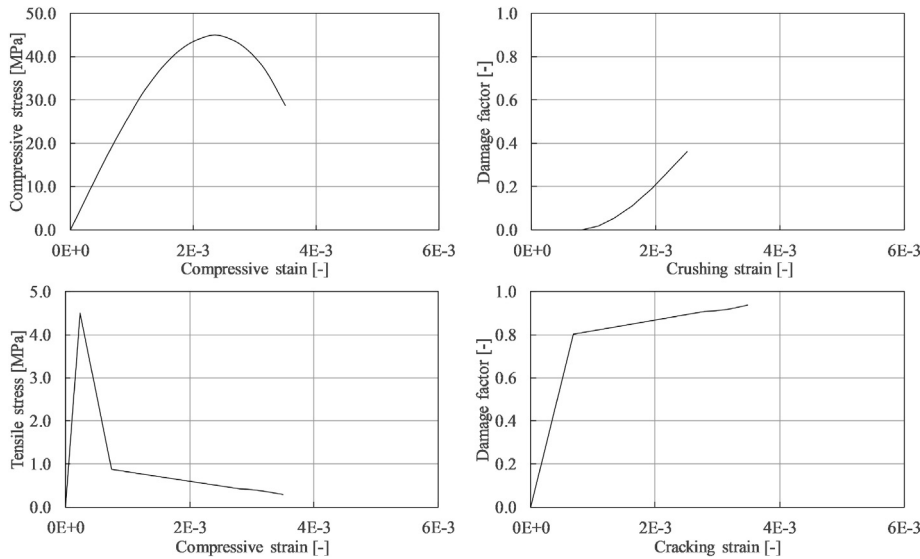
Fig. 12. Concrete properties.

1/2 and 3, 3% for material in phase 4 and 2.5% for material in phase 5). The values of the individual parameters are shown in Figs. 11 and 12.

Considering the material behaviour of the specific parts of the structure, the soil (basic and degraded), stone foundations and timber roof are modelled as linearly elastic (see Table 3), whereas the masonry walls (see Table 3 and Fig. 11) and concrete columns (see Fig. 12) are modelled as continuum plastic with damage and stiffness degradation in the sense of continuum damage mechanics. Plasticity-based damage constitutive modelling is widely used to describe the nonlinear properties of masonry structures and concrete. Such a model was first proposed for concrete analysis [37–39] and reinforced concrete (RC) structures [40] but also can be used to represent other brittle material behaviours such as for ceramic masonry structures [41,18,42]. The applied material model is described extensively in [36]. It assumes that the main two failure mechanisms are tensile cracking and compressive crushing of the masonry or concrete. The evolution of the yield (or failure) surface is controlled by two hardening variables $\tilde{\varepsilon}_t^{pl}$, which is a tensile equivalent plastic strain, and $\tilde{\varepsilon}_c^{pl}$, which is a compressive plastic strain. Both refer to failure mechanisms under tension and compression loading. It assumes that uniaxial tensile and compressive response of the brittle-like material is characterized by damage plasticity, as shown in Figs. 11 and 12.

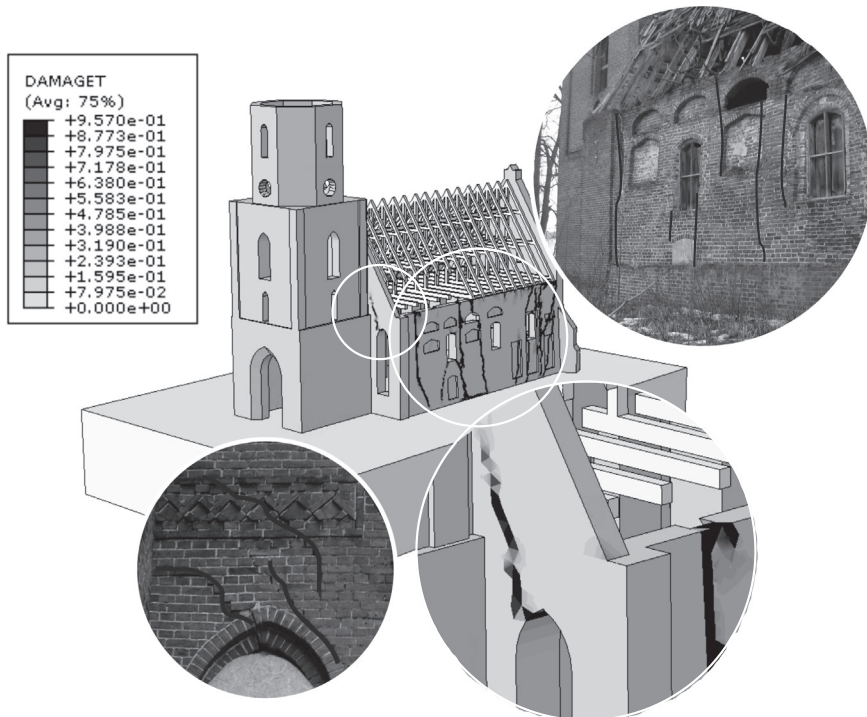
Fig. 14. Selected details of main cracks on the west-south walls compared with FEM solutions expressed by tension damage factor DAMAGET.

The main results of the numerical analysis are shown in Figs. 14–16. All the main cracks of the real structure of the church are reflected by the numerical results. Fig. 14 shows the main cracks of the west-south walls in the real structure and the resulting

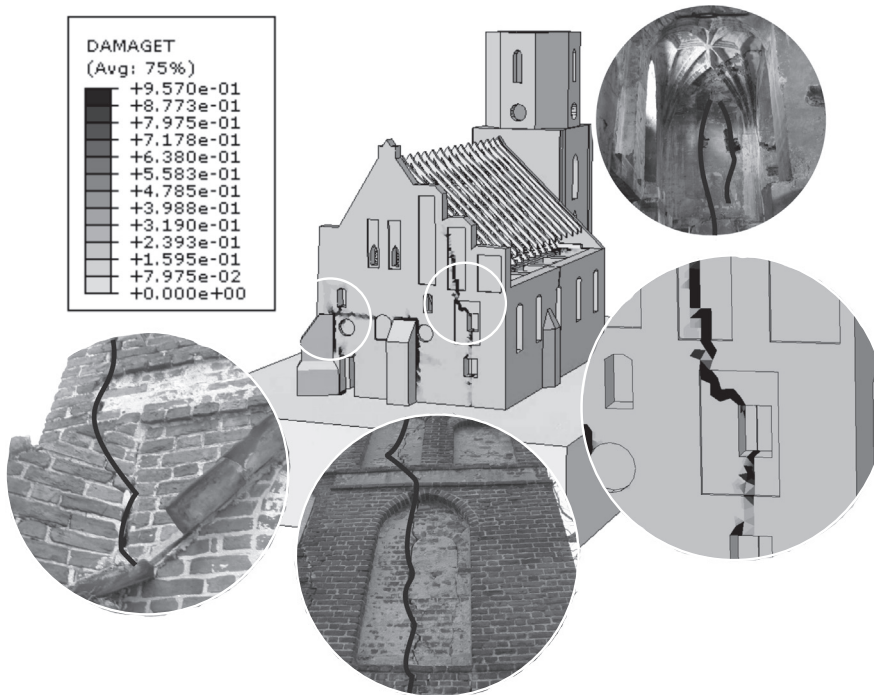
Fig. 15. Selected details of main cracks on the east wall compared with FEM solutions expressed by tension damage factor DAMAGET.

damage obtained from the numerical analysis. Similarly, the main damage to the east wall and the damage to the inner nave arch are presented together with the appropriate numerical results of the mechanical analysis in the Figs. 15 and 16.

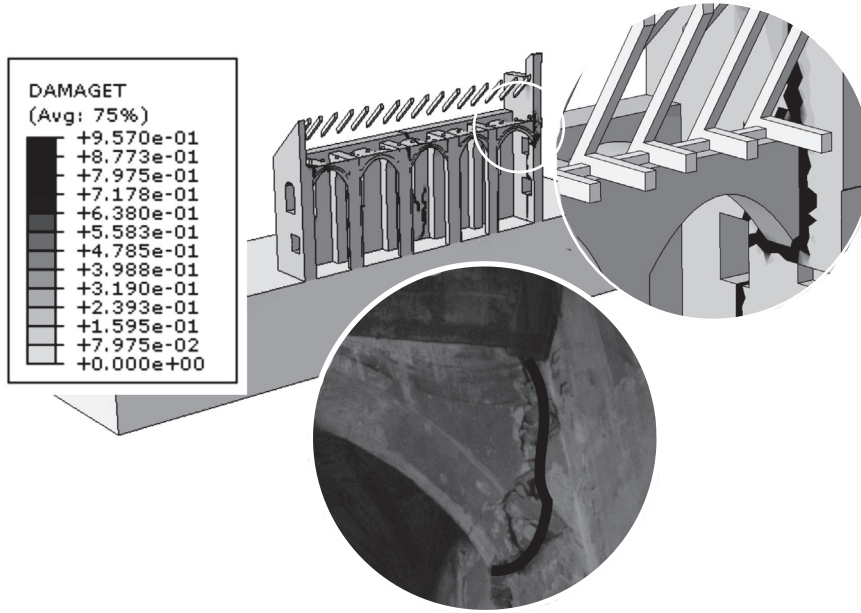
Fig. 16. Selected detail of main cracks on the arch of the inner nave compared with FEM solutions expressed by tension damage factor DAMAGET.

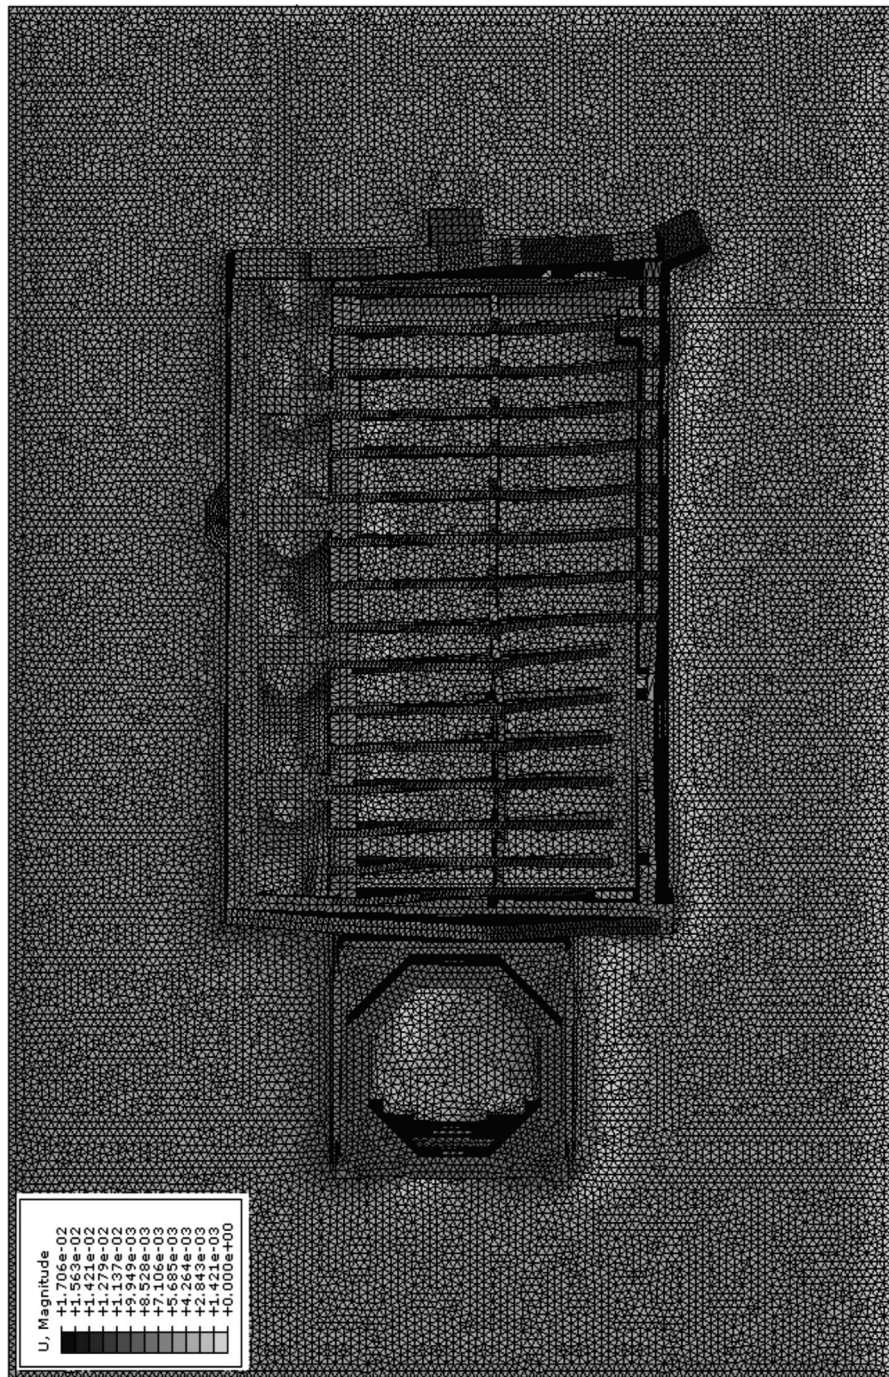
Fig. 18. Numerical solution – deformations [m] according to soil volume at $H = 1.5$ m ($L = 37$ m, $B = 24$ m).
