Finite element modelling of a historic church structure in the context of a masonry damage analysis

Marcin Kujawa^{a,*}, Izabela Lubowiecka^a, Czesław Szymczak^b

^a Gdańsk University of Technology, Faculty of Civil and Environmental Engineering, Department of Structural Mechanics, G. Narutowicza 11/12, 13 80-233 Gdańsk, Poland

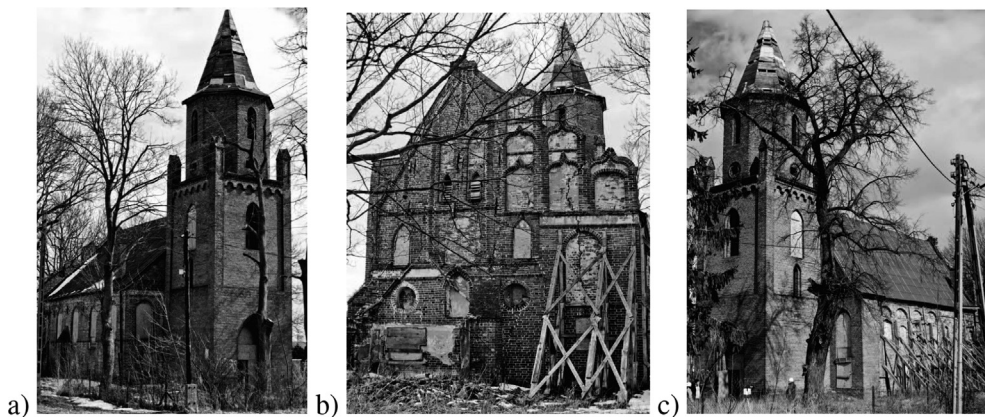
Fig. 2. Views of the church (a) north-west, (b) east, (c) west-south.

In the XIX century, two brick buttresses were built in the western corner of the south wall and in the east wall (see Fig. 4). In 2009, during the renovation, three columns of concrete were built into the southern inner wall (see Figs. 3 and 4). These three pillars are not founded on any foundation. The eastern wall is also comprised of two layers, and some vertical cracks of significant width are observed on it (see Figs. 2 and 15).

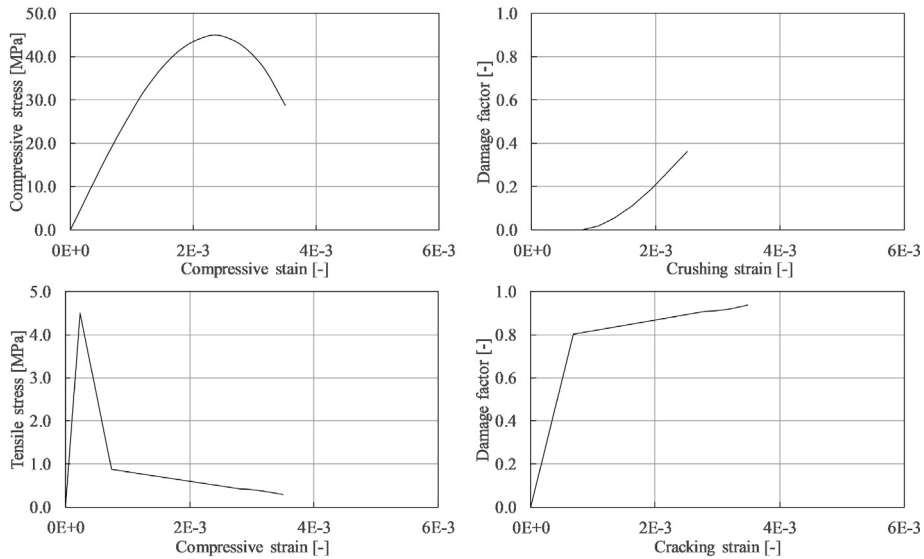
Fig. 12. Concrete properties.

1/2 and 3, 3% for material in phase 4 and 2.5% for material in phase 5). The values of the individual parameters are shown in Figs. 11 and 12.

Considering the material behaviour of the specific parts of the structure, the soil (basic and degraded), stone foundations and timber roof are modelled as linearly elastic (see Table 3), whereas the masonry walls (see Table 3 and Fig. 11) and concrete columns (see Fig. 12) are modelled as continuum plastic with damage and stiffness degradation in the sense of continuum damage mechanics. Plasticity-based damage constitutive modelling is widely used to describe the nonlinear properties of masonry structures and concrete. Such a model was first proposed for concrete analysis [37–39] and reinforced concrete (RC) structures [40] but also can be used to represent other brittle material behaviours such as for ceramic masonry structures [41,18,42]. The applied material model is described extensively in [36]. It assumes that the main two failure mechanisms are tensile cracking and compressive crushing of the masonry or concrete. The evolution of the yield (or failure) surface is controlled by two hardening variables $\tilde{\varepsilon}_t^{pl}$, which is a tensile equivalent plastic strain, and $\tilde{\varepsilon}_c^{pl}$, which is a compressive plastic strain. Both refer to failure mechanisms under tension and compression loading. It assumes that uniaxial tensile and compressive response of the brittle-like material is characterized by damage plasticity, as shown in Figs. 11 and 12.

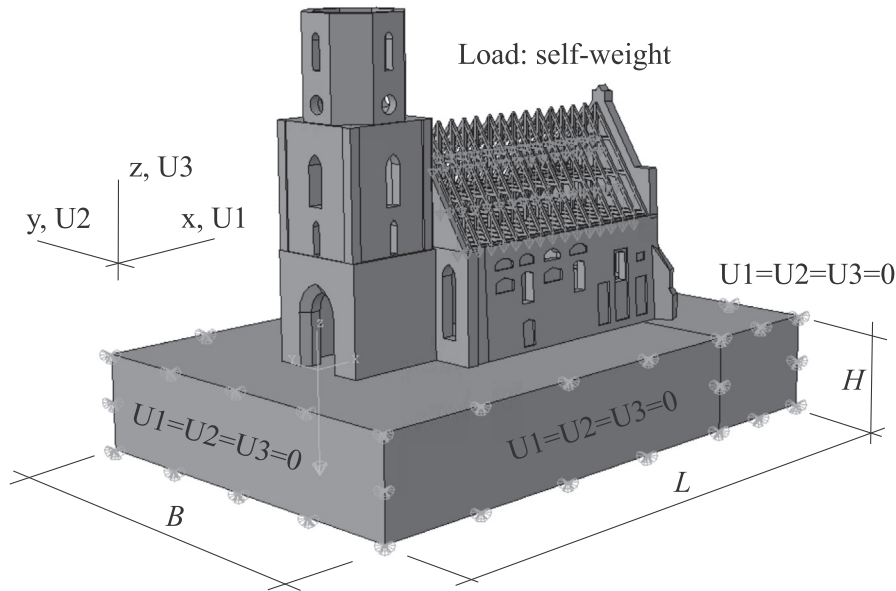
Fig. 13. FEM model: load and boundary conditions.

The whole numerical model (see Fig. 13) is built of 4-node linear tetrahedral volumetric finite elements with one integration point and three degrees of freedom in each node-type C3D4 [35]. The total number of finite elements in all the analysis cases equals approximately 3.5 million. The FE mesh density was determined in a parametric study based on convergence analysis of the cracked form. The numerical model is loaded only by its self-weight. The geometrically nonlinear analysis was performed using a dynamic explicit procedure [36], as it is computationally efficient for the analysis of large models with relatively short dynamic response times and for the analysis of extremely discontinuous events or processes. The dynamic explicit analysis can also be used to perform a quasi-static analysis. In the proposed numerical solution (quasi-static technique), the load is applied smoothly; consequently, slow deformation triggers a low strain rate. This type of analysis allows for using a consistent, large-deformation theory. In view of the above, the proposed method of analysis is highly effective for studying the damage and degradation of masonry structures. Due to this approach, one can track very carefully the propagation of gradually occurring damage (like cracking and crushing) under an increasing load value, regardless of the type of loads. The ABAQUS package apparently offers several other methods performing dynamic analysis of nonlinear problems, such as implicit dynamic analysis. However, implicit dynamic analysis is not as effective as the explicit approach. The authors' experience shows that while modelling large complex nonlinear problems, like damage of masonry structures, a solution convergence problem often emerges at the time of structural degradation start while applying implicit dynamic analysis.

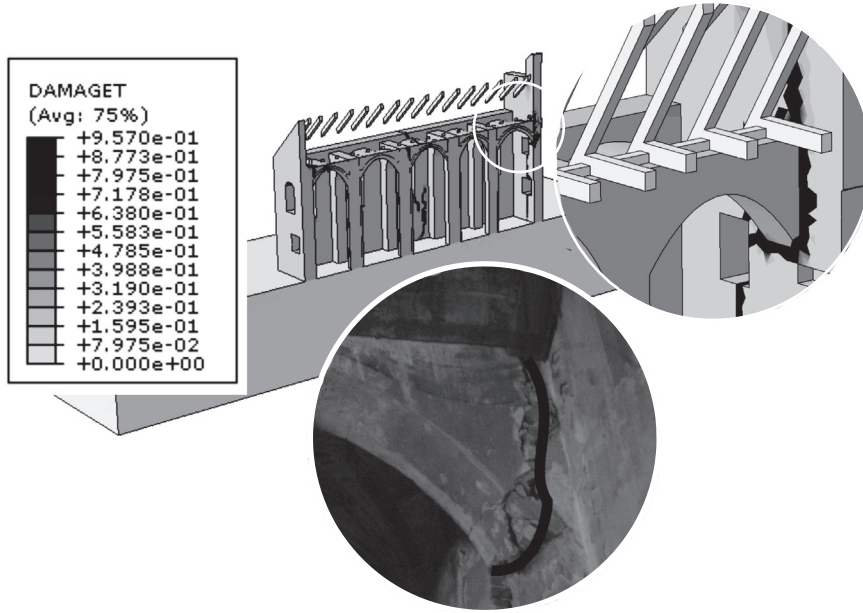
Fig. 16. Selected detail of main cracks on the arch of the inner nave compared with FEM solutions expressed by tension damage factor DAMAGET.

damage obtained from the numerical analysis. Similarly, the main damage to the east wall and the damage to the inner nave arch are presented together with the appropriate numerical results of the mechanical analysis in the Figs. 15 and 16.
