Condition of reinforced concrete structures and their degradation mechanism at the former Auschwitz concentration and extermination camp

The paper presents the results of investigations on reinforced concrete structures present in the former Auschwitz I and Auschwitz II-Birkenau concentration and extermination camp. Field inspection employing non-destructive method of reinforcement potential measurement according to the ASTM-C 876-15 standard, followed by laboratory investigations performed on genuine historic reinforced concrete samples collected from the former Auschwitz camp allowed assessment of the actual condition of this 70-year old construction material. Electrochemical potential measurements allowed mapping of the regions characterized by enhanced reinforcement corrosion risk and the regions of its immunity. Composition of concrete, water absorbency, content of detrimental salts, degree and profile of carbonation as well as mechanical properties were evaluated. The obtained results revealed the most common and probable mechanism responsible for degradation of the reinforced concrete structures in the former Auschwitz camp.

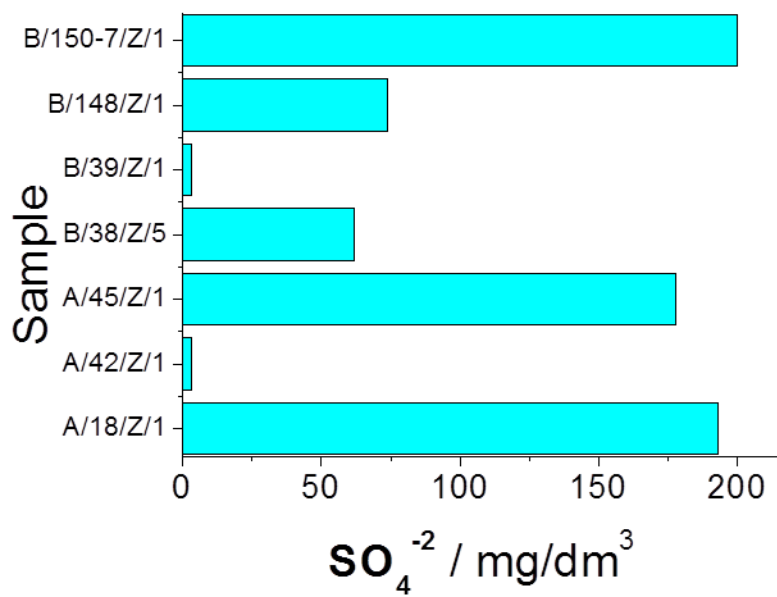
Figure 12

The content of sulphate ions is between 3mg/dm^3 and 200mg/dm^3 (Fig. 12). In this case it is impossible to find any territorial relation either with the Auschwitz I or with the Auschwitz II-Birkenau. The main reason of SO_4^{2-} ions presence is most probably connected with atmospheric pollution due to industrial plants and transportation routes localized nearby. Emission of sulphur oxides to the atmosphere, where they combine with water forming acid is a direct source of sulphate ions. Presence of these acidic species contributes to a decrease in alkalinity of concrete and this enhances the process of carbonation.

Fig. 12. Concentration of sulphate ions in analysed concrete samples.
