## **Condition of reinforced concrete structures and their degradation mechanism at the former Auschwitz concentration and extermination camp**

The paper presents the results of investigations on reinforced concrete structures present in the former Auschwitz I and Auschwitz II-Birkenau concentration and extermination camp. Field inspection employing non-destructive method of reinforcement potential measurement according to the ASTM-C 876-15 standard, followed by laboratory investigations performed on genuine historic reinforced concrete samples collected from the former Auschwitz camp allowed assessment of the actual condition of this 70-year old construction material. Electrochemical potential measurements allowed mapping of the regions characterized by enhanced reinforcement corrosion risk and the regions of its immunity. Composition of concrete, water absorbency, content of detrimental salts, degree and profile of carbonation as well as mechanical properties were evaluated. The obtained results revealed the most common and probable mechanism responsible for degradation of the reinforced concrete structures in the former Auschwitz camp.

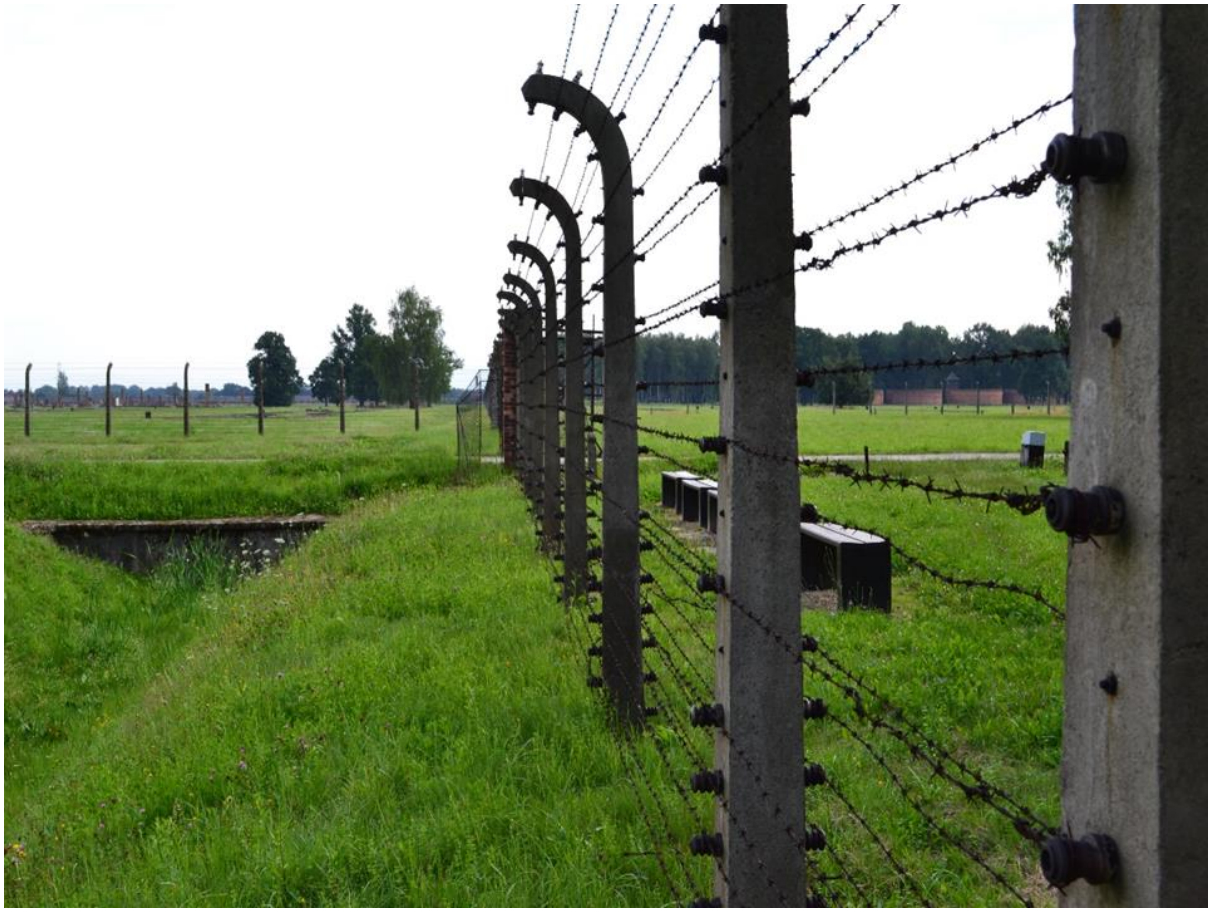
Figure 1

Fig. 1. Landscape of the former Auschwitz II-Birkenau camp with numerous concrete structures including poles of the electric fence and sewage channels.

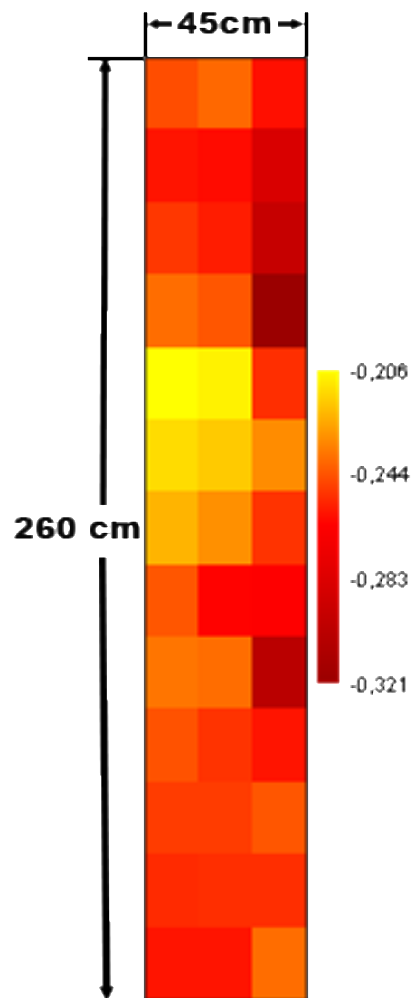
Fig. 6 presents investigation of electrochemical potential of reinforcing steel of a concrete pole of the fence located in a park outside the building of camp commandant in the former Auschwitz I. Potential measurements encompassed the entire height and width of the pole. Successive measurements formed a grid with 20cm spacing between measurements along vertical direction and 15cm spacing along horizontal direction. The grid was chosen in the way providing measurements at the position of reinforcements as well as in the locations where no reinforcement, just concrete was present underneath. Position of the reinforcement was identified prior to the measurements based on visual assessment of damaged bottom part of the pole, where the reinforcement had been revealed. The obtained potential map encompassing the entire pole height and width (Fig. 6a) shows that the reinforcement potential is between 0.206V and -0.312V, which according to the standard means that corrosion activity is uncertain. Generally, lower potential values are recorded along the right edge of the pole suggesting higher likelihood of corrosion. The measurement results are consistent with visual observations performed on site, which revealed no significant degradation of the pole. Only small concrete cracks running from the edge of the pole were detected. They probably resulted from mechanical stresses imposed by winds impacting the fence. However, neither large cracks penetrating the bulk of concrete cover nor any fragments of concrete spalling were noticed, which suggest at most moderate corrosion risk of embedded reinforcing steel.

Fig. 6. Electrochemical potential map (a) and potential measurement execution (b) on reinforced concrete pole of the fence in a park outside the building of Auschwitz camp commandant.

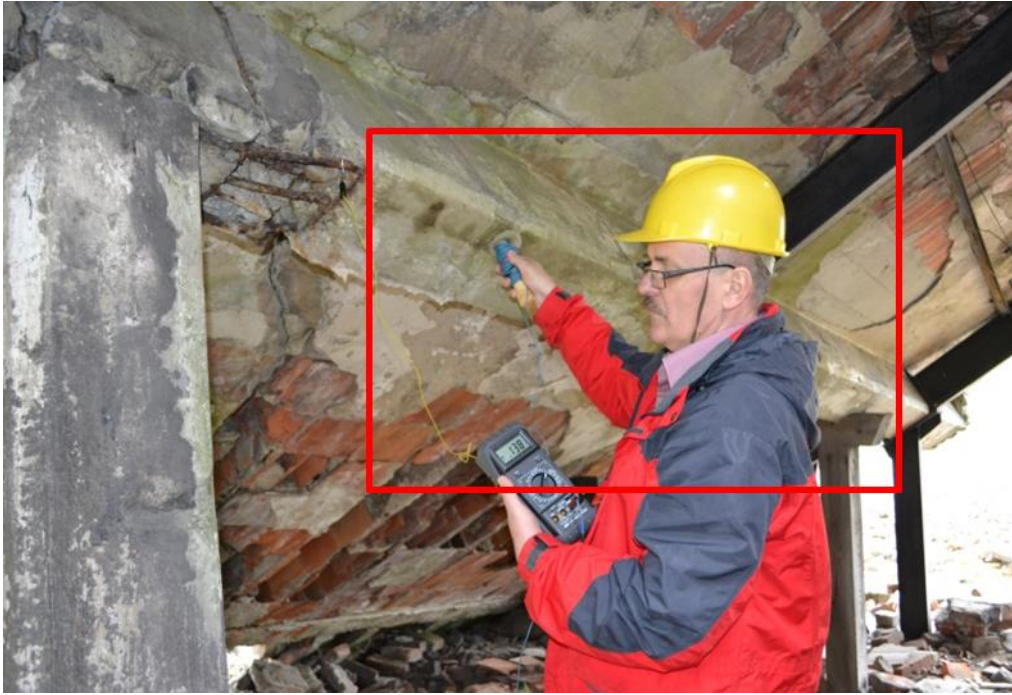
Investigation of electrochemical potential of the reinforcing steel of a concrete floor beam inside the ruins of crematorium no. 2 in the Auschwitz II-Birkenau is illustrated in Fig. 7.

Successive measurements formed a grid with 20cm spacing between measurements along the length of the beam and 15cm spacing along its width. The grid was chosen in the way providing measurements at the position of reinforcements as well as in the locations where no reinforcement, just concrete was present underneath. Position of the reinforcement was identified prior to the measurements based on visual assessment of damaged part of the beam, where the reinforcement had been revealed. The potential map encompassing a section of the beam 160cm x 45cm (Fig. 7a) reveals that the reinforcement potential is between -0.115V and -0.185V. The ASTM-C 876-15 standard classifies such situation as the one in which there is a greater than 90% probability that no reinforcing steel corrosion is occurring in that area at the time of measurement. Indeed, the examined fragment of the beam is characterized by high mechanical integrity, it is free of large cracks, protrusion and spalls. The reason could be that this floor beam is located inside the crematorium ruins (Fig. 7b) and hence it is not directly exposed to atmospheric precipitation. The latter could have contributed to impeding concrete degradation process. Moreover, further studies on depth of carbonation showed that such elements of the crematorium ruins as floors and beams possess a relatively thick layer of concrete cover over the reinforcing steel. Accordingly, the carbonation process has not reached the reinforcement yet, thus maintaining low corrosion risk.

Fig. 7. Electrochemical potential map (a) and potential measurement execution (b) on reinforced concrete floor beam inside the ruins of crematorium no. 2 in the Auschwitz II-Birkenau.
