Article

Short and Long Term Measurements in Assessment of FRP Composite Footbridge Behavior

Abstract: The paper presents application of different sensors for the purpose of short and long term measurements, as well as a structural health monitoring (SHM) system to assess the behavior of a novel fiber reinforced plastics (FRP) composite footbridge. The aim is to present a thorough and concise description of these sensors networks and results gathered with their aid during in situ measurement of strains, displacements, and vibrations, as only a few works are available in this field. The bridge geometry, material solutions, and properties are described at first. Then the measurement devices composing the system and subsystems of sensors are elaborated on. Subsequently, the bridge research program is described and the results are shown and discussed. Finally, it is concluded that the use of selected sensors is helpful in assessment of the behavior of the novel structure, and moreover in validation of its numerical models. The collected data confirmed many assumptions made during the bridge design process and allowed us to accept it for exploitation.

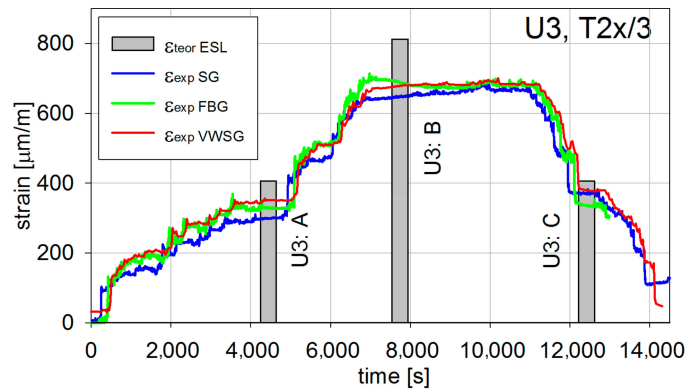
Figure 16. Longitudinal strains in T2x/3 for the U3 test.

During the short-term load tests, all three systems of strain measurement sensors were used. The exemplary results, being the extreme values, shown in Figures 15 and 16, present registered strains (temperature compensation had been made during the measure) correspondingly during U1 and U3 tests in T2x/3 measurement point (refer to Figures 5, 6, and 9). The experimental results ε_{exp} are compared with the numerical ones $\varepsilon_{\text{teor}}$ ESL. The results in the remaining measurement points reveal similar character and result precision, and hence are not depicted.

All strains measured with three different techniques are quite comparable. Therefore, it can be concluded that the in situ strain values are correct. The differences observed between them are caused mainly by slightly different locations of sensors. It is not possible to locate all of them precisely at the same point of the bridge. Additionally, the measurements can be also influenced by the sensor characteristics and their measuring precision. The numerical values are higher or close to the in situ ones. This shows that the structure is in general stiffer than it was designed to be and therefore enables safe exploitation.

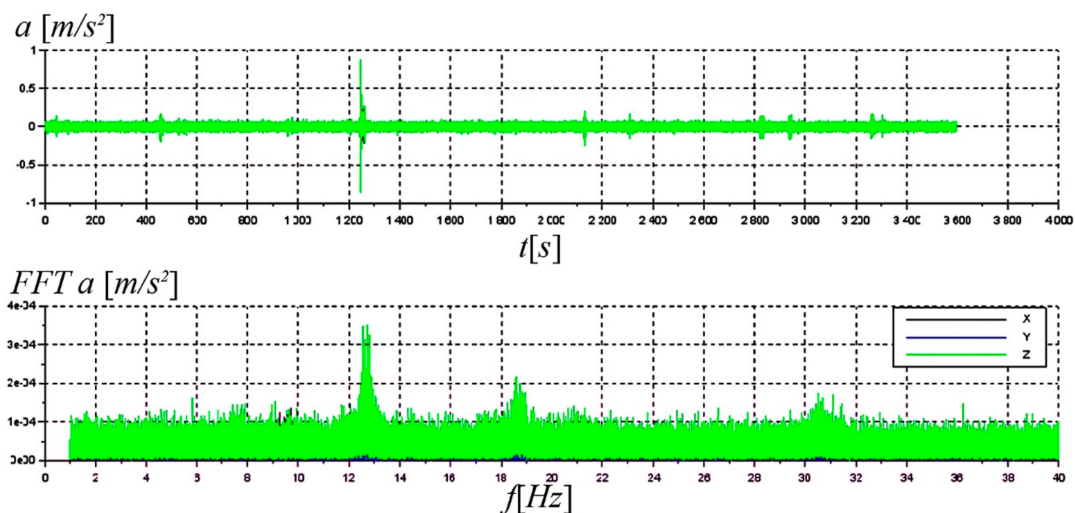
Figure 27. Example data of vibration monitoring with FFT analysis.

While performing the ambient testing, small groups of people only visited the footbridge occasionally. The object was located at the GUT campus beyond the main pedestrian traffic areas and was not used intensively. But the vibration monitoring system was still able to identify some natural frequencies of the structure. The natural frequencies analysis were limited to 40 Hz, due to numerical analysis results (see reference [34]), which showed that the basic structural characteristics fall within this range. The Fast Fourier Transform was obtained automatically with its own system continuously analyzing the recorded signal. In Figure 27 the exemplary measurement data with FFT analysis is presented. It may be observed that the values of around 12.5 Hz and 18.4 Hz are noticeable in the frequency domain. They correspond to the values of 3rd and 5th natural frequencies identified during short-term dynamic tests [34]. The values of natural frequencies did not change throughout the entire research period. On this basis, it can be concluded that the structure global stiffness did not change.
