# Short and Long Term Measurements in Assessment of FRP Composite Footbridge Behavior

Faculty of Civil and Environmental Engineering, Department of Mechanics of Materials and Structures, Gdańsk University of Technology, G. Narutowicza 11/12, 80-233 Gdańsk, Poland; mikolaj.miskiewicz@pg.edu.pl (M.M.); bartosz.sobczyk@pg.edu.pl (B.S.)

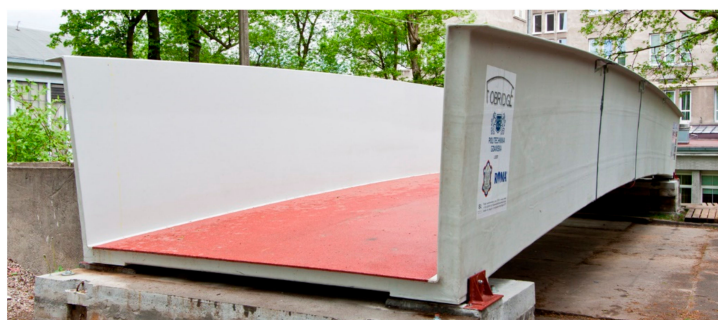
**Figure 1.** Composite footbridge designed within the FOBRIDGE project.

In 2015, the consortium associating Gdańsk University of Technology (GUT), Military University of Technology in Warsaw and ROMA Co. Ltd. (Grabowiec, Poland) constructed a single element, sandwich composite footbridge with a span of 14 m long using vacuum infusion technology (Figure 1). This is the final product of the FOBRIDGE project, which aims to design pedestrian and cyclist bridges made of composite materials for use over dual carriageways and motorways. The footbridges were designed from scratch. The whole process resulting in bridge production included development of a preliminary concept, material selections, identification of material properties, numerical simulations, strength calculations, and serviceability analyses. The structure is innovative aforementioned for these reasons. According to the author knowledge, it has been the first structure in the world to be classified as a consistent, single element structural girder, without any connectors or fasteners, made of sandwich shells, entirely produced in a single cycle vacuum infusion process. The application of non-classical materials caused problems, as no guidelines nor recommendations were available in existing design codes during project realization. This is why the project was expanded to include additional material parameters identification, validation analyses at different complexity levels, and experimental tests.

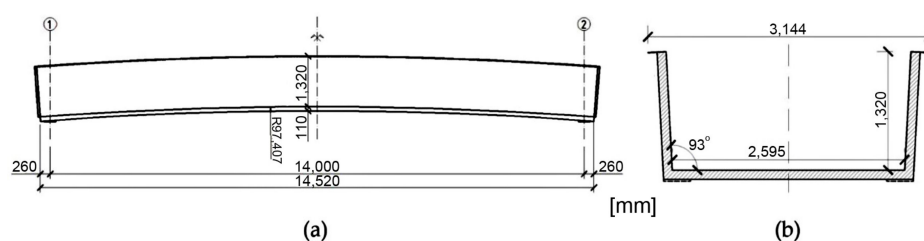
**Figure 2.** Footbridge views: (a) Side view; (b) Cross section.

The considered footbridge is a composite, U-shape, simply supported, shell-type sandwich structure, the dimensions of which are shown in Figure 2. The total weight of the footbridge superstructure is 3200 kg. It is completely made of hi-tech composites, without any conventional elements. The footbridge was designed to carry a uniformly distributed 5 kN/m<sup>2</sup> service load.

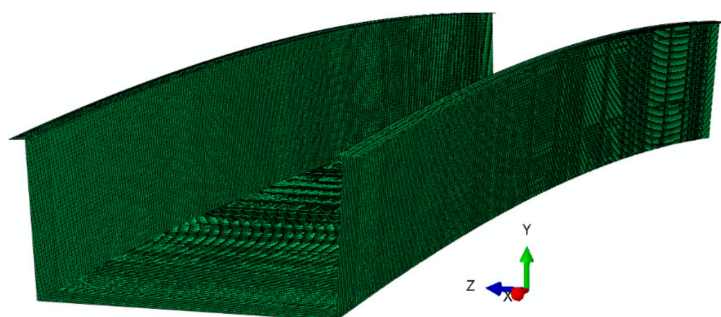
Figure 3. Visualization of the footbridge numerical model.

Many finite element method (FEM) computational models with different levels of complexity were created in order to estimate the bridge response under different conditions. They were used to carry on various studies intending to design the footbridge and establish a load tests program, including using a ballast selection or location of network of sensors. All the aforementioned studies were however preceded by complex validation analyses of laminate coupons, sandwich beams and 3 m long full-scale footbridge segment (see references [29,30]). In this paper some FEM estimations of strains and displacements under loads applied during short-term static load test are compared with the in-situ values in order to evaluate accuracy of measurements and modeling. A pure shell equivalent single layer (ESL) (refer to reference [31]) FEM model was used for this purpose (refer to Figure 3), which was motivated by the fact that in this case, only a global response of the bridge needed to be determined and consideration of local effects and influences could be avoided. The precision of numerical results was sufficient and relatively low computational effort was required. It is worth mentioning that the ESL was also found to be used in more sophisticated approaches of shell structures analysis [32].

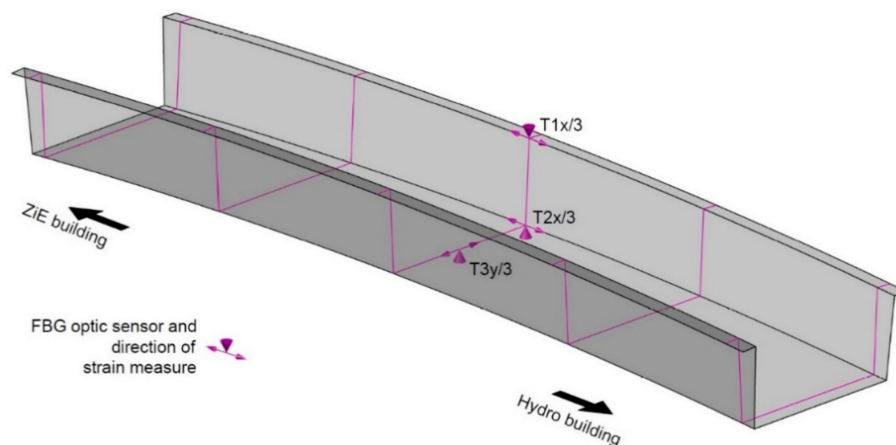
**Figure 5.** Location of FBG optic fiber sensors.

The fiber optic measurement system is based on two kinds of sensors. It includes three Bragg gratings to measure strain and one for temperature compensation. They form a one wire chain, ending in the SC/APC connector, see Figure 4. The following parameters characterize the Sylex (Bratislava, Slovakia) strain gauges used in measurements: 8 mm measuring length,  $0.85 \mu\epsilon$  resolution,  $1.7 \mu\epsilon$  accuracy, range of measure up to  $5000 \mu\epsilon$ . The temperature gauge parameters are:  $0.1 \text{ }^\circ\text{C}$  resolution,  $0.2 \text{ }^\circ\text{C}$  accuracy, in a measuring range from  $-20 \text{ }^\circ\text{C}$  to  $+150 \text{ }^\circ\text{C}$ . The single strain gauge length is 30 mm, it was fixed to the structure by the cyano-acrylate dedicated glue. The measurements were carried out using the Sylex SCN-80 S-line Scan 800 interrogator and a computer with dedicated ILLumiSense Strain software. The locations of the sensors are shown in Figure 5, they are all placed in one cross-section at the mid-span.

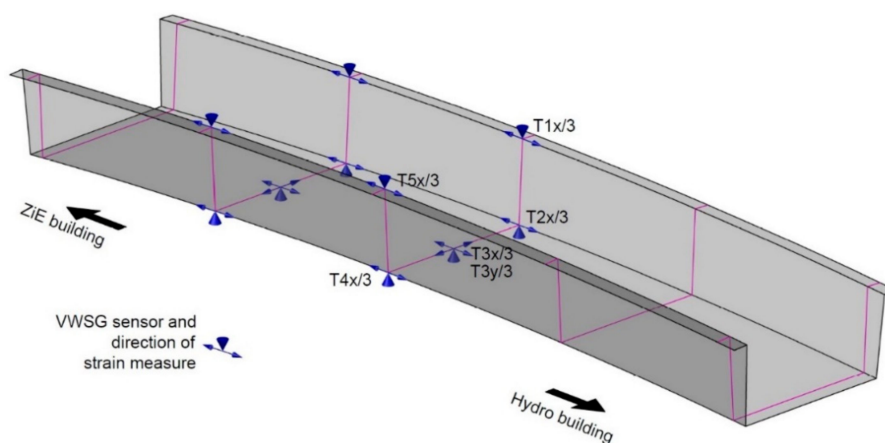
**Figure 6.** Location of VWSG sensors.

The VWSG measurement system is based on twelve GEOKON strain and temperature model 4000 gauges. The strain is measured on the basis of changes in the natural frequency of a string attached to anchor blocks inside a device. The system is characterized by a very good stability during long-term monitoring. The sensors are connected to the 16-channel recorder, which initiates the measurement within a given time interval. The parameters of the sensors are: measuring length of 150 mm, measuring range up to 3000  $\mu\epsilon$ , resolution of 1  $\mu\epsilon$ , accuracy <0.5% FS, temperature range  $-20\text{ }^{\circ}\text{C}$  to  $+80\text{ }^{\circ}\text{C}$ , simultaneous measurement of temperature and strain. The locations of the VWSG are shown in Figure 6. The sensors are placed in two cross-sections, at quarter and mid-span. One of the sensors, being fixed to the bridge deck is presented in Figure 7.

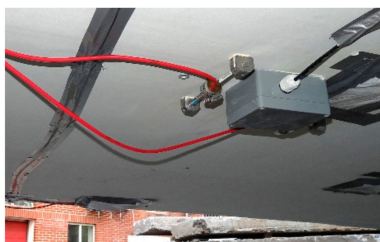
Figure 7. VWSG sensor fixed to the bridge.

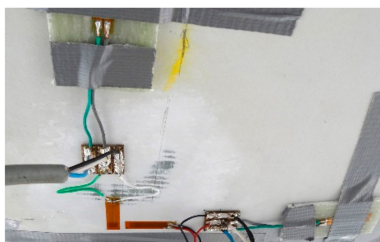
Figure 8. SG sensors mounted to the structure.

The measurement system is based on the electrical resistance strain gauges. The Hottinger Baldwin Messtechnik (HBM) (Darmstadt, Germany) foil gauges are used. They have the following properties: active grid length of 20 mm, 120  $\Omega$  nominal resistance and 50,000 microstrain range. Temperature is compensated in each measurement point using individual sensors, as is shown in Figure 8. The measurements were carried out using the HBM QuantumX MX1615B strain gauge bridge amplifier and a computer with dedicated the CatmanEasy/AP software. The locations of the sensors are shown in Figure 9, they are placed at the quarter spans and at the mid-span and over the supporting area (a rosette).

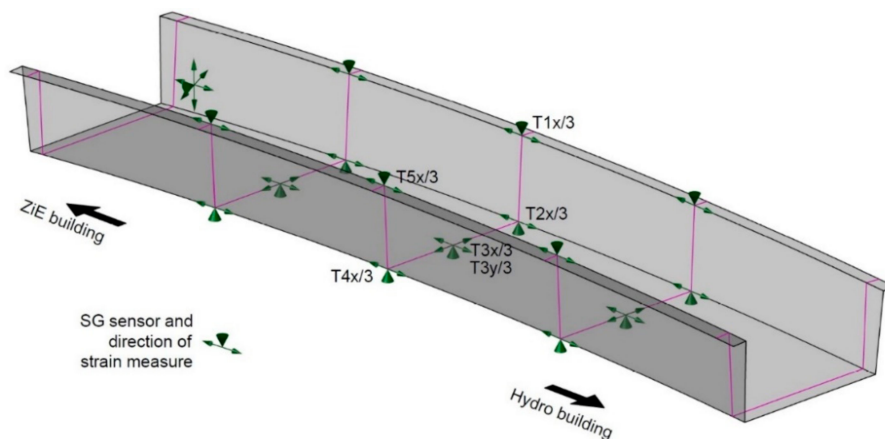
Figure 9. Location of SG sensors.

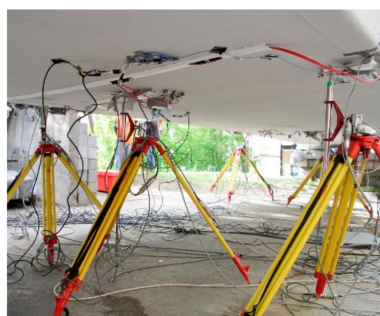
**Figure 10.** Inductive transducers used during measurements.

The displacement measurement subsystem includes inductive transducers (see Figure 10) and precision leveling. The nine 100 mm range HBM inductive transducers connected to the HBM MX840B universal amplifiers are located as shown in Figure 11. The precision leveling measurement by Leica Geosystems (Heerbrugg, Switzerland) Nova TM50 Robotic Total Station was achieved with an accuracy of 0.1 mm in the locations presented in Figure 11 as well.

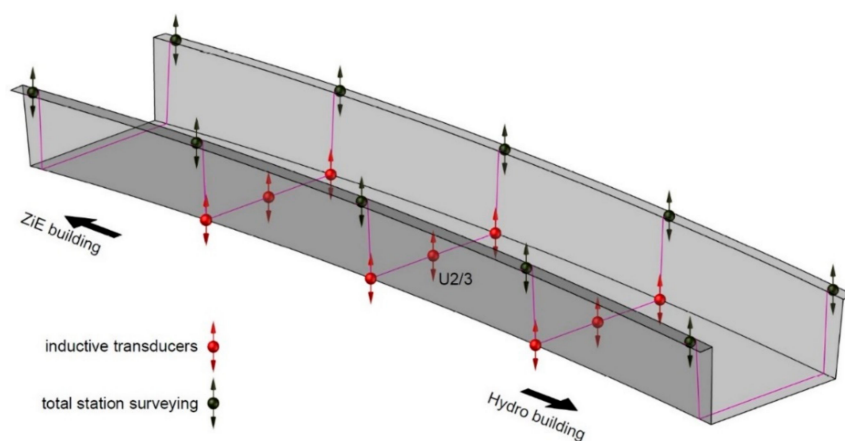
**Figure 11.** Location of displacement measurement points: inductive transducers and total station surveying.

Also, displacements were measured during the short-term test. The example results from inductive sensors are shown in Figures 17 and 18 correspondingly for U1 and U3 tests in U2/3 points, for which extreme values were reported (refer to Figure 11).

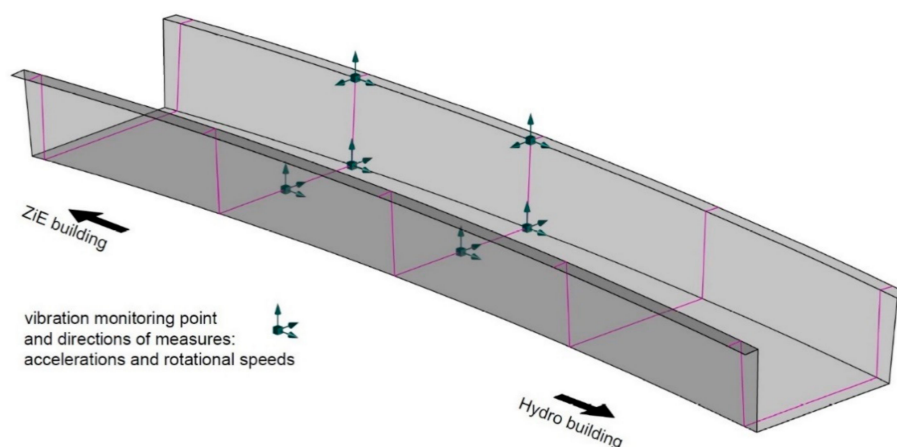
Figure 12. Location of vibration monitoring sensors.

The vibration measurement subsystem was based on a six-channels prototype sensors. They comprise of three integrated orthogonal channels to measure accelerations and three orthogonal channels to measure rotational speed. The accelerometers output range is  $\pm 2$  g, the default frequency measure capabilities range from 0 Hz to 40 Hz (possible to 200 Hz), and the error of non-linearity is 0.5%. The gyroscopes range is  $\pm 250$  °/s, the default and possible frequency range is the same as above and the error of non-linearity is 0.2%. The data is sent to a workstation the via internet. This allows for previewing results in real time and data archiving. It also provides a possibility of measurement signal post processing at any time. The sensors are designed to work in temperatures from  $-30$  °C to  $+85$  °C and have a degree of protection of IP67. The system, in total, contains six sensors, six-channels each, giving eighteen measurement points. Their locations are shown in Figure 12.

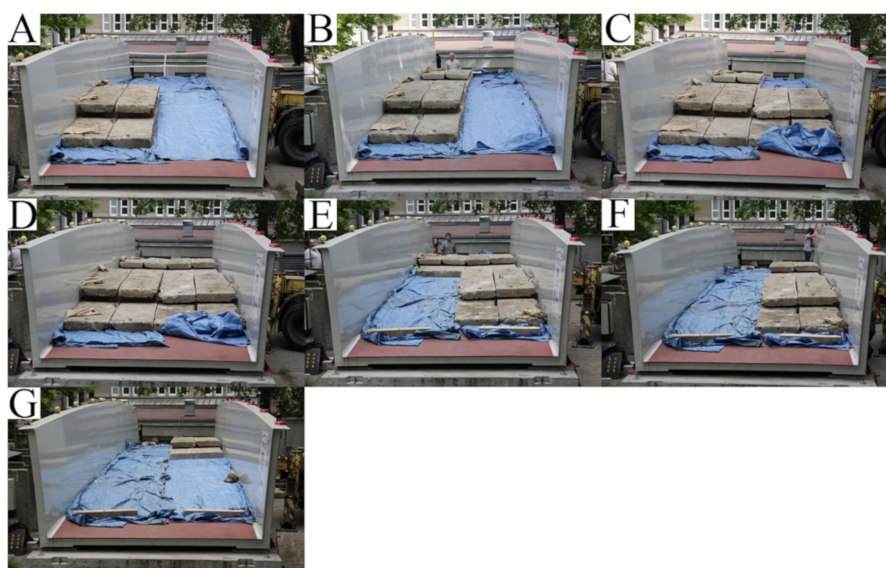
Figure 13. Loading sequence during the U1 test (from A to G).

In all static cases, the ballast was applied using concrete slabs. The total weights of the slabs during the tests were—U1: 141.2 kN, U2: 150.0 kN, and U3: 201.7 kN. The load was always put on the deck in subsequent steps. During the U1 test, the concrete slabs were placed in seven steps from A to G (each quarter of the deck) were loaded separately, see Figure 13. During U2 and U3 tests in three steps from A to C, each half of the deck loaded separately, see Figure 14. The ballast was laid on the structure in stages, asymmetrically, with respect to the longitudinal and transverse axes of the footbridge. The approach, in which so many different types of measuring points are used, was designed to identify possible irregularities in the behavior of the footbridge parts.

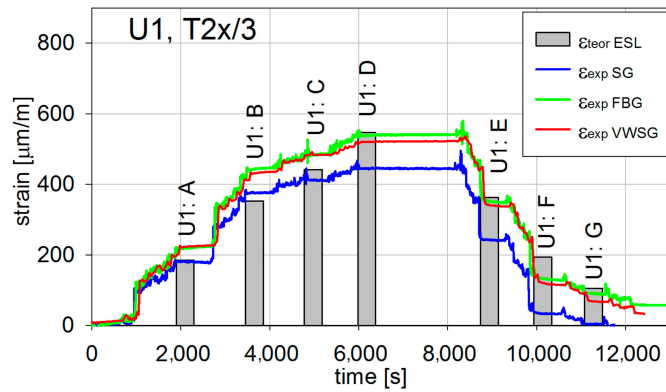
Figure 15. Longitudinal strains in T2x/3 for the U1 test.

During the short-term load tests, all three systems of strain measurement sensors were used. The exemplary results, being the extreme values, shown in Figures 15 and 16, present registered strains (temperature compensation had been made during the measure) correspondingly during U1 and U3 tests in T2x/3 measurement point (refer to Figures 5, 6, and 9). The experimental results  $\varepsilon_{\text{exp}}$  are compared with the numerical ones  $\varepsilon_{\text{teor}}$  ESL. The results in the remaining measurement points reveal similar character and result precision, and hence are not depicted.

All strains measured with three different techniques are quite comparable. Therefore, it can be concluded that the in situ strain values are correct. The differences observed between them are caused mainly by slightly different locations of sensors. It is not possible to locate all of them precisely at the same point of the bridge. Additionally, the measurements can be also influenced by the sensor characteristics and their measuring precision. The numerical values are higher or close to the in situ ones. This shows that the structure is in general stiffer than it was designed to be and therefore enables safe exploitation.

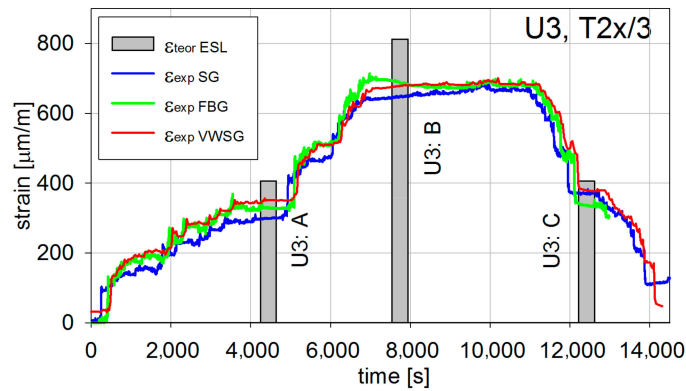
Figure 16. Longitudinal strains in T2x/3 for the U3 test.

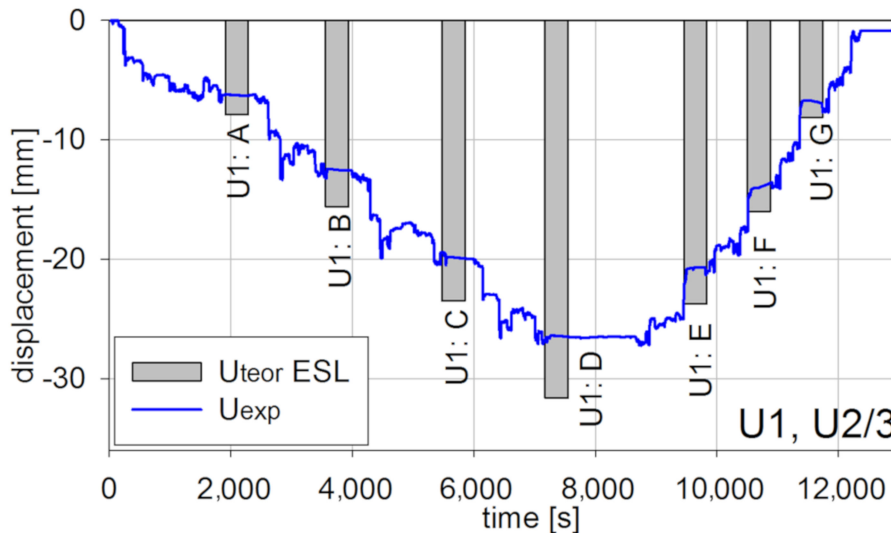
Figure 17. Vertical displacements in U2/3 for the U1 test.

The displacement inductive sensors measurements were checked using geodetic precision leveling and thus assessed as precise. Therefore, they can be used to assess the behavior of the innovative bridge. Similarly as in the case of a strain measure, the in situ measure revealed a stiffness margin for the safety of the bridge.

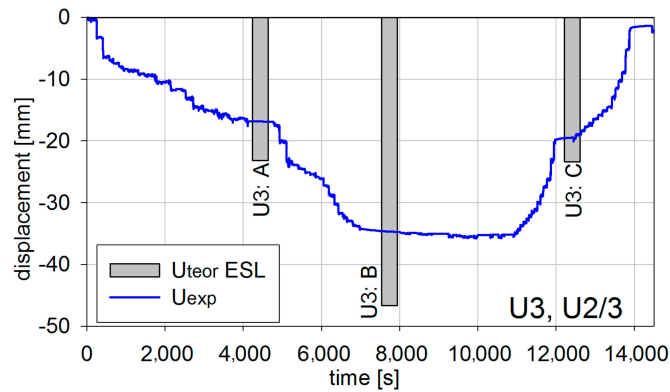
Figure 18. Vertical displacements in U2/3 for the U3 test.

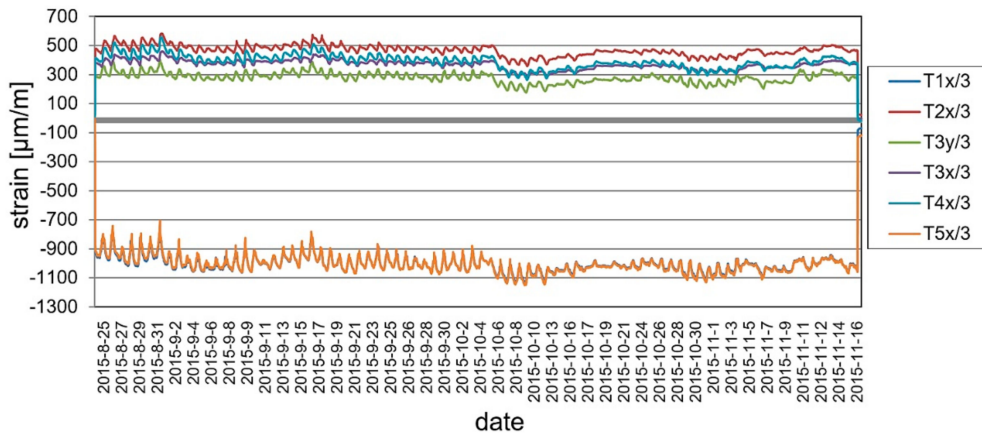
Figure 19. Strain monitoring using VWSG sensors during the long-term load test.

During the long-term load tests (U2 ballast had been left on the deck) the measurement system included VWSG sensors and vibration monitoring, as well as periodic precision leveling. The changes of the mid-span strains in time are shown in Figure 19, while the change of temperature in the same domain of time as presented for strains is shown in Figure 20. The established time intervals measurements in characteristic points of the structure by precision leveling is presented in Figure 21. For more detailed verification, regardless of whether the weight of the ballast caused rheological changes in displacements, the obtained results were normalized with respect to the deflection at start of the test. The result is shown in Figure 22.

As was predicted, only a small strain and displacement deviations are observed because of the diurnal and seasonal changes of temperature. The performance of the bridge did not change because of rheological effects and inelastic strains or permanent displacements did not occur.

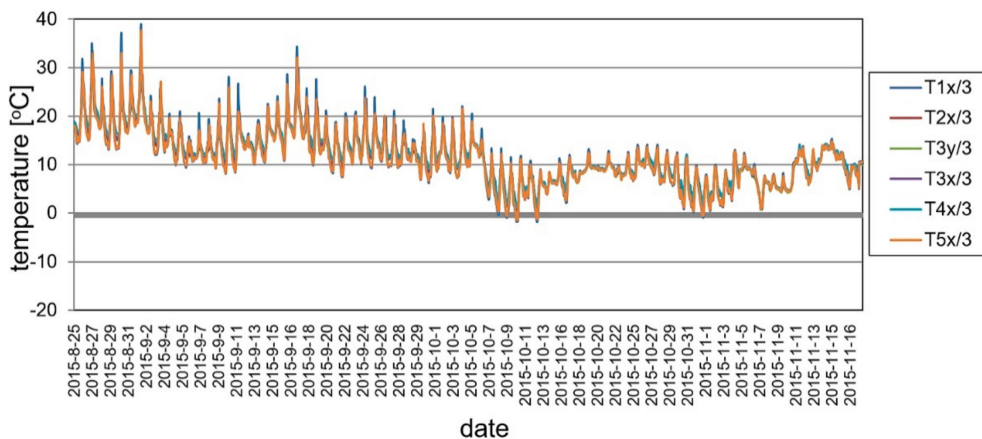
Figure 20. Temperature changes during the long-term load test.

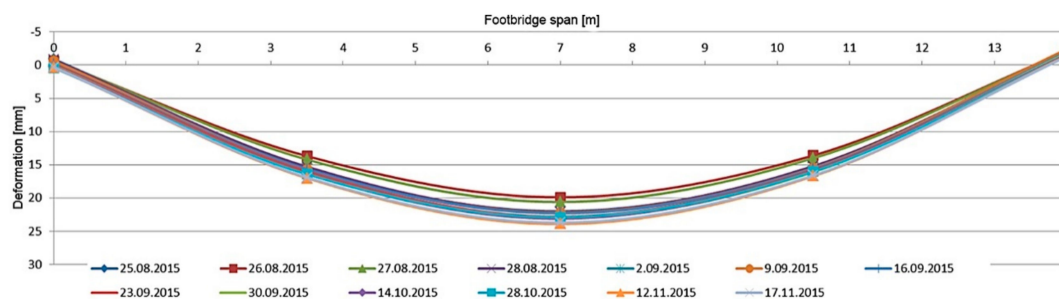
Figure 21. Displacements in U4 measurement points, footbridge with ballast.

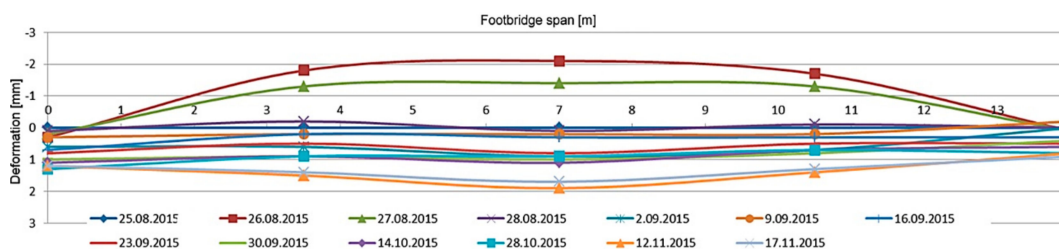
Figure 22. Normalized displacements in U4 points, footbridge with ballast.

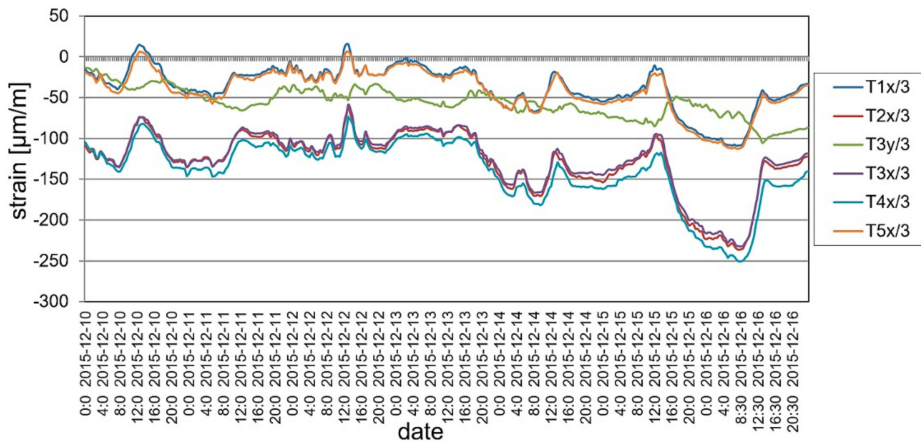
Figure 23. Strain monitoring using VWSG sensors during a one week period.

The structure was still continuously monitored by the SHM system when there were no static loads on the footbridge, between May 2015 and May 2016. In order to maintain readability of the recorded data, the presentation of results was limited to the periods of November 2015 and May 2016. The changes of the mid-span strains in time for ambient testing during a sample week period is shown in Figure 23. The temperature change in the same domain of time as presented for strains is shown in Figure 24. According to the surveillance observations and the gathered data the temperature changes and wind were the main influences affecting the footbridge. It can be observed in Figures 25 and 26, which are strains and temperature time histories throughout the six month monitoring period, that because of these effects, strains range from about  $-400$  to  $400$  microstrains. Nevertheless, higher values were calculated at the stage of bridge designing. Therefore, the SHM strain measurement confirms the safe design and behavior of the bridge for environmental influences. The graphs clearly show the impact of both daily temperature changes and the ones associated with the change of seasons. The research confirmed previous observations that composite sandwich material is sensitive to thermal influences, which should definitely be taken into account when designing this type of structure.

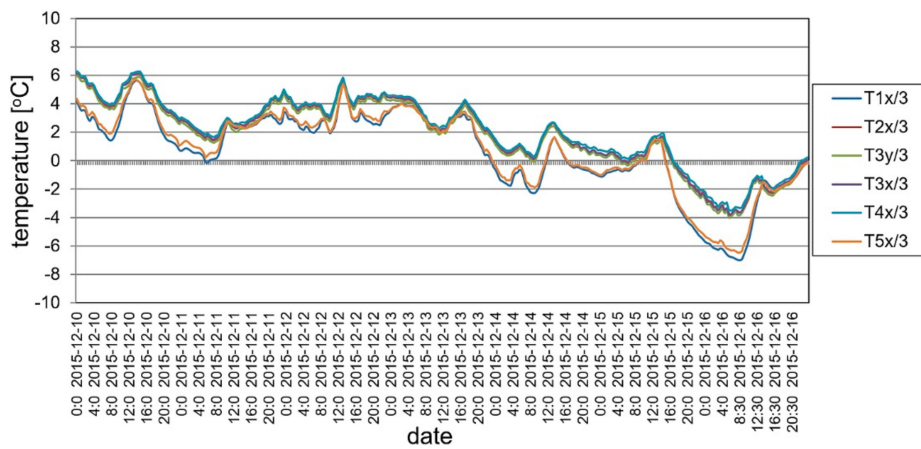
Figure 24. Temperature changes during a one week period.

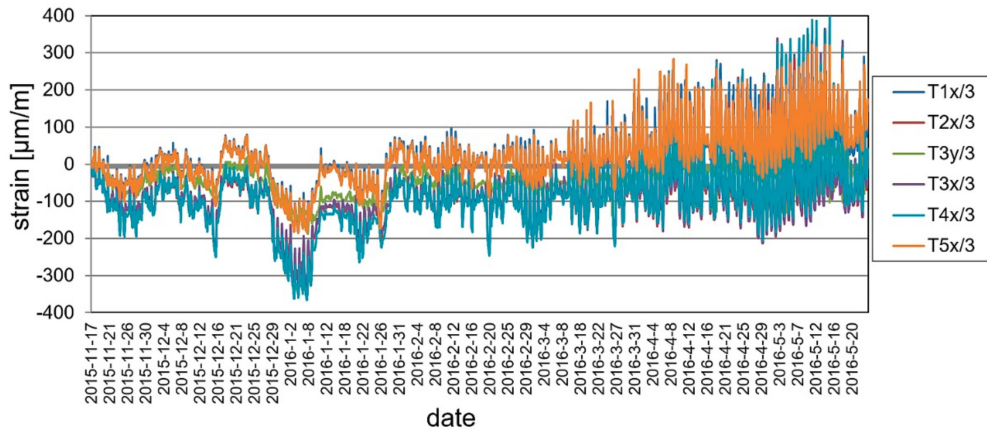
Figure 25. Strain monitoring using VWSG sensors during a six month monitoring period.

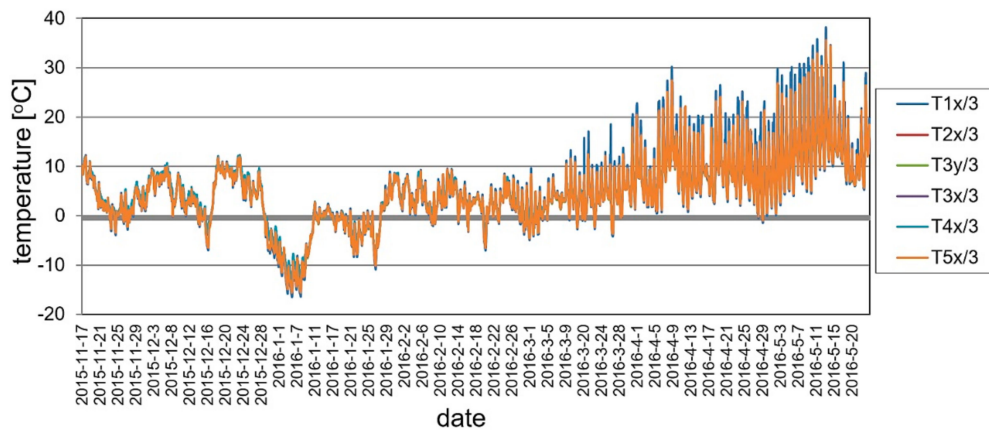
Figure 26. Temperature changes during a six month monitoring period.

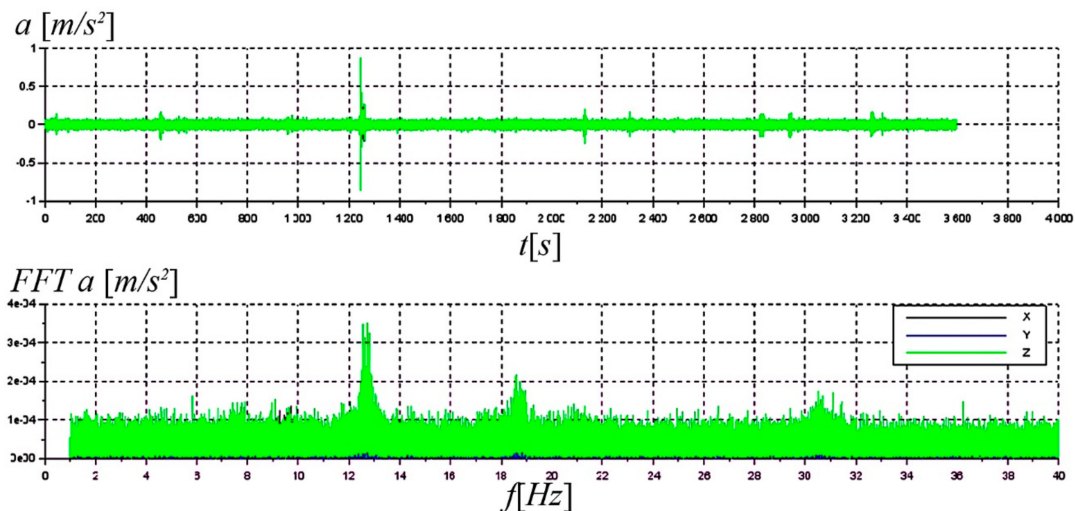
Figure 27. Example data of vibration monitoring with FFT analysis.

While performing the ambient testing, small groups of people only visited the footbridge occasionally. The object was located at the GUT campus beyond the main pedestrian traffic areas and was not used intensively. But the vibration monitoring system was still able to identify some natural frequencies of the structure. The natural frequencies analysis were limited to 40 Hz, due to numerical analysis results (see reference [34]), which showed that the basic structural characteristics fall within this range. The Fast Fourier Transform was obtained automatically with its own system continuously analyzing the recorded signal. In Figure 27 the exemplary measurement data with FFT analysis is presented. It may be observed that the values of around 12.5 Hz and 18.4 Hz are noticeable in the frequency domain. They correspond to the values of 3rd and 5th natural frequencies identified during short-term dynamic tests [34]. The values of natural frequencies did not change throughout the entire research period. On this basis, it can be concluded that the structure global stiffness did not change.
