Nondestructive Testing of the Miter Gates Using Various Measurement Methods

Faculty of Civil and Environmental Engineering, Gdansk University of Technology, 80-233 Gdańsk, Poland; mikbincz@pg.edu.pl (M.B.); przkalit@pg.edu.pl (P.K.); szulwic@pg.edu.pl (J.S.)

The aim of this paper is to indicate the causes of the poor operation of the water gates at the river barrage on the Vistula river in Włocławek (the city located in the center of Poland). The problem had been identified by lock operators during normal operations of the chamber filling and emptying. It was related to a “sudden movement” that caused vibrations and shocks of the lock lower gates. The vibrations were transformed to other structural elements and were also noticeable in the control room building. The administrator of the facility failed to identify the main cause of the excessive vibration. Long-time and intensive vibrations can cause structural damage to a river barrage. Control structures related to the damaged strategic facilities pose a serious hazard and can cause enormous human and material losses. Due to these concerns, the facility owner commissioned an engineering evaluation regarding the cause of the vibr

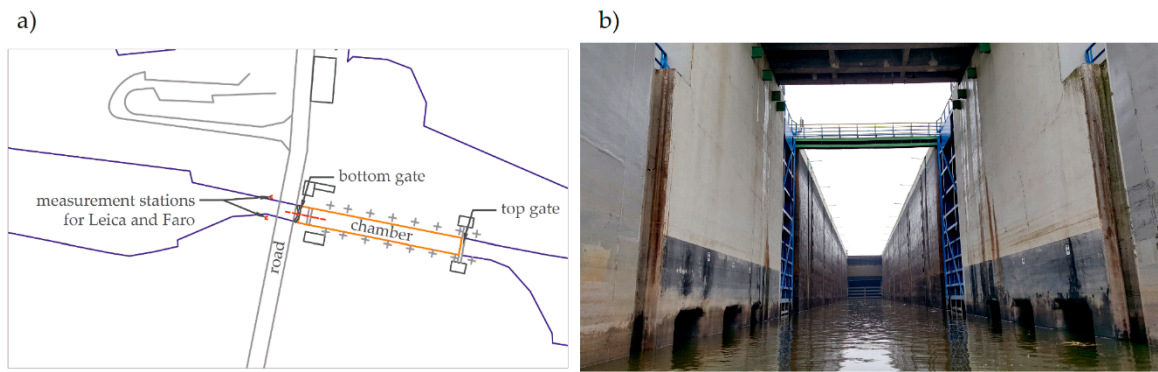
The lock was delivered mainly for navigation purposes, raising and lowering boats, ships, and other watercraft between different levels on the river. The maximum designed drop was 12.80 m, and the actual drop was 14.40 m. The lock, including roadstead, was located on the left bank. It was provided by a chamber with a size 115.00 × 12.00 m, at a downstream bar min. depth of 3.50 m (1.10 m at present). The lock featured a chamber, including the upper head and bottom head (Figure 1). The top closing of the lock was provided by a hydraulically driven segment that ensured water energy dissipation when filling the chamber with water. The bottom head was provided by a hydraulically-driven support gates. The upper and bottom head featured a monolithic reinforced-concrete structure. The chamber was provided with six dock sections, each 16.00 m long, provided with isolation joints. For repair purposes, steel flashboard beams were designed. If necessary, they were installed with a mobile crane. Chamber filling and emptying followed by-pass canals. Canal inlets and outlets were provided inside the heads at the two ends of the lock. By-pass canals carried the water towards the longitudinal chamber gallery, with openings located along the whole length, in the lower part of the chamber walls. By-pass canals were provided with flat gate valves.

Figure 1. (a) Diagram of the lock in the Wloclawek river barrage; (b) View of the lock from the bottom side.

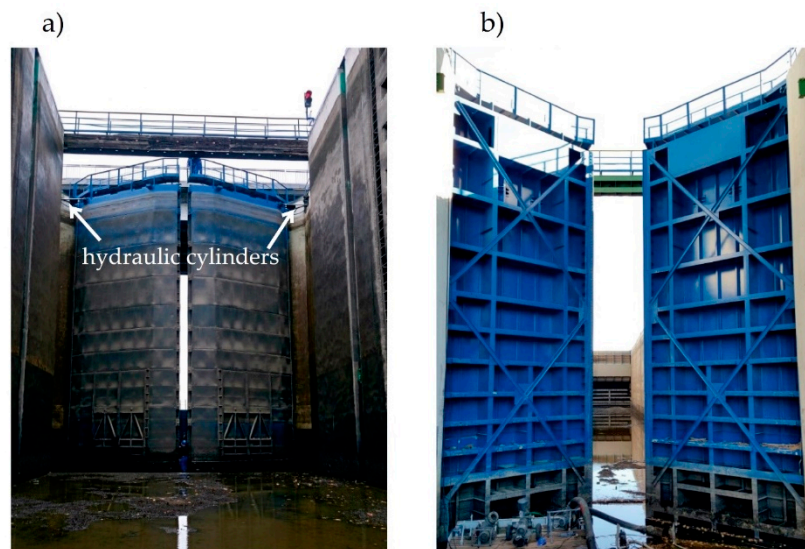
The support gates of the bottom head were related to the movable double-leaf (Figure 2) feature with a frame structure, including I-section girders. The frame was covered with sheet cladding from the side of the lock. The gates' elements were made from steel, with yield strength $f_y = 235$ MPa. Additional elements included bracing, rubber sealing, arched bearings, and rotating bearings, and top deck. Gates closing and opening were provided by hydraulic cylinders.

Figure 2. General view of the Wloclawek lock bottom miter gates. (a) From the side of the lock; (b) From the side of downstream.

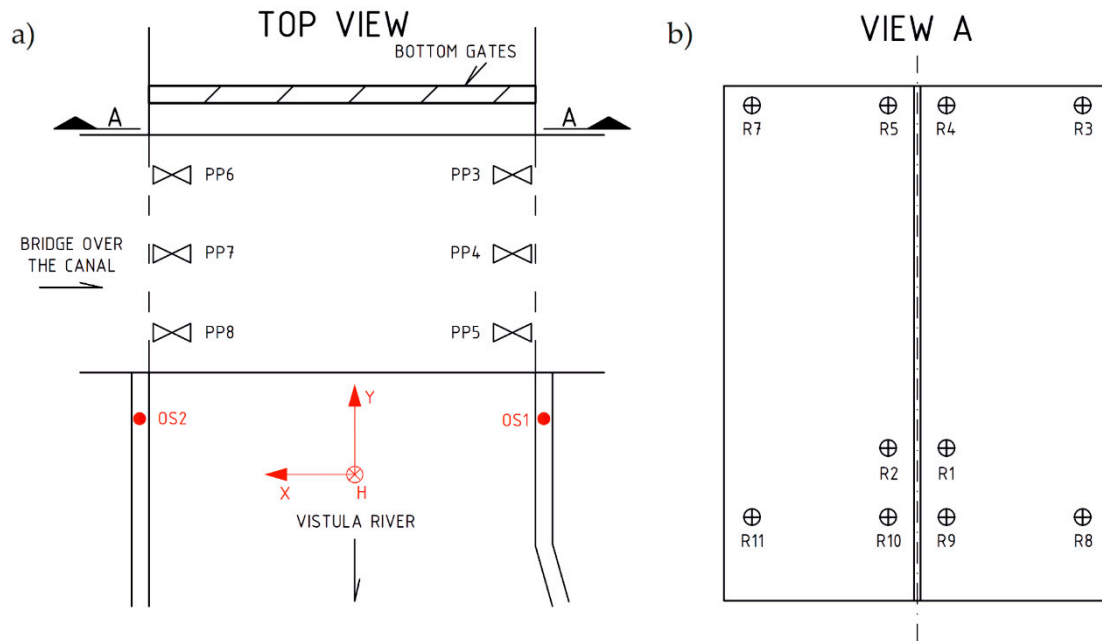
Surveying measurements were based on measurements performed with Leica TS30 (Leica Geosystems AG, Heerbrugg, Switzerland) (with a precise mode about 0.6 mm + 1 ppm / typ. 7 s) at data recording precision of 0.1 mm. Figure 6 specifies the locations of control points (from PP3 to PP8), measurement positions (OS1 and OS2), and measuring points (from R1 to R10).

Figure 6. Sketch regarding a location of gates displacement measuring points. (a) Sketch regarding the location of control points and measurement positions, top view; (b) View from bottom water.

For comprehensive survey and assessment regarding the entire gate deformation, measurements were performed with laser scanning. All measurements were performed using the Faro branded device, Focus 3D X130 (FARO Swiss Holding GmbH, Beringen, Switzerland) (with an accuracy of about 2 mm and a measurement speed up to 1 million points per second). Survey results allowed assessment regarding gates' element deformation during lock filling. Before measurement, stabilization followed 6 flat marks (Figure 6a) to ensure proper coordination of the system, and 6 positioning balls (Figure 7) providing data records at the required accuracy. Due to the gates' dimensions (12.50 × 16.00 m) and difficulty in accessing the gates, there was a need to take measurements from two different positions (from the left side "OS1" and the right side "OS2", Figure 6) when performing the scanning.

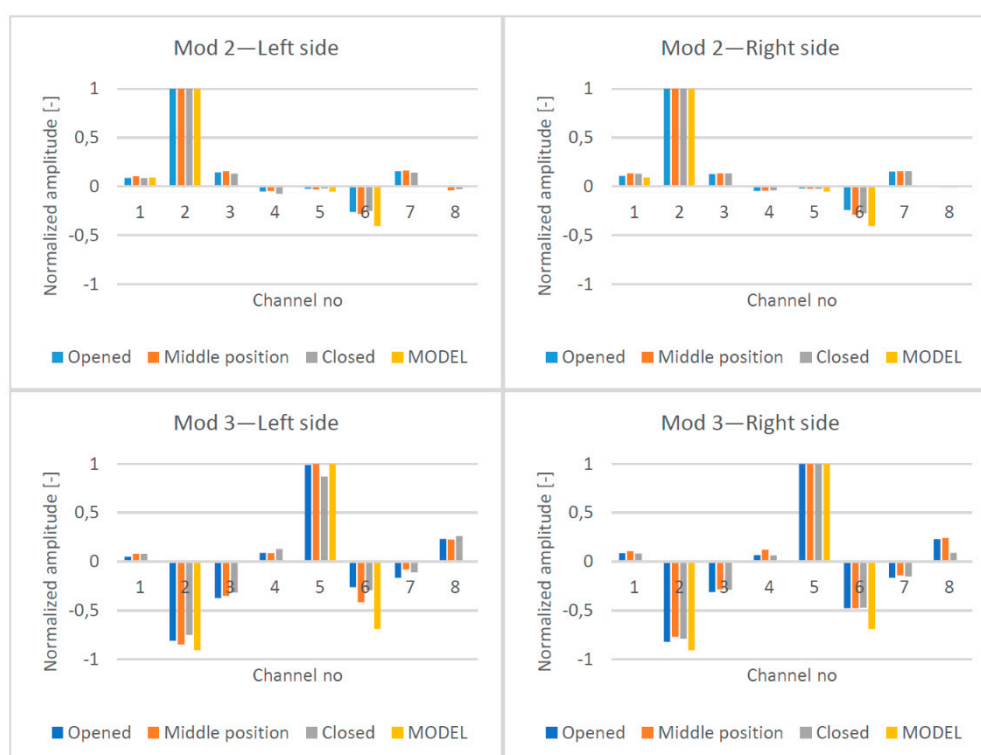
Figure 15. Comparison of the normalized eigenforms identified in three different positions of the gate's leaves for the two identified mods. Yellow bars represent corresponding results from the numerical model.

Dynamic measurements in different positions of the gates' leaves do not indicate any relevant displacements of the support bearings. A small difference between the identified, normalized modal displacements can be a consequence of adherence of the gasket to concrete elements. Differences occur, especially in the case of point K6, which is located near the bottom part of the gates, where the gasket is mounted. In addition to this, eigenfrequencies and eigenforms confirm matching between real structure and the numerical model.

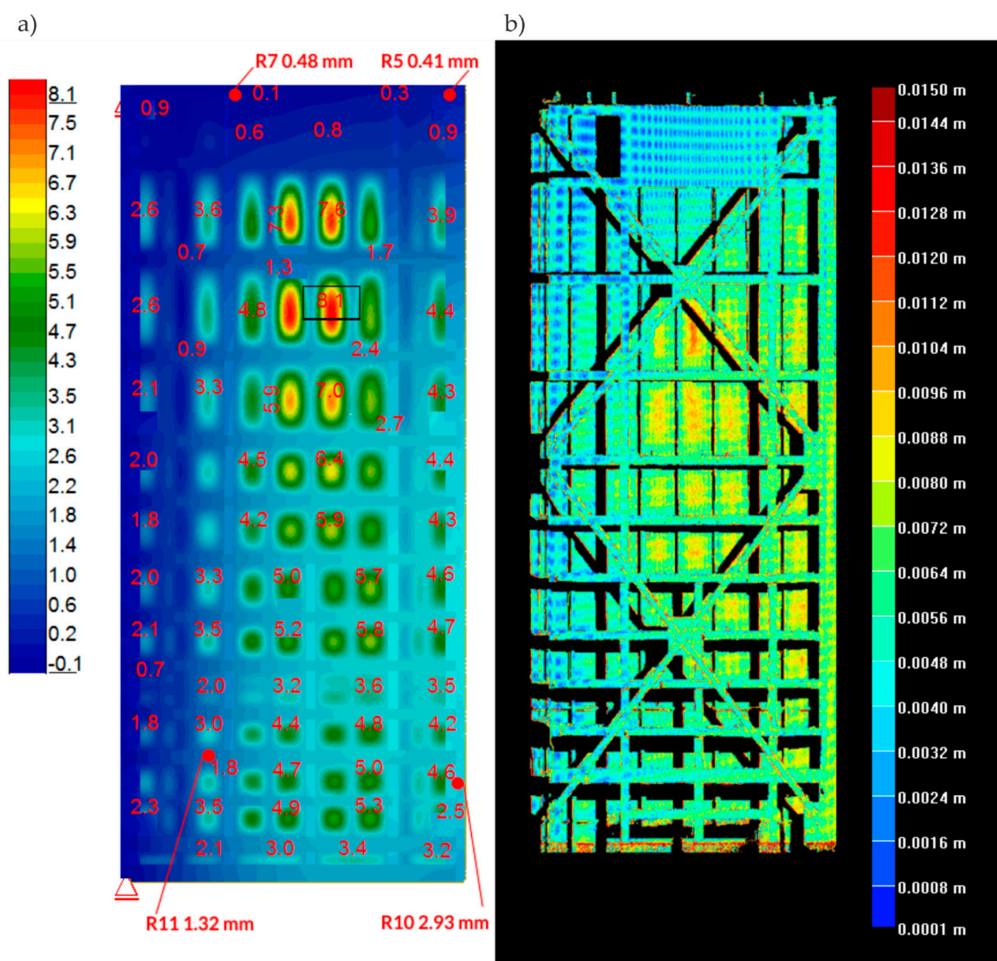
Note, at minimal water level, the minimal opening of the lock gates followed as a result of wind. During the initial filling phase, the displacement was also affected by the deformation of the gaskets. This fact explained the difference between dY displacements during filling and emptying. In addition, because of this, the diagram regarding top water increases from the 1/3 to the 3/3 level was used, as the most representative for the comparative analysis of displacements. The comparative analysis was performed regarding displacements at Y direction (horizontally at longitudinal direction) obtained during surveying measurements and laser scanning against numerical calculations. Figure 18 includes graphics of the results. On the map of displacements calculated with the numerical model (Figure 18a), four points are marked. The exact values of the calculated displacements are given. At these points, the measurement was performed with the use of a tachymeter. Table 4 shows a comparison of the calculated and measured displacements. Attention should be paid to two points (R4 and R5), for which the differences are in the order of several hundred percent. For the remaining points, the differences are much smaller. In Figure 18b, laser scanning results are presented. They were calculated by subtracting the coordinates of the two point clouds from two different measurements.

Figure 18. Comparative analysis regarding displacements at Y direction from. (a) Numerical model (mm); and (b) Laser scanning (m), top water increases from the 1/3 to the 3/3 level.

The comparative analysis was performed regarding measurements and calculations of structure displacement resulted from water level change from 1/3 to 3/3. Horizontal displacements, at a direction parallel to the gates' surface obtained based on the numerical model and the measurements with the tachymeter, were similar. Insignificant variance resulting from gates additional displacements resulted from pressure and gasket deformation at the initial phase during lock filling, which is a natural effect. Thanks to the miter gasket's deformation the sealing of gates was provided. The numerical model did not include this phenomenon; only points close to the miter axis indicate an anomaly. Displacements measured with tachymeter in points R5 and R4 (miter top corner) are significantly different than those obtained with the numerical model. However, the remaining results indicate that structure operation was consistent with the numerical model (design input). Therefore, we could exclude any significant damage to the main structural elements.

The displacements indicated by laser scanning were bigger than the results obtained using two other methods. The work provided an example regarding measurement accuracy difference during the elaboration of differential maps [58]. Additionally, water level changed slightly in the lock during laser scanning that featured a measurement period significantly longer (about seven min) than the one with the tachymeter.
