Nondestructive Testing of the Miter Gates Using Various Measurement Methods

The aim of this paper is to indicate the causes of the poor operation of the water gates at the river barrage on the Vistula river in Włocławek (the city located in the center of Poland). The problem had been identified by lock operators during normal operations of the chamber filling and emptying. It was related to a “sudden movement” that caused vibrations and shocks of the lock lower gates. The vibrations were transformed to other structural elements and were also noticeable in the control room building. The administrator of the facility failed to identify the main cause of the excessive vibration. Long-time and intensive vibrations can cause structural damage to a river barrage. Control structures related to the damaged strategic facilities pose a serious hazard and can cause enormous human and material losses. Due to these concerns, the facility owner commissioned an engineering evaluation regarding the cause of the vibrations and a proposed method of repair. Given the high importance of facilities in the form of locks on waterways, the detection of possible failures and appropriate monitoring of the

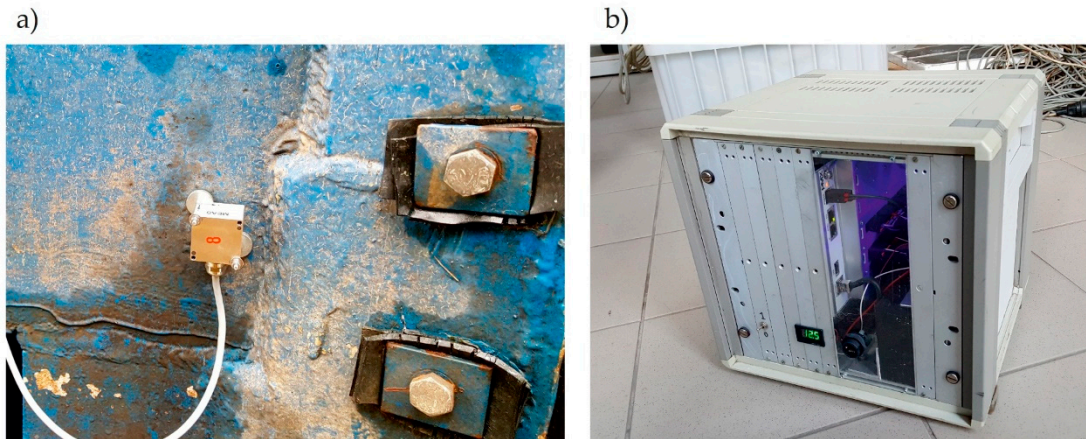
In addition, acceleration measurements were performed on the gates' steel structure. As mentioned, the dynamic measurements had two main purposes, i.e., validation of the numerical FEM model and detecting of the unexpected movements of bearings. The measuring system consisted of the HBM PMX Amplifier (Hottinger Baldwin Messtechnik GmbH, Darmstadt, Germany) system, 4 MEMS (Micro Electro Mechanical System) Direct Current (DC) response accelerometers, and wires. The amplifier was connected by an Ethernet wire to a PC computer. HBM CatmanEasy (Hottinger Baldwin Messtechnik GmbH, Darmstadt, Germany) software installed on the PC was used in the configuration of the system and data acquisition. The used amplifier was designed for, and typically utilized in, industry control systems. However, after some modifications, its parameters allowed researchers to use it in laboratory and field tests. Improvements were carried out by the crew of the Field Test Laboratory of the Technical University of Gdansk. The amplifier was covered with a stiff box to protect it from mechanical damage and adverse weather conditions. Additionally, a battery was inserted into the box. Therefore, after connection with the PC computer (notebook type), it created a stand-alone, portable, 16-channels measuring system, which could be used for up to 8 hours without access to electricity. Another advantage was the elimination of redundant, additional vibrations coming from the electric generator's work. It was especially significant to use low-noise sensors when low-magnitude vibrations are measured. Thus, the created acquisition system is very universal and convenient for field tests on bridges and other infrastructure constructions. In the system, following MEMS DC response, 4 to 20 mA signal output sensors were used as follows: 2 tri-axial accelerometers TE 4332M3-002 (TE Connectivity Ltd., Schaffhausen, Switzerland) and 2 one-axial accelerometers TE 4312M3-002. The following characteristic parameters of these accelerometers were: range ± 2 g, sensitivity 4.0 mA/g, frequency response 0 to 200 Hz, and natural frequency 700 Hz. The noise measured on the gates' leaf, if no intentional load was applied, was in the range of ± 0.005 m/s². The acquisition sampling rate was established to be 300 Hz. If predicted, interesting natural frequencies of the gates were below 30 Hz, it was evaluated as high enough to ensure the obtainment of all information about vibrations. Figure 9 shows the instrumentation for the acceleration measurements.

Figure 9. (a) Used tri-axis accelerometer TE 4332M3-002; (b) The individually improved HBM PMX Amplifier.
