# Nondestructive Testing of the Miter Gates Using Various Measurement Methods

The aim of this paper is to indicate the causes of the poor operation of the water gates at the river barrage on the Vistula river in Włocławek (the city located in the center of Poland). The problem had been identified by lock operators during normal operations of the chamber filling and emptying. It was related to a “sudden movement” that caused vibrations and shocks of the lock lower gates. The vibrations were transformed to other structural elements and were also noticeable in the control room building. The administrator of the facility failed to identify the main cause of the excessive vibration. Long-time and intensive vibrations can cause structural damage to a river barrage. Control structures related to the damaged strategic facilities pose a serious hazard and can cause enormous human and material losses. Due to these concerns, the facility owner commissioned an engineering evaluation regarding the cause of the vibrations and a proposed method of repair. Given the high importance of facilities in the form of locks on waterways, the detection of possible failures and appropriate monitoring of th

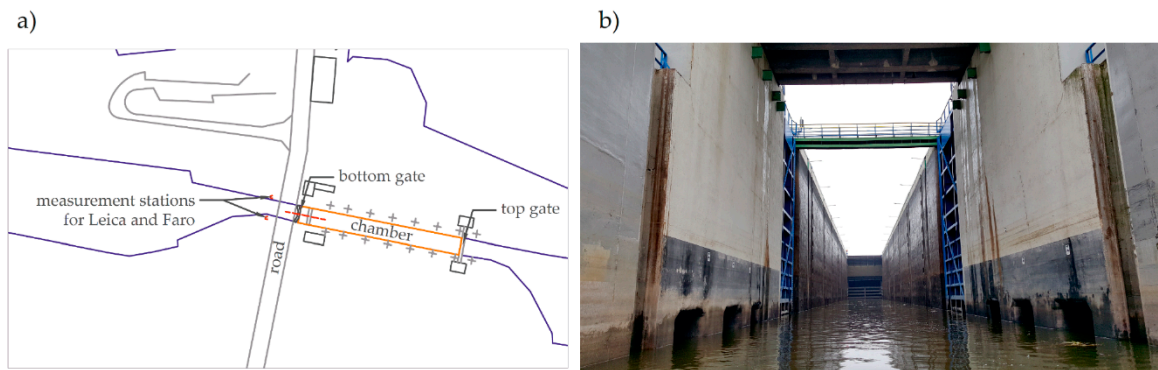
The lock was delivered mainly for navigation purposes, raising and lowering boats, ships, and other watercraft between different levels on the river. The maximum designed drop was 12.80 m, and the actual drop was 14.40 m. The lock, including roadstead, was located on the left bank. It was provided by a chamber with a size 115.00 × 12.00 m, at a downstream bar min. depth of 3.50 m (1.10 m at present). The lock featured a chamber, including the upper head and bottom head (Figure 1). The top closing of the lock was provided by a hydraulically driven segment that ensured water energy dissipation when filling the chamber with water. The bottom head was provided by a hydraulically-driven support gates. The upper and bottom head featured a monolithic reinforced-concrete structure. The chamber was provided with six dock sections, each 16.00 m long, provided with isolation joints. For repair purposes, steel flashboard beams were designed. If necessary, they were installed with a mobile crane. Chamber filling and emptying followed by-pass canals. Canal inlets and outlets were provided inside the heads at the two ends of the lock. By-pass canals carried the water towards the longitudinal chamber gallery, with openings located along the whole length, in the lower part of the chamber walls. By-pass canals were provided with flat gate valves.

**Figure 1.** (a) Diagram of the lock in the Wloclawek river barrage; (b) View of the lock from the bottom side.

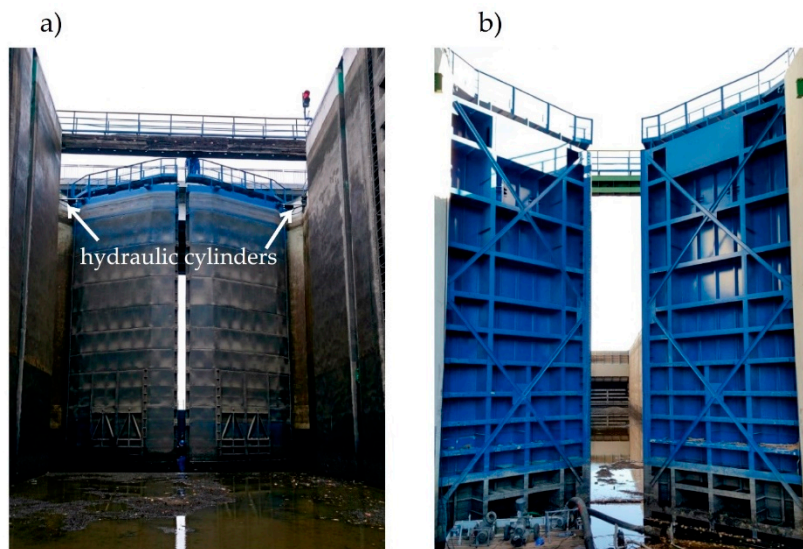
The support gates of the bottom head were related to the movable double-leaf (Figure 2) feature with a frame structure, including I-section girders. The frame was covered with sheet cladding from the side of the lock. The gates' elements were made from steel, with yield strength  $f_y = 235$  MPa. Additional elements included bracing, rubber sealing, arched bearings, and rotating bearings, and top deck. Gates closing and opening were provided by hydraulic cylinders.

**Figure 2.** General view of the Wloclawek lock bottom miter gates. (a) From the side of the lock; (b) From the side of downstream.

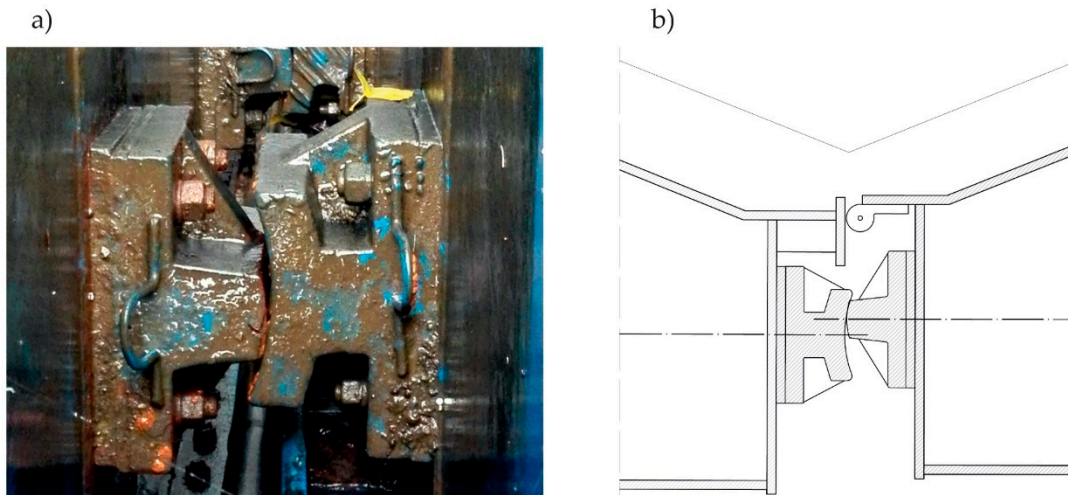
When totally emptied, the structure of the lock chamber underwent inspection based on visual examination, including photo records. The examination indicated misaligned miter bearings. Figure 3a shows a misaligned bearing that was observed. Figure 3b presents a scheme of this phenomenon.

Figure 3. Observed misalignment of miter bearings. (a) Real view; (b) Scheme of the top view.

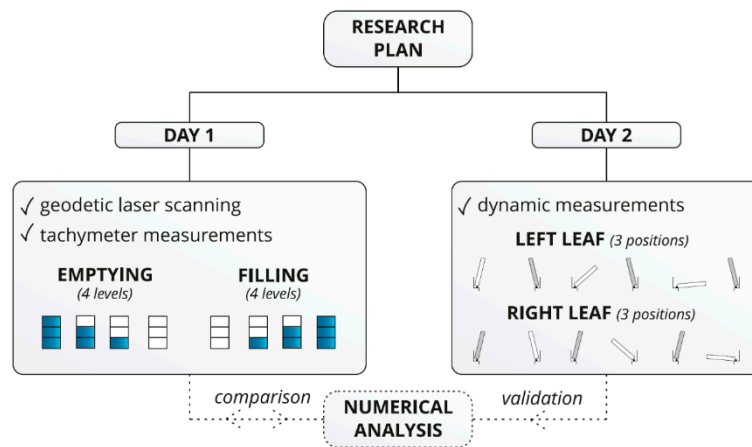
Additionally, consultations followed with operators regarding any noticed cases related to interruption of lock filling and emptying. Operators reported some factors contributing to the sudden movement such as high temperature, strong wind blowing from the east (top water), and the irregular position of miter bearings after gates closing. According to the received information, the following goals of this research were set: To assess the static work of the lock during filling and emptying and assess work and condition of rotational bearings on the top and bottom. To achieve the goals, surveying and dynamical field tests were planned (Figure 4). Before the field tests, a numerical model was created. Static and modal analyses were executed. Static calculations were conducted for a comparison with surveying measurements. Dynamic calculations were conducted to evaluate the quality of the numerical model as comparing with modal model parameters with parameters identified in dynamic measurements. During the first day of the tests, the lock underwent emptying and filling, and each procedure included 4 steps. Following each step, the water level was recorded, including surveying measurements and laser scanning. During the second day of the tests, dynamic measurements were conducted. Six setups were done, 3 per each lock’s gates’ leaf. In each setup, the leaf had various opening angles, i.e., closed position, midposition between closed and opened, and fully opened position.

Figure 4. Diagram of tests regarding the lock in the Wloclawek river barrage.

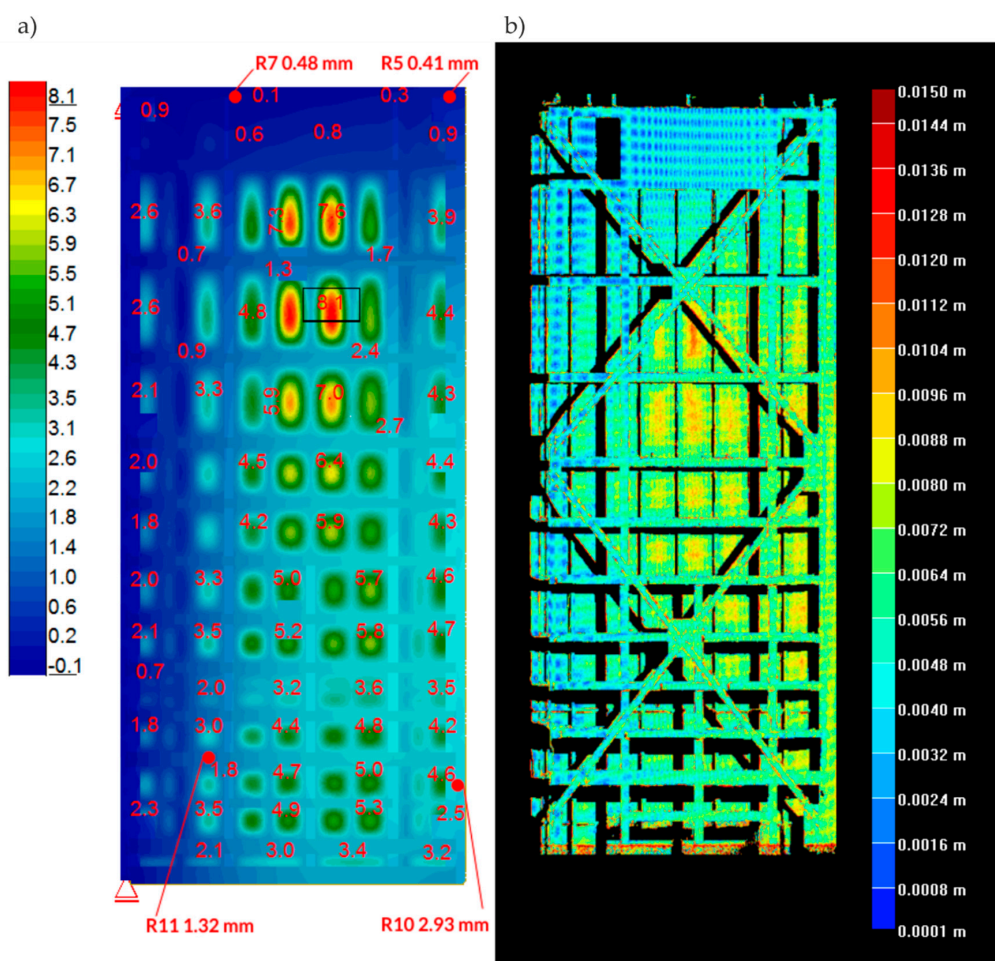
Note, at minimal water level, the minimal opening of the lock gates followed as a result of wind. During the initial filling phase, the displacement was also affected by the deformation of the gaskets. This fact explained the difference between dY displacements during filling and emptying. In addition, because of this, the diagram regarding top water increases from the 1/3 to the 3/3 level was used, as the most representative for the comparative analysis of displacements. The comparative analysis was performed regarding displacements at Y direction (horizontally at longitudinal direction) obtained during surveying measurements and laser scanning against numerical calculations. Figure 18 includes graphics of the results. On the map of displacements calculated with the numerical model (Figure 18a), four points are marked. The exact values of the calculated displacements are given. At these points, the measurement was performed with the use of a tachymeter. Table 4 shows a comparison of the calculated and measured displacements. Attention should be paid to two points (R4 and R5), for which the differences are in the order of several hundred percent. For the remaining points, the differences are much smaller. In Figure 18b, laser scanning results are presented. They were calculated by subtracting the coordinates of the two point clouds from two different measurements.

**Figure 18.** Comparative analysis regarding displacements at Y direction from. (a) Numerical model (mm); and (b) Laser scanning (m), top water increases from the 1/3 to the 3/3 level.

The comparative analysis was performed regarding measurements and calculations of structure displacement resulted from water level change from 1/3 to 3/3. Horizontal displacements, at a direction parallel to the gates' surface obtained based on the numerical model and the measurements with the tachymeter, were similar. Insignificant variance resulting from gates additional displacements resulted from pressure and gasket deformation at the initial phase during lock filling, which is a natural effect. Thanks to the miter gasket's deformation the sealing of gates was provided. The numerical model did not include this phenomenon; only points close to the miter axis indicate an anomaly. Displacements measured with tachymeter in points R5 and R4 (miter top corner) are significantly different than those obtained with the numerical model. However, the remaining results indicate that structure operation was consistent with the numerical model (design input). Therefore, we could exclude any significant damage to the main structural elements.

The displacements indicated by laser scanning were bigger than the results obtained using two other methods. The work provided an example regarding measurement accuracy difference during the elaboration of differential maps [58]. Additionally, water level changed slightly in the lock during laser scanning that featured a measurement period significantly longer (about seven min) than the one with the tachymeter.
