# Dissimilar underwater wet welding of HSLA steels

Jacek Tomków<sup>1</sup> · Dariusz Fydrych<sup>1</sup> · Grzegorz Rogalski<sup>1</sup>

The high-strength low-alloy S460ML and S460N steels were chosen for underwater wet welding of dissimilar T-joints using covered electrodes. For improving the quality of joints, the temper bead welding (TBW) method was used. The application of TBW in pad welding conditions has been investigated earlier but the possibility of usage of this technique in welded joints was not analyzed. The main aim of the study was to check the influence of TBW on the hardness and structures of the heat-affected zone (HAZ) of dissimilar T-joints made in the underwater conditions. The experiments conducted showed that the technique used can reduce the susceptibility to cold cracking by decreasing the hardness in HAZ, which is a result of changes in its structure. The TBW technique reduced the hardness in the HAZ of the S460N steel by 40–50 HV10 and in S460ML by 80–100 HV10. It was also found that the changes in S460ML and S460N were much different, and therefore, the investigated technique can provide better results in the steel characterized by lower carbon equival

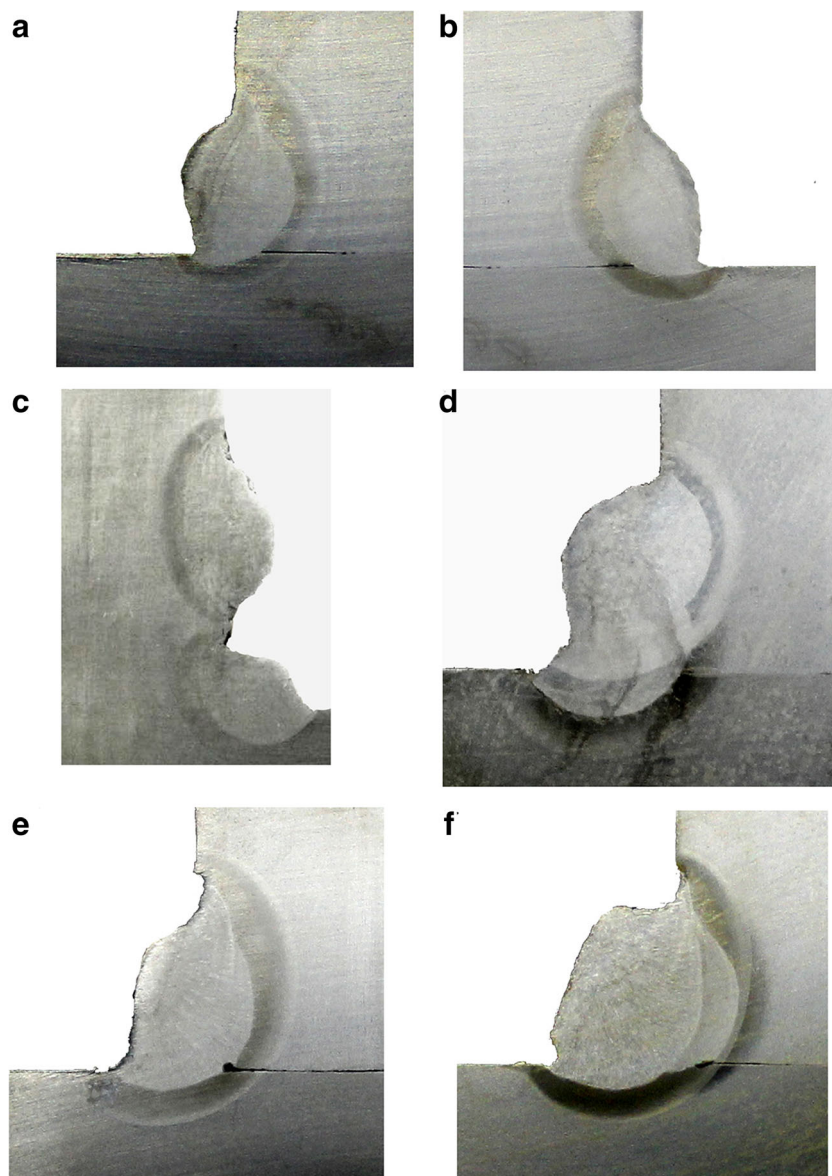
**Fig. 3** Results of the macroscopic testing. **a** Weld 1 specimen 1—without TBW, **b** weld 2 specimen 1—without TBW, **c** weld 1 specimen 2—pitch 0%, **d** weld 2 specimen 2—pitch 79%, **e** weld 2 specimen 3—pitch 91%, and **f** weld 1 specimen 3—pitch 100%

Macro- and microscopic investigations were performed in accordance with EN ISO 17639:2013 standard [46]. After cutting, all the cross-sections were ground, polished, and etched with Nital (4%). The main aim of the macroscopic testing was to calculate the pitch in specimens 2 and 3. During macroscopic observations, the imperfection was seen as gas pores in both welds from specimen 1, weld 1 from specimen 2, and weld 2 from specimen 3. All these imperfections were located near the point of contact between the BMs. The used TBW technique did not affect their formation—the second weld did not cover these places. The results of the macroscopic testing are presented in Fig. 3.

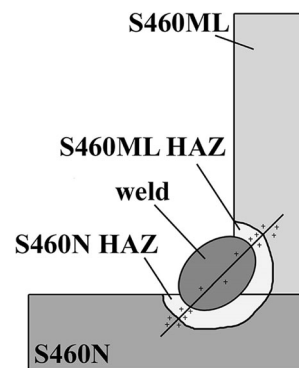
Fig. 5 Hardness point distribution for specimen welded without and with TBW technique

The hardness was measured in BM, in each HAZ, and in the weld material for each investigated weld of a specimen. The schema of distribution of hardness points is presented in Fig. 5.

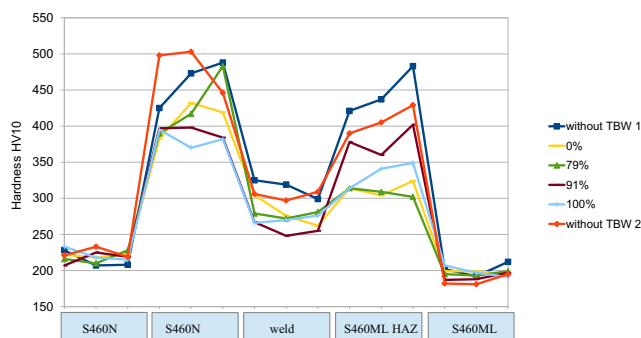
**Fig. 6** Hardness HV10 distribution for each specimen

EN ISO 15614-1:2017 standard for used steels. It was also observed that the hardness of S460N HAZ was higher than that of S460ML HAZ. In the specimen with the 0% pitch, the heat from the second bead, which was laid in S460N BM, affected the hardness of both steels. Second, HAZ was overlapping first in S460ML, and the hardness in this area decreased by 80–100 HV10 in comparison with the specimens welded without the TBW technique. In S460N HAZ, the hardness decreased by 40–80 HV10. In the next specimens, it was observed that if the pitch between two beads increased, the hardness in HAZ and weld material decreased. The best results for the investigated BMs were observed in the specimens with 100% pitch. The hardness measurements showed that the TBW technique allowed to reduce the hardness HV10 values of joints made in the water to the values lower than in specimens welded in the air [27]. Similar results were observed for welding of HSLA steel butt joints [49]. The reduction of hardness limits one of the factors adding to the initiation of cold cracks, which contributes to a reduction of cracking susceptibility.

The values of hardness in each point are presented in Table 4. The phrase “without TBW” means specimen welded without additional (tempering) bead. The specimen with “0%” pitch was welded with tempering bead. However, in the area of cutting specimen for metallographic testing, the second bead did not lay on the first one (Fig. 3c), but the heat from the second bead affects the previous laid stitch. The hardness distributions for each specimens are presented in Fig. 6.
