Dissimilar underwater wet welding of HSLA steels

Abstract

The high-strength low-alloy S460ML and S460N steels were chosen for underwater wet welding of dissimilar T-joints using covered electrodes. For improving the quality of joints, the temper bead welding (TBW) method was used. The application of TBW in pad welding conditions has been investigated earlier but the possibility of usage of this technique in welded joints was not analyzed. The main aim of the study was to check the influence of TBW on the hardness and structures of the heat-affected zone (HAZ) of dissimilar T-joints made in the underwater conditions. The experiments conducted showed that the technique used can reduce the susceptibility to cold cracking by decreasing the hardness in HAZ, which is a result of changes in its structure. The TBW technique reduced the hardness in the HAZ of the S460N steel by 40–50 HV10 and in S460ML by 80–100 HV10. It was also found that the changes in S460ML and S460N were much different, and therefore, the investigated technique can provide better results in the steel characterized by lower carbon equivalent C_{EIIW} .

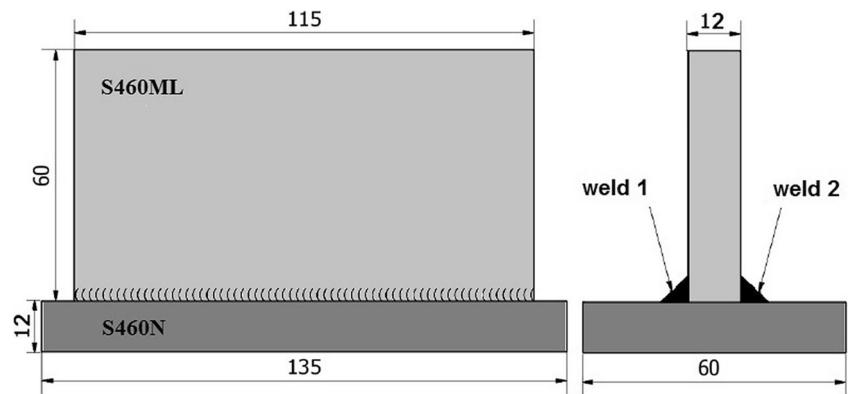
Fig. 1 Schematic view of T-joints with fillet welds

water surface to the upper surface of S460N steel) at a temperature of 20 °C. Plates from S460ML steel had a dimension of 115 × 60 mm; dimension and plates from the S460N steel had a dimension of 135 × 60 mm. The schema of T-joint is presented in Fig. 1.

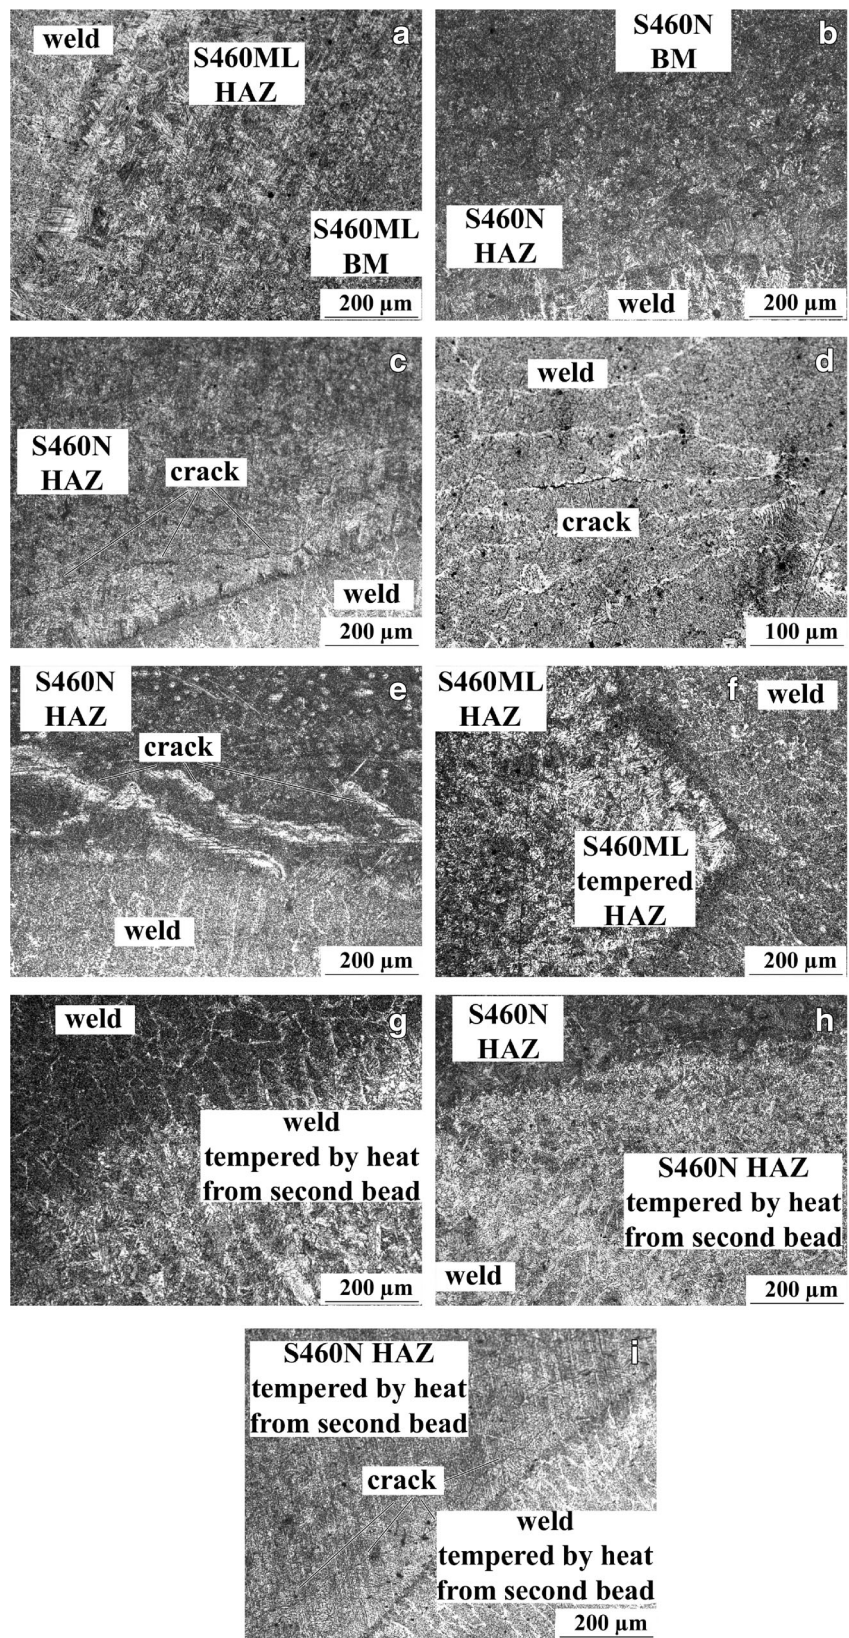
Fig. 4 Results of the microscopic tests. **a** Structure of S460ML HAZ—without TBW, **b** structure of S460N HAZ—without TBW, **c** cracks in S460N HAZ—without TBW, **d** cracks in weld material—without TBW, **e** cracks in S460N HAZ—pitch 0%, **f** tempered S460N HAZ—pitch 0%, **g** S460ML weld material tempered by heat from second bead, **h** tempered S460N HAZ that was affected by heat from second bead, and **i** cracks in S460N HAZ—pitch 91%

After macroscopic tests, the microscopic investigations were performed. The weld metal structures in specimen 1 were built of dendrites. In the specimen 1—welded without TBW technique, brittle structure such as low-carbon martensite was found in the HAZ of both steels in each welded joint. Near the fusion line the Widmannstätten structure was observed (Fig. 4a and b). In addition, in the HAZ of the S460N steel, cracks were found in weld 2, which was welded with a lower heat input (Fig. 4c). These cracks started in HAZ and propagated along approximately 80% of the length of the fusion line in the S460N steel. Cracks were also found in the weld material of the specimens in

which the TBW technique was not applied (Fig. 4d). In the case of specimens made using TBW, there was no crack in the weld materials. In weld 1 specimen 2, where the pitch was 0%, the HAZ in S460N was not changed and still presented brittle structures with cracks (Fig. 4e). The pitch was 0%; however, the HAZ from tempering bead refined and tempered the coarse-grained zone of the first bead in the S460ML steel (Fig. 4f). In the specimens with the pitch in the range of 79–100%, the tempering effect was observed in the HAZ of both the investigated materials. With an increase in the pitch, there was a decrease of grain size, which was expected in accordance with previous works [30, 31]. In the places where the HAZ of the second bead tempering the weld from the first bead, there was a partial disappearance of the structure of the dendritic base bead and the formation of a ferritic fine-grained structure (Fig. 4g). The structures in the area where the HAZ from tempering bead overlapped the HAZ of the first bead in both steels were characterized by the refined and tempered coarse-grained zone (Fig. 4h). The cracks in the HAZ of the BMs were found only in weld 2 in specimen 3 in the S460N steel (Fig. 4i). In the previous investigations [27, 30], it was found that TBW could not repair the microcracks that formed during the welding of the first bead. However, TBW could help to avoid cold cracking that might occur after welding [47, 49].

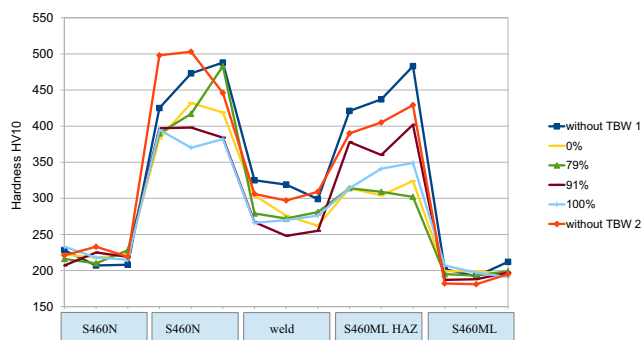
**Fig. 6** Hardness HV10 distribution for each specimen

The values of hardness in each point are presented in Table 4. The phrase “without TBW” means specimen welded without additional (tempering) bead. The specimen with “0%” pitch was welded with tempering bead. However, in the area of cutting specimen for metallographic testing, the second bead did not lay on the first one (Fig. 3c), but the heat from the second bead affects the previous laid stitch. The hardness distributions for each specimens are presented in Fig. 6.
