Non-Destructive Testing of the Longest Span Soil-Steel Bridge in Europe—Field Measurements and FEM Calculations

Abstract: The article describes interdisciplinary and comprehensive non-destructive diagnostic tests of final bridge inspection and acceptance proposed for a soil-steel bridge made of corrugated sheets, being the European span length record holder (25.74 m). As an effect of an original concept a detailed and precise information about the structure short-term response was collected. Periodic diagnostics of bridge deformations was done one year after it was built. Load test design was based on numerical simulations performed by means of finite element method (FEM). In situ measurements were done with the aid of: inductive sensors, optical total station, and terrestrial laser scanner. The results produced by terrestrial laser scanning were used to build a precise image of structure deformation in 3D space during the tests. The accuracy of laser mapping was significantly increased using the information coming from total station and inductive sensors. These have higher accuracy and therefore can be used as reference. Thus, new quality in measurements is introduced. Good corre

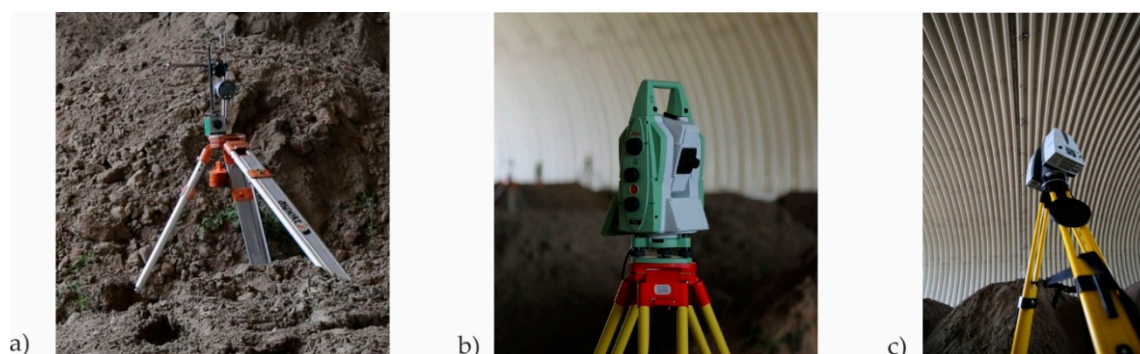
Figure 4. Devices and sensors used to measure basic bridge properties: (a) vertical translation inductive sensor, (b) total station, (c) laser scanner.

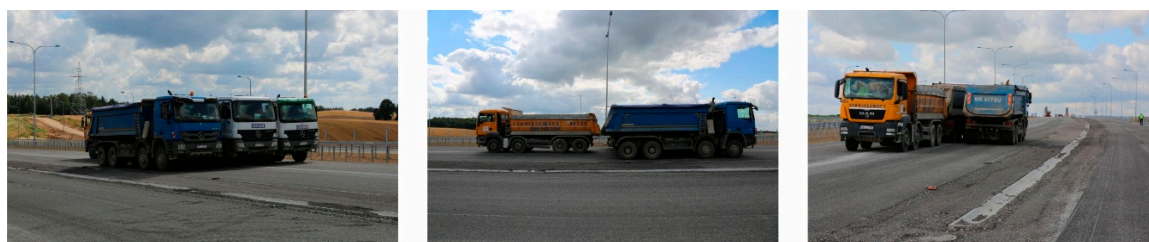
Figure 8. The trucks, positioned during the S1 test configuration. Views from three different perspectives.

To load the bridge and study its response during the tests 4-axle trucks were used. The total mass of each of the truck was 32 tons. The trucks were positioned in a way to maximize the loading effects in the measurement points. Two configurations of trucks positions were studied during the classical static tests. These were denoted as S1 and S2. The trucks were put on the bridge one by one, steadily in columns. Schematic drawing of trucks locations during the S1 test configuration is presented in Figure 7. Views from three different perspectives that document trucks positions during the S1 test configuration are shown in Figure 8.

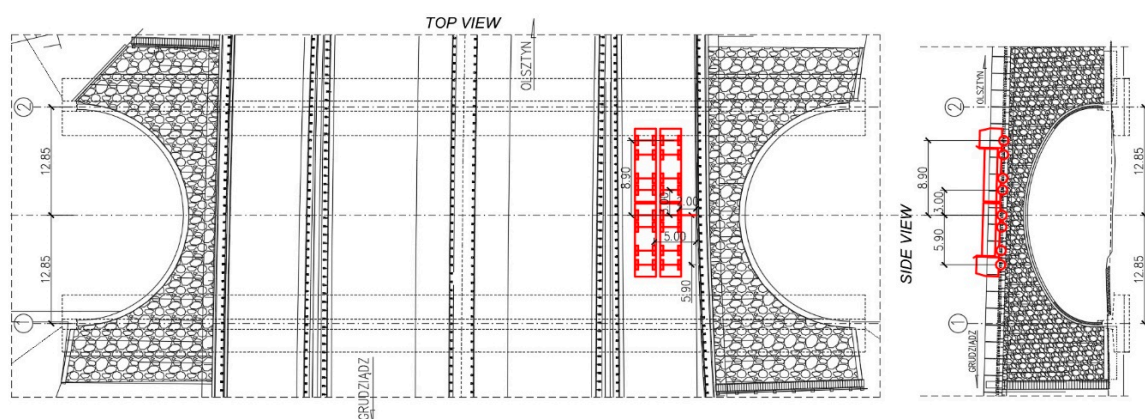
Figure 9. Schematic drawing of trucks locations during the S2 test configuration (dimensions in (m)).

Schematic drawing of trucks locations during the S2 test configuration is presented in Figure 9. Views from three different perspectives that present trucks positions during the S2 test are depicted in Figure 10.

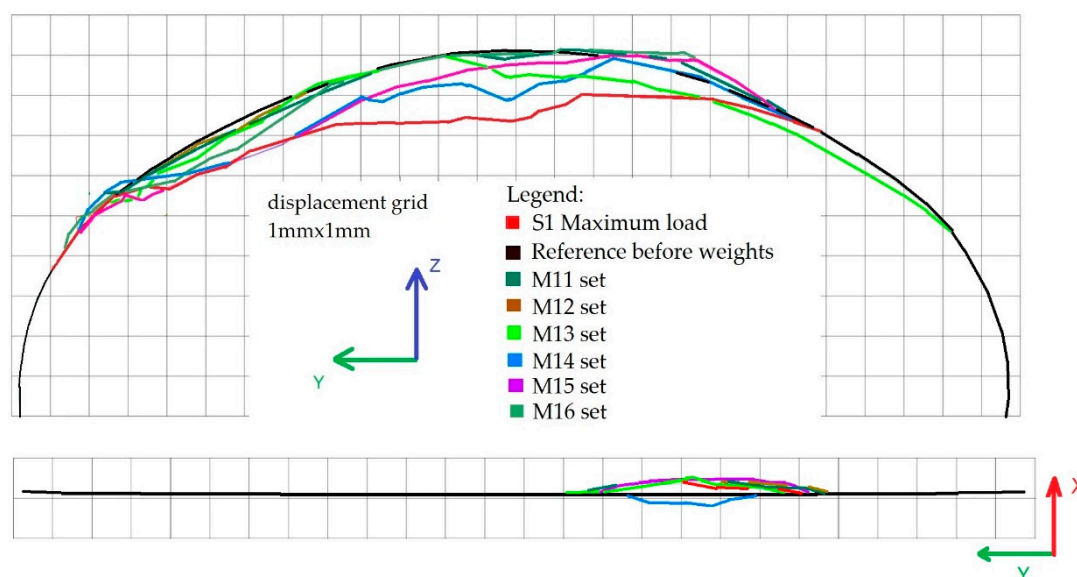
Figure 13. Deformations of the bridge cross Section 2-2 in the Y-Z (top) and X-Y (bottom) planes under loading schemes S1 and M11–M16.

At that point, data were collected, containing images of reference and deformed states of the structure. Therefore the displacements of the steel shell were easily calculated for all the cross sections under consideration. The resulting deformations of the bridge cross Section 2-2 in the Y-Z and X-Y planes under loading schemes S1 and M11–M16 are shown in Figure 13. Similarly in Figure 14, shell deformations are shown for the 4-4 cross section for the following loading conditions S2 and M21–M26.

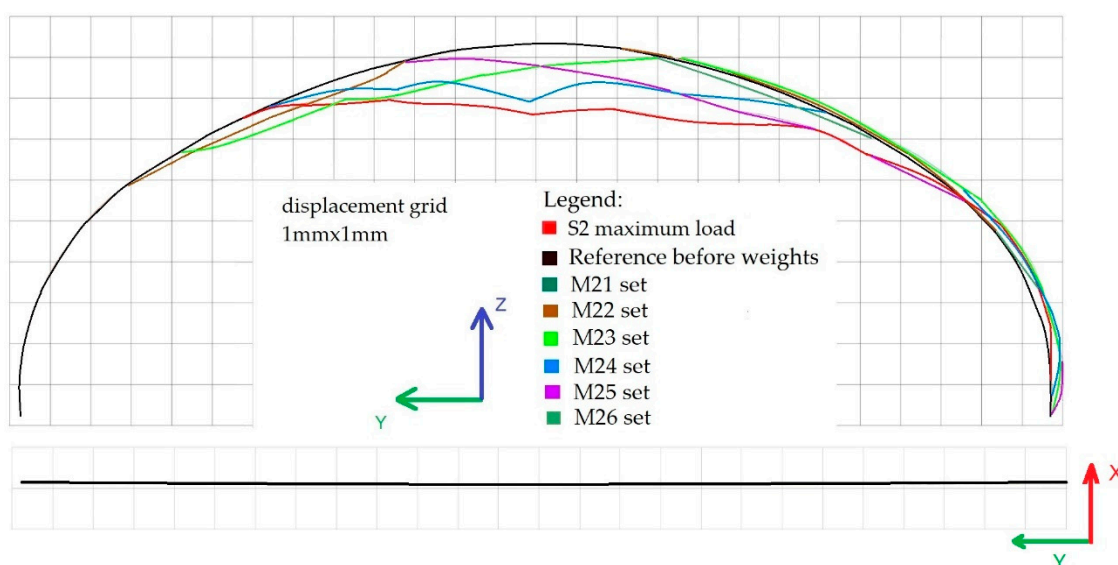
Figure 14. Deformations of the bridge cross Section 4-4 in the Y-Z (top) and X-Y (bottom) planes under loading schemes S2 and M21–M26.

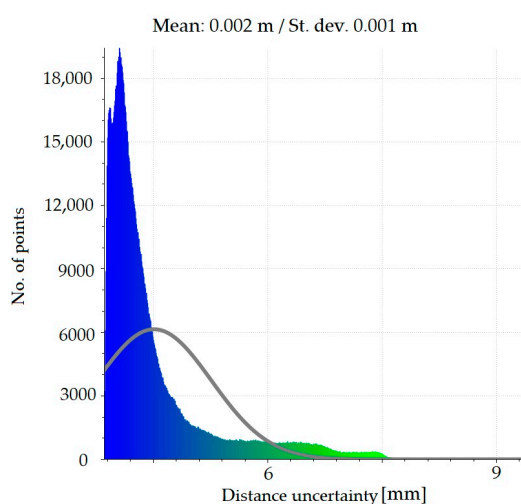
Figure 17. Distance uncertainty statistic.

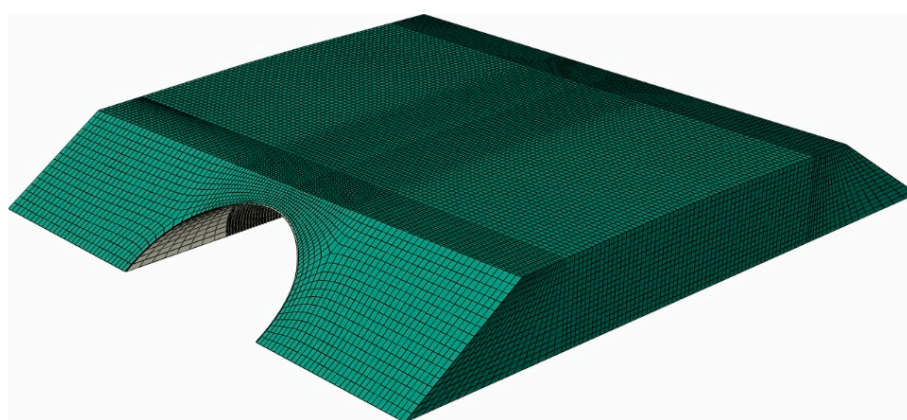
Figure 20. Finite element method (FEM) computational domain of the bridge.

Its size (distance from the bridge to the outer boundaries of the domain) was selected in such a way that it did not affect the results in the area of the steel shell. A structured mesh of finite elements was created. First-order solid C3D8I elements (refer to [58]) were used to model the soil continuum. These elements are enhanced by incompatible modes. This formulation enables very strong reduction of the locking effect, as stiffening in bending, being a consequence of the parasitic shear stresses or Poisson's effect, is almost eliminated. The steel parts were represented by shell S4 elements (see for example papers [34,59–61] for other applications of shell elements) with linear shape functions and full 2×2 in-plane Gauss-Legendre integration scheme and some additional procedures preventing the locking effect. In the central part of the structure, namely in the region where the in situ measurements were taken, the corrugated sheets were modelled in detail having regard to the real geometry. A simplification was made close to the structure ends, where the steel sheets were treated as a shell endowed with equivalent orthotropic properties and thickness. It is worth mentioning that, often, the whole steel shell is treated as the one having some equivalent properties and uniform thickness (see for example papers [42,62]). Nevertheless, such a simplification cannot be done here, because we are interested in accurate estimation of stresses in the shell-corrugated sheets. The whole computational domain of the soil-steel composite structure is shown in Figure 20 and the detail depicting modelling approach of steel shell in Figure 21.

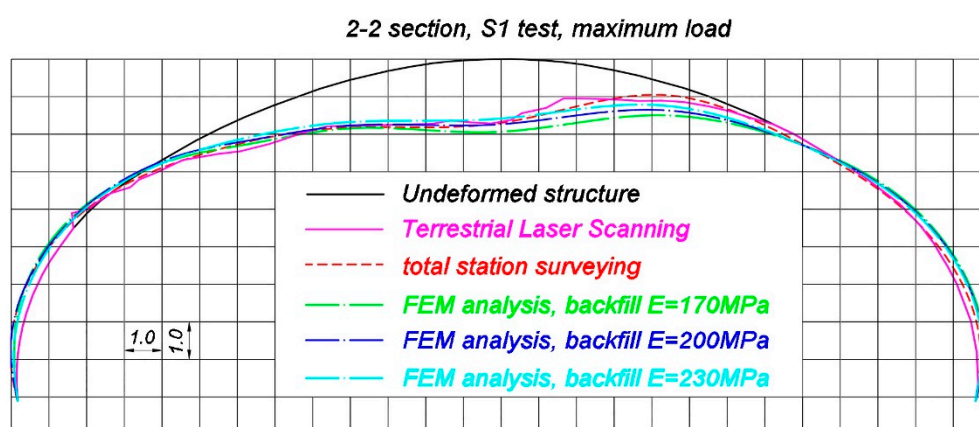
Figure 22. Comparison of the deformed shapes of the bridge in 2-2 section during the S1 test, when maximum load was applied, measured using terrestrial laser scanning, total station, and estimated by means of FEM (deformations in (mm) are 1000 times scaled).

It is seen in Figures 22–24 that the FEM estimations, even for different variants of the backfill elastic modulus, are generally in accordance with the measurements with regard to their quality and quantity. The backfill elastic modulus is an important parameter that affect the bridge response. It is a bit underestimated, when $E = 170$ MPa. Better quality results are obtained for $E = 200$ MPa and $E = 230$ MPa. In order to investigate displacements of the steel shell in detail, now, the extreme vertical displacements, that were obtained in the p4/2 point for the test S1, p4/4 for the test S2 and the corresponding FEM values (for different backfill material properties) are analyzed in Table 3. In Table 3 both total ($U_{in-situ,tot}$) and elastic ($U_{in-situ,el}$) in situ measured displacements are presented to highlight the issue of the shell shape change when the bridge was unloaded.
