Article

Non-Destructive Testing of the Longest Span Soil-Steel Bridge in Europe—Field Measurements and FEM Calculations

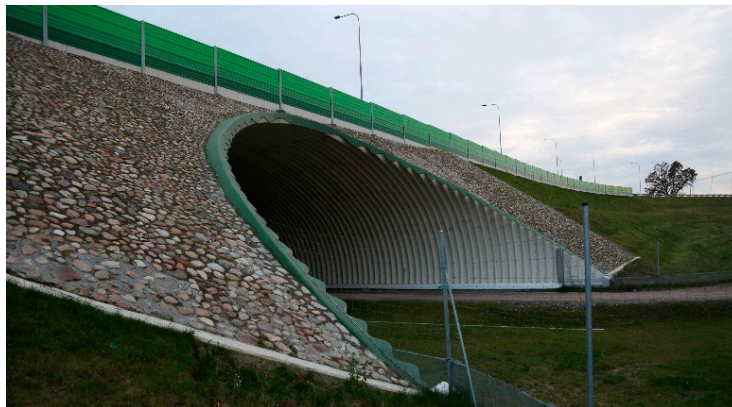
Figure 2. Close up of one of the bridge sides taken in October 2019.

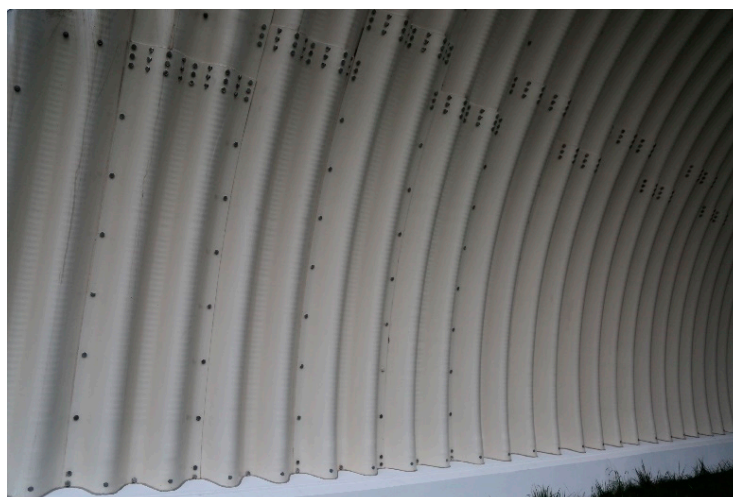
Figure 3. The corrugated steel sheets and their bolt connections.

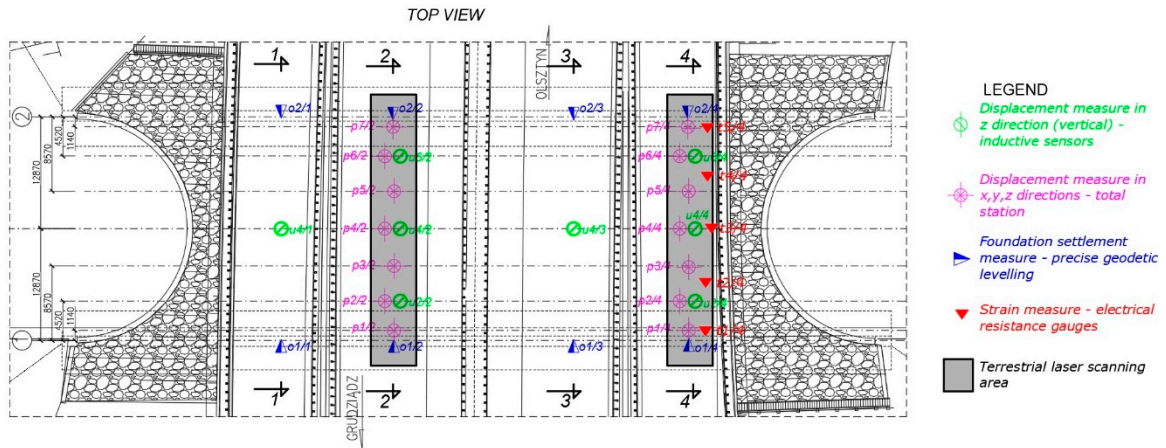
Figure 5. Location of the network of sensor used to collect the data during the static tests. Top view of the bridge.

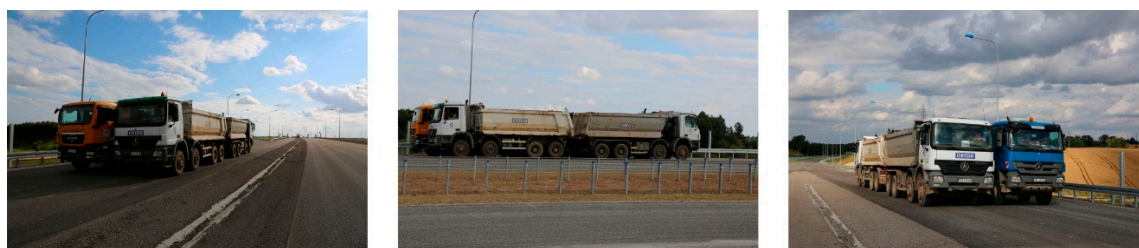
Figure 10. The trucks, positioned during the S2 test configuration. Views from three different perspectives.

Schematic drawing of trucks locations during the S2 test configuration is presented in Figure 9. Views from three different perspectives that present trucks positions during the S2 test are depicted in Figure 10.
