Article

Plasticity of Bead-on-Plate Welds Made with the Use of Stored Flux-Cored Wires for Offshore Applications

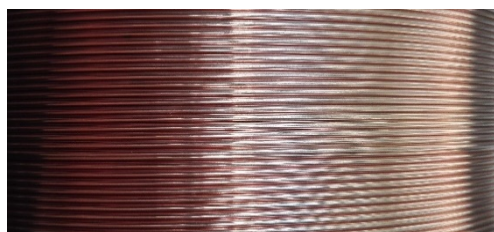
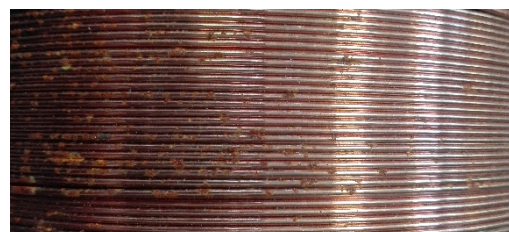
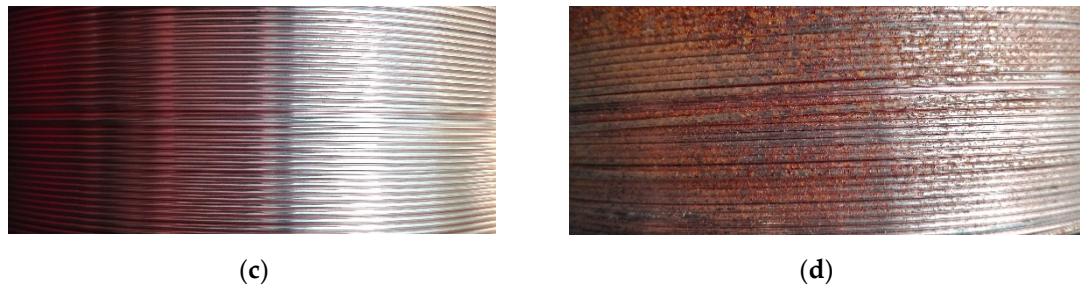
Figure 4. The surface layer of wire after storage: (a) A wire stored in Gdańsk welding site (GWS); (b) A wire stored in Mońki agricultural building (MAB); (c) B wire stored in Gdańsk welding site (GWS); (d) B wire stored in Mońki agricultural building (MAB).

Wires in delivery condition and wires stored for 1 month have been subjected to visual examinations. Photographs of the surface layer of those wires in delivery condition were already presented in the previous publication [20]. Pictures of the surface of the stored wires are shown in Figure 4. It can be clearly seen that the surface of wires stored in MAB has greater degradation than the surface of wires stored in GWS.

Differences can also be seen between the degradation that occurred in A wire and B wire. Both wires stored in the GWS have a shiny, smooth surface with no corrosion areas and no visible signs of degradation or environmental impact. In the MAB environment, A wire began to undergo surface corrosion—numerous corrosion areas of a small range are visible. The boundaries between the individual coils are clear, the non-corroded areas are still shiny and smooth. The B wire stored in the same environment was significantly more degraded. The entire surface is covered with corrosion products, which in some places have a significant thickness. Areas without a thick layer of rust were covered with a thin layer of corrosion products and there were no shiny areas.

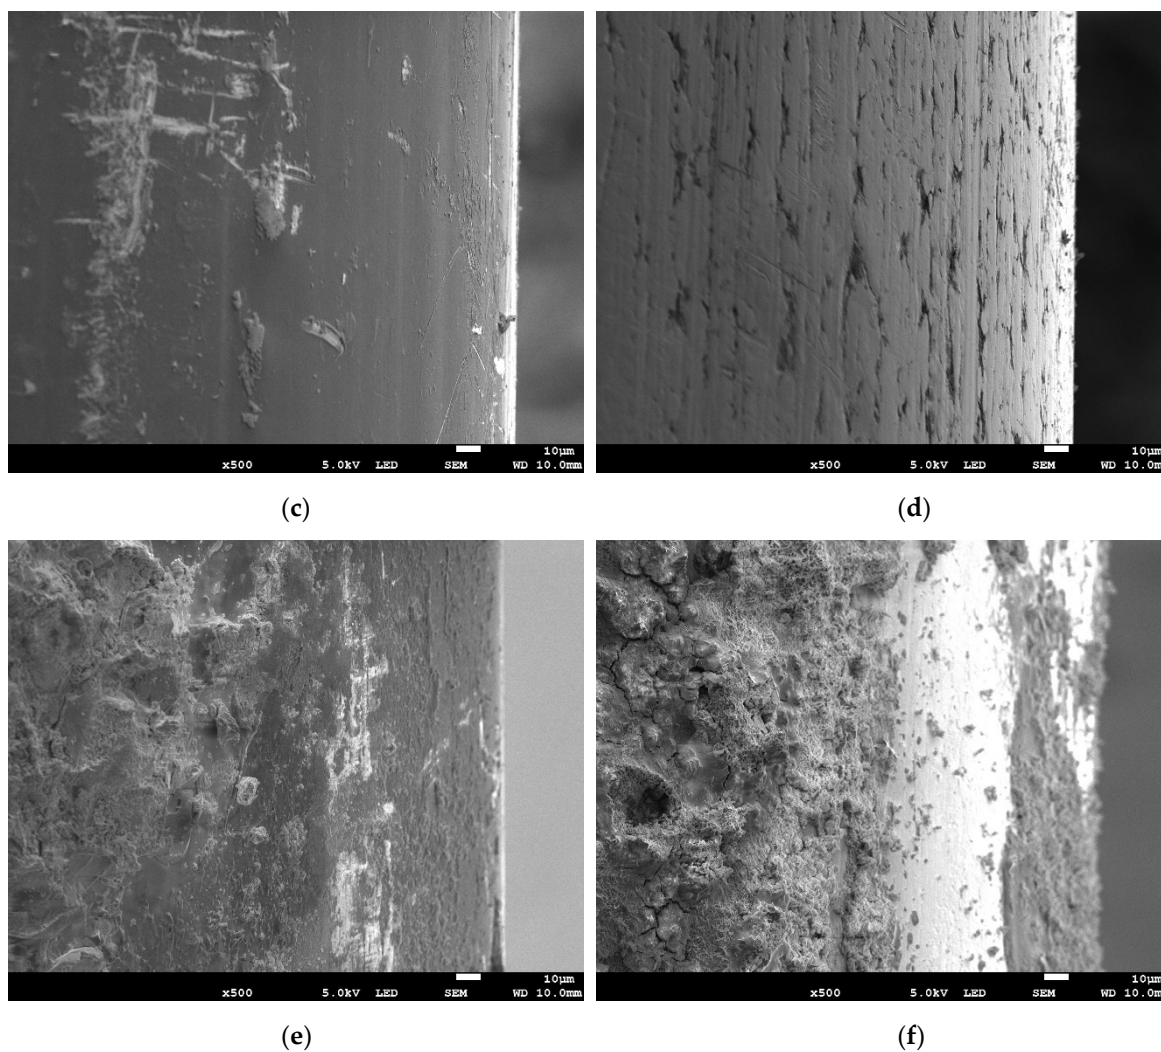
Figure 5. Surfaces of flux-cored wires: (a) A wire in delivery condition; (b) B wire in delivery condition; (c) A wire stored in GWS; (d) B wire stored in GWS; (e) A wire stored in MAB; (f) B wire stored in MAB.

SEM images show that the surfaces of both wires in delivery condition significantly differ (Figure 5a,b). The A wire is smooth, has a homogeneous surface without gaps in the continuity of the copper coating. On the contrary, B wire shows longitudinal grooves on the surface, located parallel to the axis of the wire and the direction of material forming. After storing the wires in GWS, A wire still has a smooth surface; only small precipitations can be observed on it (Figure 5c). The EDS analysis (Figure 6a) shows that these products mainly contain copper. B wire behaved similarly—in the grooves visible in Figure 5d, copper compounds accumulated (Figure 6c). Both wires from the MAB location are characterized by a high degree of degradation (Figure 5e,f). On their surface, precipitations of iron oxides were found, which was confirmed by the EDS analysis (Figure 6b,d). The differences between these wires can be seen in the SEM photos at higher magnification—A wire is only locally covered with a thicker layer of corrosion products, but a thin, brittle layer of iron oxides has formed on its surface (Figure 6b). A much thicker layer of corrosion products has accumulated on B wire. Figure 5e,f show the most degraded parts of the wires. Figure 5c–f also show the edge of the wires, which in each case shows no signs of corrosion other than atmospheric corrosion.

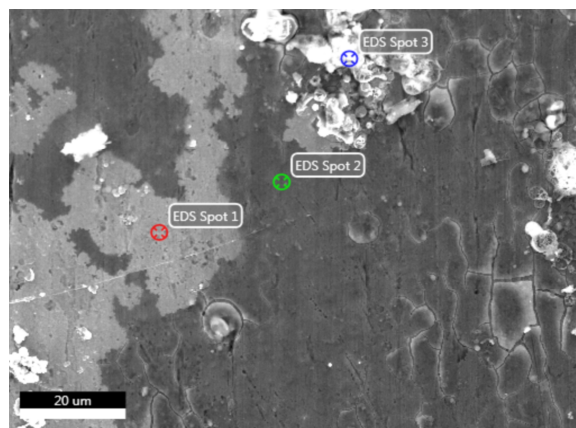
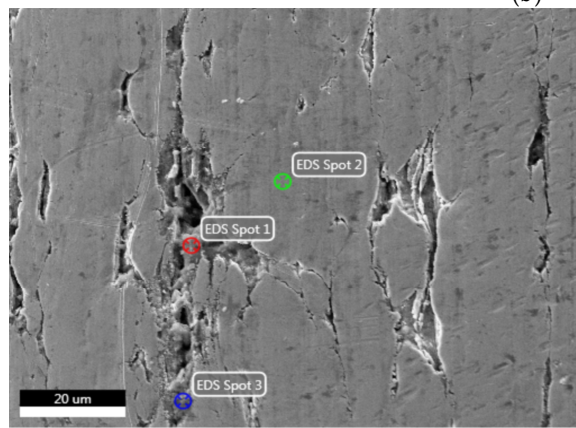
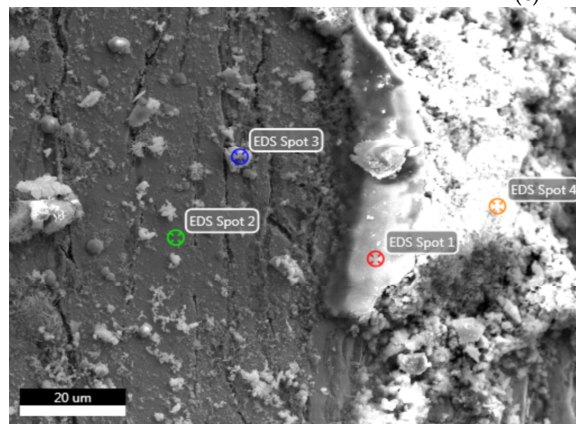
Zone	Fe	Cu	O	S
EDS Spot 1	5.01	91.44	3.55	-
EDS Spot 2	4.64	86.83	7.46	1.07
EDS Spot 3	4.19	90.68	4.48	0.65

Zone	Fe	Cu	O	S
EDS Spot 1	5.57	92.18	1.49	0.76
EDS Spot 2	43.53	53.44	2.45	0.58
EDS Spot 3	76.09	13.70	7.74	2.48

Zone	Fe	Cu	O	S
EDS Spot 1	22.38	65.55	9.43	2.68
EDS Spot 2	47.97	52.03	-	-
EDS Spot 3	22.37	58.85	19.48	4.30

Zone	Fe	Cu	O	S
EDS Spot 1	60.51	5.43	33.58	0.48
EDS Spot 2	66.30	33.70	-	-
EDS Spot 3	71.56	6.04	21.74	0.66
EDS Spot 4	60.68	6.26	32.61	0.45

Figure 6. SEM image and spot EDS analysis of flux-cored wires: (a) A wire stored in GWS; (b) A wire stored in MAB; (c) B wire stored in GWS; (d) B wire stored in MAB.

2. The wires stored in the welding site had a less degraded surface and after storage the copper compounds appeared in grooves. After being stored in an agricultural building, the surface of the wires was covered with iron compounds—for the B wire the amount of corrosion products is greater.

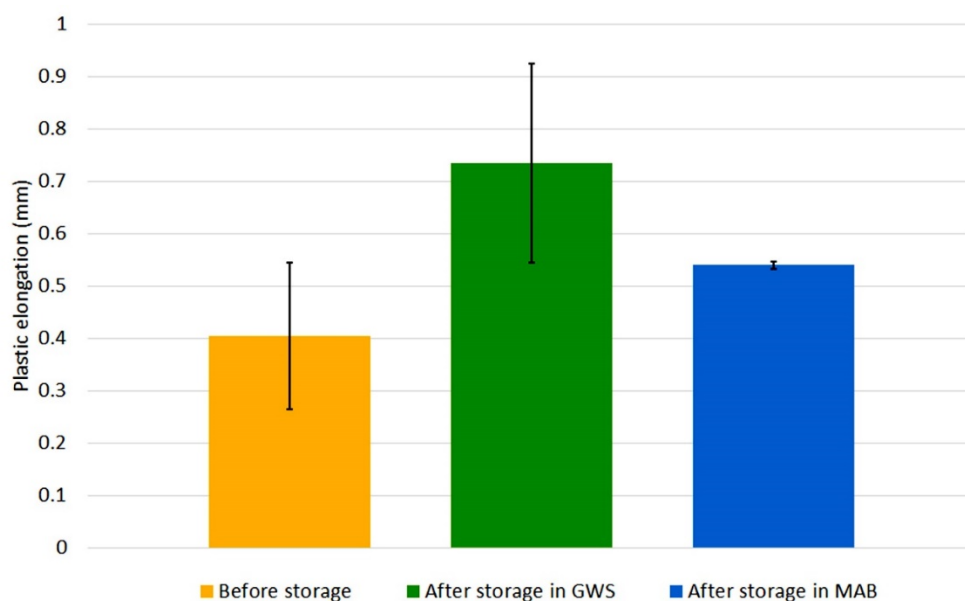
Figure 8. Change in plastic elongation of welds made with A wire, caused by storage for 1 month.

The obtained values of plastic elongation and standard deviation for all specimens confirm the statistical significance of the results. Although the wires have the same specification, their elongation values in the initial state differ. The A wire, regardless of its storage location, was characterized by an increase in plastic elongation. The increase was greater in the case of GWS—nearly twice. However, B wire showed a different trend. Each of the specimens, welded with both GWS and MAB wire, had a smaller plastic elongation compared to the specimen welded with the wire in delivery condition. A large drop was particularly visible in the wire from MAB—the plasticity of the weld metal dropped almost four times with a double drop for the wire stored in GWS.

The plasticity of the welds was influenced by the storage conditions of the tested flux-cored wires. The A wire is clearly less sensitive to the environment. In this case, changes occurred in the direction of increasing plasticity, but they were less intense than in the case of B wire. The degradation of B wire caused a deterioration in the plasticity of bead-on-plate welds in both storage environments. The list of plasticity indexes values (Table 5) shows very large differences which were found for the tested conditions.

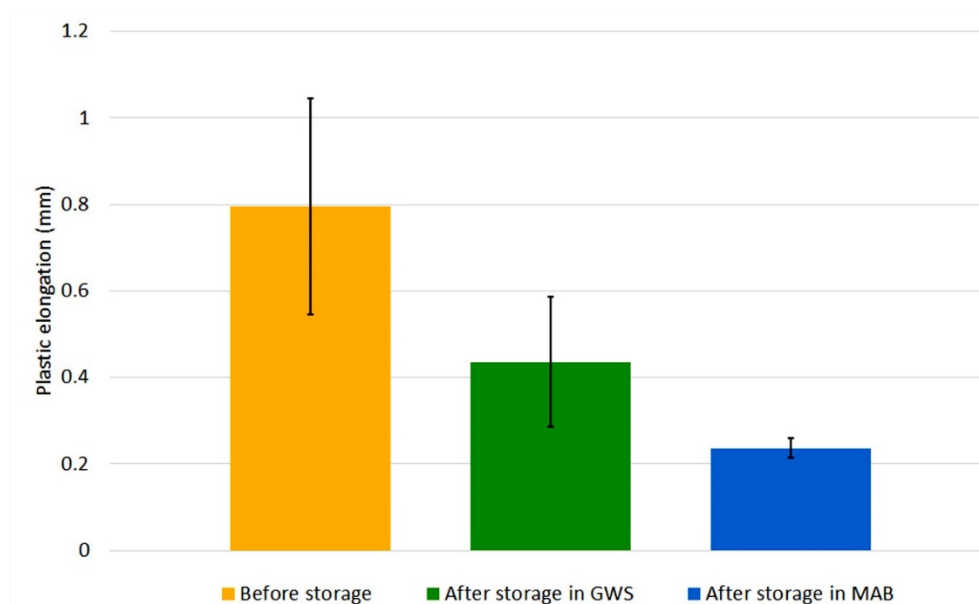
Figure 9. Change in plastic elongation of welds made with B wire, caused by storage for 1 month.

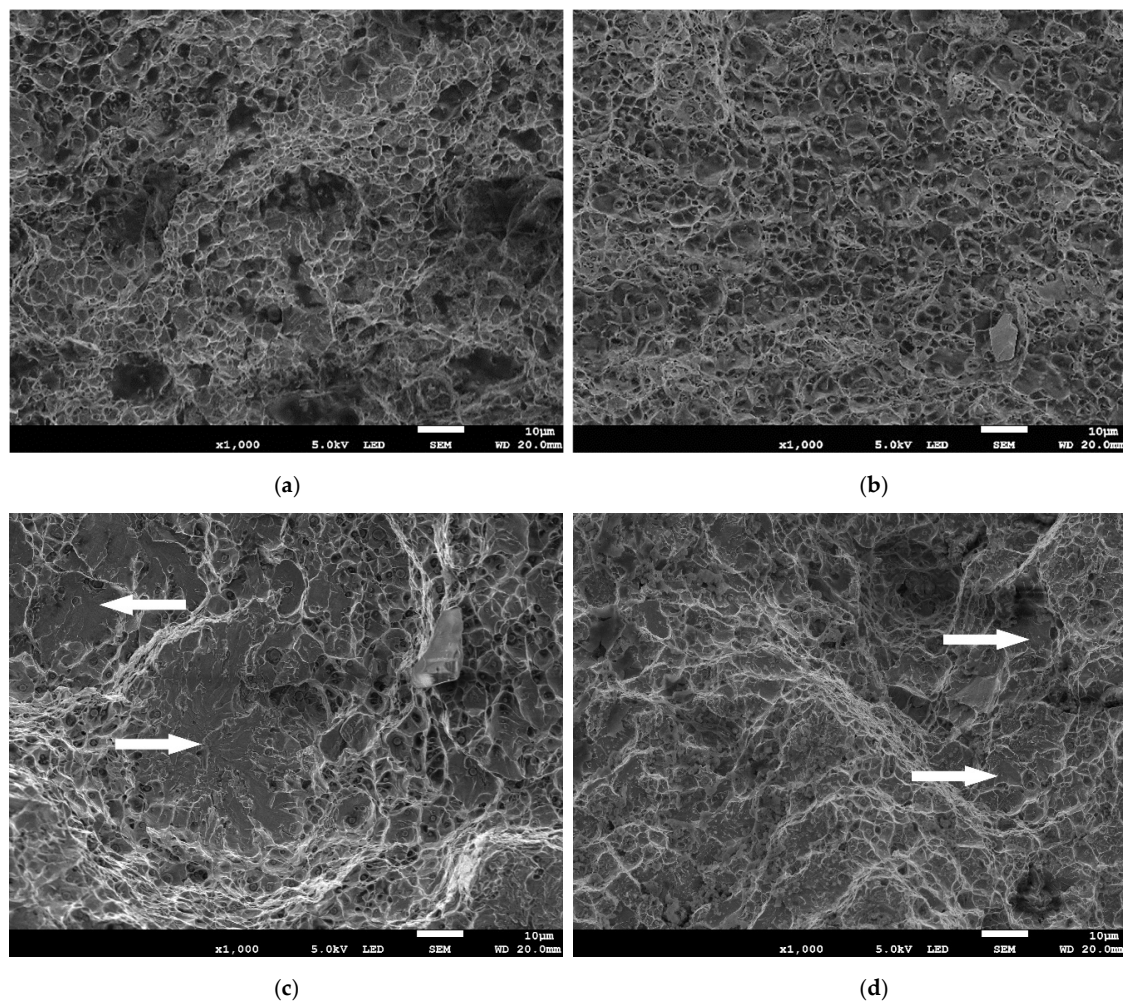
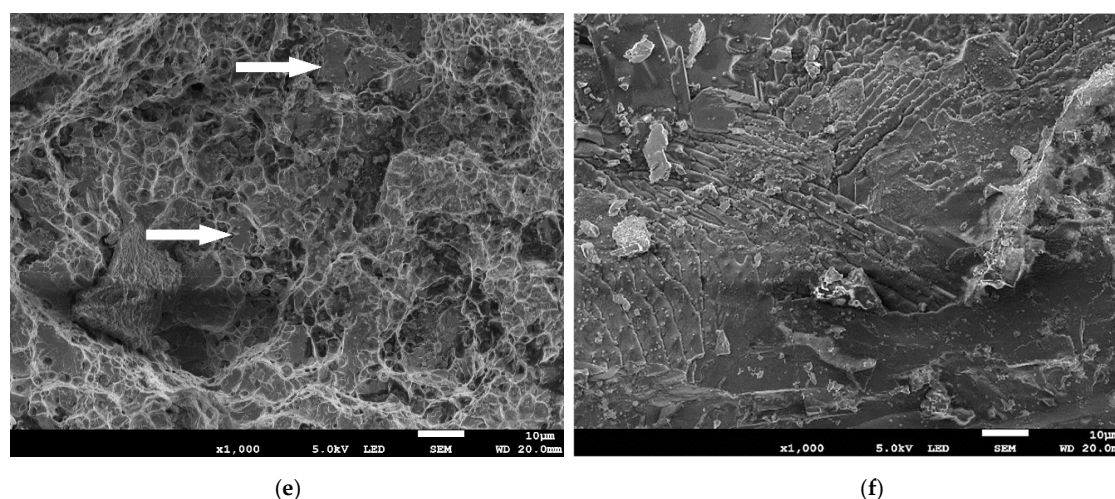
Figure 10 shows SEM images of fractures after tensile test. In Figure 10a,b, dimples, characteristic of the ductile microvoid coalescence fracture, are clearly visible. Such a fracture mode predominated in specimens made with wires in delivery condition. An increased share of the brittle fracture (marked with white arrows) was observed in specimens made of wire from the GWS and in the specimen made of A wire from MAB (Figure 10c–e). In this case, the quasi cleavage fracture was found. Three zones can be observed—at the face the fracture was more ductile, dimples appeared larger, in the middle zone between dimples flat cleavage areas appeared and at the root there were dimple clusters and larger areas of cleavage, with large steps. Figure 10f shows the fracture surface of a specimen made using B wire stored in MAB. In this specimen, cleavage fracture dominates. At 1000× magnification, only single dimples are visible, situated between large cleavage areas.

Figure 10. Fracture surfaces of specimens after tensile tests: (a) specimen made using A wire in delivery condition; (b) specimen made using B wire in delivery condition; (c) specimen made using A wire stored in GWS; (d) specimen made using B wire stored in GWS; (e) specimen made using A wire stored in MAB; (f) specimen made using B wire stored in MAB.

A change in plasticity can also be observed by comparing the mode of fracture of the tensile tested specimens (Figure 10). The most characteristic is the transition from the ductile microvoid coalescence fracture to the almost complete cleavage fracture for the specimen made using B wire stored in MAB. Such a great change is directly related to the results of plasticity indexes (Table 5), which also indicate a very intense degradation of bead-on-plate weld plasticity for this wire and location. In all fracture surfaces, at least some dimples were found and they were all equiaxed, which confirms that tensile loading was the main loading type responsible for breaking of specimens.

4. The mode of the fracture in tensile specimens varied depending on the storage conditions and grade of wire. Under the influence of monthly storage, there was a change from the ductile microvoid coalescence fracture to the almost complete cleavage fracture.
