A Critical Reanalysis of Uncontrollable Washboarding Phenomenon in Metal Band Sawing

Abstract: The article analyzes the cutting process of hard bars. Investigations conducted in industrial conditions demonstrated the presence of surface errors in the machined workpieces in the form of washboard patterns. The purpose of this study was to analyze the results of cutting on band sawing machines with different band saw blades. The cutting processes were conducted on three different horizontal band sawing machine types. Analyzed material was an alloy steel Ø40 mm rod with a hardened surface covered with a thin layer of chromium. The hardness of the outer layer was 547 HV with a core hardness of 180 HV. The surface topography measurements of the processed workpieces were carried out with the 3D Optical Profiler, which supplied information on the irregularities of the processed material texture. In each of the analyzed cases, a corrugated surface was obtained after sawing, which is the effect of the occurrence of the washboarding phenomenon, despite the fact that the teeth of each band saw had variable pitches. The washboarding phenomenon when cutting rods with hard surfaces is caused by

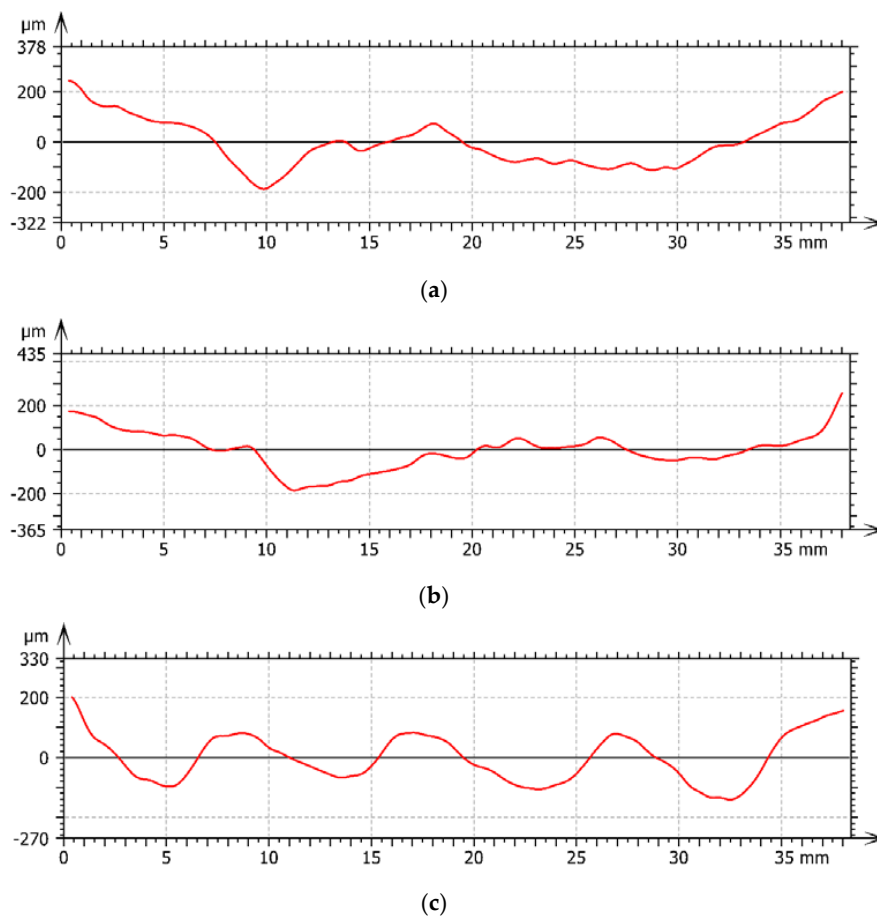
Figure 7. Exemplary W—profile at 50% position of the samples #1 (a), #2 (b), and #3 (c).

An exemplary W-profile at 50% position of the sample #3 is presented in Figure 7. According to the values of waviness parameters and profile information given in Table 3, the middle of the machined samples #1 and #2 was distinctly above the edge, 2–3 μm wide, and with deep furrows. In sample #3, all of the furrows after machining process were well visible and their height was similar level to regular spacing of hills and valleys.
