Article

Optimization of Stabilizing Systems in Protection of Cultural Heritage: The Case of the Historical Retaining Wall in the Wisłoujście Fortress

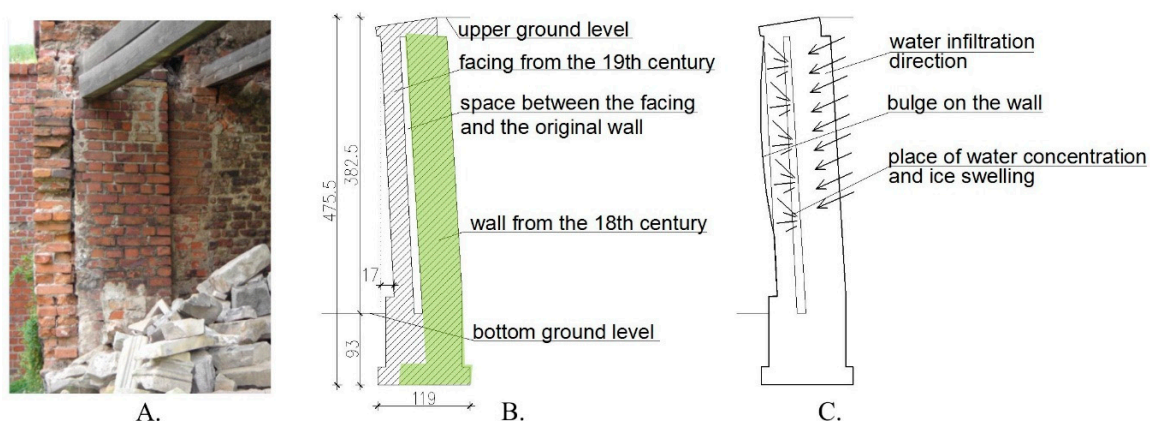
Figure 3. The retaining wall after its repairs from the second half of the 19th century: (A). The interface between the original wall and the 19th century siding layer, (B). Current geometry of the wall, (C). Scheme of water circulation in the wall.

Because the wall did, in fact, resist earth pressure for about 130 years, numerous vertical cracks have appeared on the surface of the wall, approximately within 0.5–2.3 m from each other (Figure 4). There is also surface freeze–thaw cycle damage visible on the wall, which could, to an untrained eye, look like cracks. Since the second half of the 19th century, two significant series of repairs have been carried out. The first was the addition of a 25 cm-thick brick siding layer and the second one was a buttress. The new facing (Figure 3A,B and Figure 5) was added without re-walling, which, paradoxically, led to deterioration of masonry over time: a crevice that developed between the new and old walls collected water (Figure 4). At low temperatures, the water froze, bursting the wall and

causing bulges in its upper part (150 cm from the top of the wall), which increased its deviation from the vertical (see Figure 3). In 2016, the deviation from plumb amounted to approximately 15 cm.
