# Underwater Local Cavity Welding of S460N Steel

**Abstract:** In this paper, a comparison of the mechanical properties of high-strength low-alloy S460N steel welded joints is presented. The welded joints were made by the gas metal arc welding (GMAW) process in the air environment and water, by the local cavity welding method. Welded joints were tested following the EN ISO 15614-1:2017 standard. After welding, the non-destructive—visual, penetrant, radiographic, and ultrasonic (phased array) tests were performed. In the next step, the destructive tests, as static tensile-, bending-, impact- metallographic (macroscopic and microscopic) tests, and Vickers HV10 measurements were made. The influence of weld porosity on the mechanical properties of the tested joints was also assessed. The performed tests showed that the tensile strength of the joints manufactured in water (567 MPa) could be similar to the air welded joint (570 MPa). The standard deviations from the measurements were—47 MPa in water and 33 MPa in the air. However, it was also stated that in the case of a complex state of stress, for example, bending, torsional and tensile stresses, the welding imperfections (e.g., pores

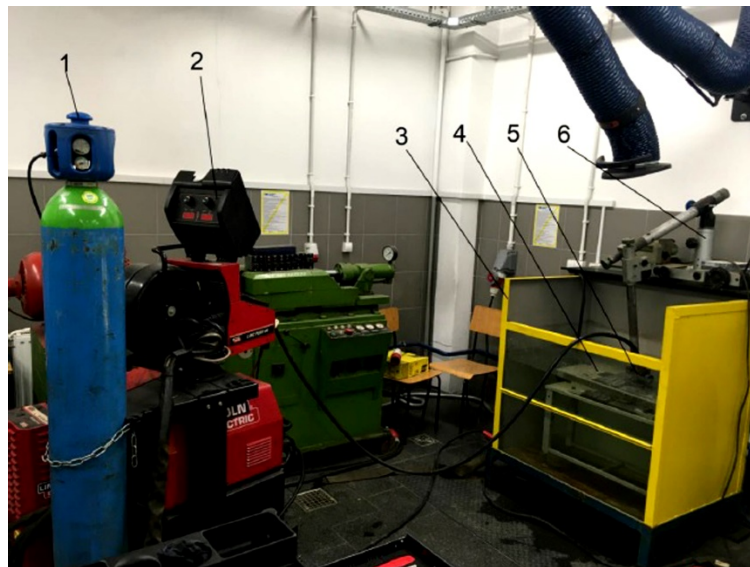
**Figure 1.** Welding test stand: 1-gas cylinder, 2-welding power source and wire feed unit, 3-tank, 4-welding table, 5-specimen, 6-welding trolley (tractor).

20 °C), using the local cavity method. Specimens were taken in the welding position PA (1G)—welding in flat position. The welding test stand is presented in Figure 1.

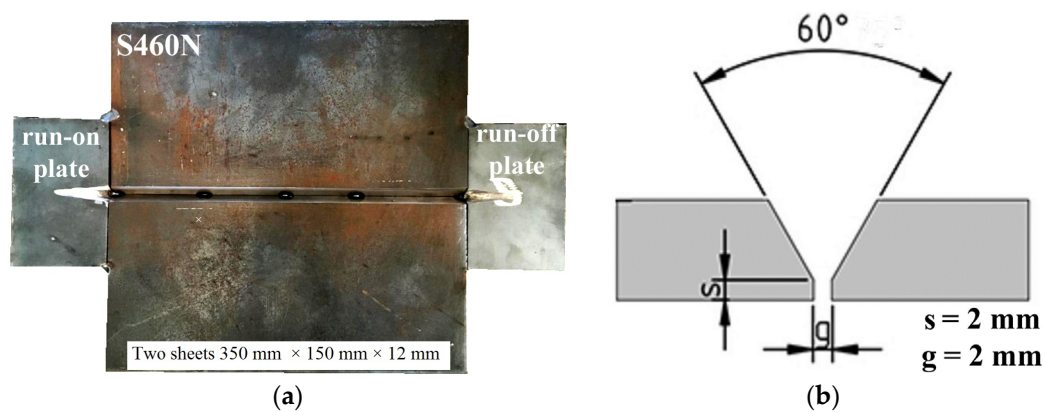
**Figure 2.** (a) The real view of the specimen before welding and (b) schematic cross-section of the specimen.

The dimensions of S460N steel plates were  $350 \times 150 \times 12$  mm, as is required in the qualification of welding procedures for butt welded joints following the EN ISO 15614-1:2017 standard [38]. Pieces of material were prepared with a “Y groove” and were joined by tack welds at the root site. The run-on and run-off plates (S460N steel,  $60 \times 100 \times 12$  mm) were used to obtain constant parameters in the tested area. The vertical view of the specimen and the schematic cross-section view are presented in Figure 2.

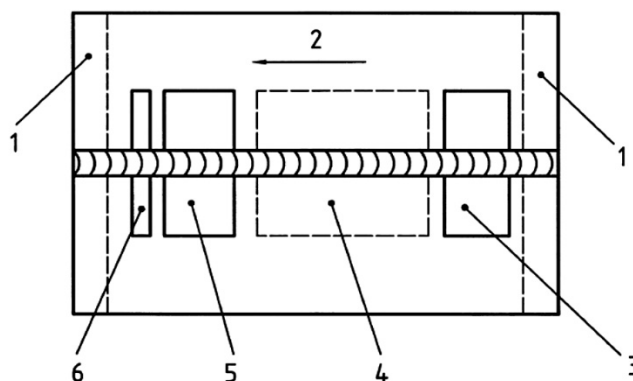
**Figure 3.** The location of test samples for destructive (DT); 1—discard 25 mm, 2—welding direction, 3—area for one tensile test specimen and bend test specimens (one for bending with tensile from the face of the weld, one for bending with tensile from the roof of the weld), 4—area for impact test specimens, 5—area for one tensile test specimen and bend test specimens (one for bending with tensile from the face of the weld, one for bending with tensile from the roof of the weld), 6—area for metallographic (macroscopic and microscopic) test specimens and one hardness test specimen.

Specimens were subjected to non-destructive (NDT) and destructive (DT) tests. In the first step, NDT was performed. The HSLA steels are characterized by high susceptibility to cold cracking in underwater conditions [8,10,20]. Cold cracks may occur up to 48 h after welding. Following this reason, the NDT was performed 48 h after welding. These kinds of tests are widely used for testing underwater constructions [40]. Both welded joints were tested using: a visual test (VT) following EN ISO 17637:2017 [41], a penetrant test (PT)—EN ISO 3452-1:2017 [42], a radiographic test (RT)—EN ISO 5579:2014 [43], and an ultrasonic test (UT), by use of an automated phased array (PA) technology—ISO 13588:2019 [44]. For RT, the ANDREX 300kV x-ray apparatus was used. During preliminary investigations, the optimal parameters were chosen: focal length 700 mm, exposure time 5 min 30 s, voltage 185 kV, anode current intensity 4.5 mA. UT was performed by PA technology with the use of a Phasor XS flaw detector (GE Research, New York, USA). For PA 16 an element head was used, with the angle of inclination at  $36^\circ$ . During tests, type A and S imaging were obtained. After NDT, both specimens were prepared for DT by cutting samples for each test. Investigated joints were cut following the requirements presented in the EN ISO 15614-1:2017 standard [38]. The location of test samples for DT is presented in Figure 3.

near the end of the joint (following the scheme presented in Figure 3). The exemplary photographs of the bending results of the bending test are presented in Figure 12. The main aim of the bending test is to determine the plastic properties of welded joints. However, it also allows checking the influence of the welding imperfections on the properties of the welded joints, as it was stated by Rogalski et al. [58]. The criterion of acceptance was defined as a bend angle of 180°. During NDT, imperfections were found in areas, from which samples for the bending test were taken. Samples from specimen SW were broken into two parts. A maximum bending angle equal to 60° was observed for the samples bent with tensile from the root of the weld (Figure 12a), which was cut from the area close to the end of the joint. The second sample (area near the beginning of the joint), which was bent under the same conditions, broke with an angle of 10°. The cross-section observation showed that almost 60% of the weld was characterized by porosity (Figure 12b). The same was noticed for a sample bent with tensile from the face of the weld, which broke with angle 35°. The second sample (area near the end of the specimen SW) has been broken with an angle of 45°. Different results have been observed for bending the samples from the joint welded in the air. Both samples cut from the area without imperfections reached the aimed angle of 180° (Figure 12c). Specimens performed from an area characterized by the lack of fusion broke through the fusion line. The sample bent with tension from the face of the weld reached a bend angle of 110°. A sample bent with tension from the root of the weld reached bend angle 90° (Figure 12d). The results that were obtained allow for a comparison of the properties of specimens welded in both environments. The bending test results allow drawing the statement that there is no connection between tensile strength and resistance for the bending process. Both specimens could obtain similar results in the tensile test. However, there are significant differences in their behavior during bending. The cooling rate is an important factor influencing the metallurgical changes. The water environment increases the intensity of heat dissipation from the welding area in relation to the air welding conditions. It leads to formation of brittle structures in the HAZ of underwater welded joints [39,55], which was proved in this paper. Therefore, it can be assumed that the simultaneous presence of a welding imperfection and a quenched structure affects the bending test results.

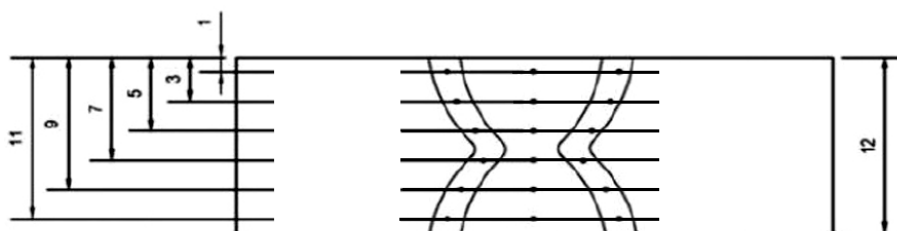
**Figure 4.** The distribution of Vickers HV10 hardness measurement points in the specimens.

(Nital 4%), to ensure the correct notch location. Two samples were tested from each joint with V-notch located in the HAZ and two with the V-notch located in the weld. The notch was V-shaped and has been made with an angle of 45° and a depth of 2 mm. The width and height of the sample were 10 mm. Tests were performed with requirements of the EN ISO 148-1:2017 standard [48]. The Vickers HV10 hardness was measured according to the (EN ISO 9015-1:2011 standard [49]). All tests were performed at room temperature (20 °C). The distribution of measurement points (each point in the picture means three measurements) in this test is presented in Figure 4.

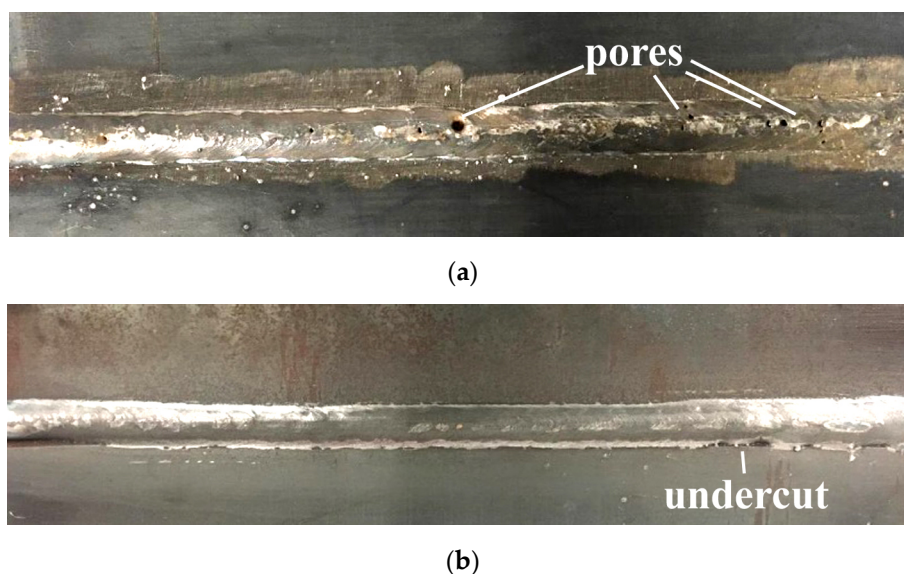
The views of the welded joints are presented in Figure 5. During the VT, significant differences were observed in specimens welded in both environments. In specimen SW the pores were found on the surface of the face of the weld and in the root area. These imperfections were located near the axis of the tested joint (Figure 5a). It was stated in the literature [27], that pores are the most common imperfection during local cavity GMAW welding. This statement was confirmed in the presented investigations. The surface of the joint welded in air was free of pores. However, the undercut (15 mm length) was observed on the weld face area (Figure 5b). This imperfection was observed earlier in GMAW welded joints performed with 460 grade steel [50,51].

**Figure 5.** View of: (a) specimen SW and (b) specimen SA.

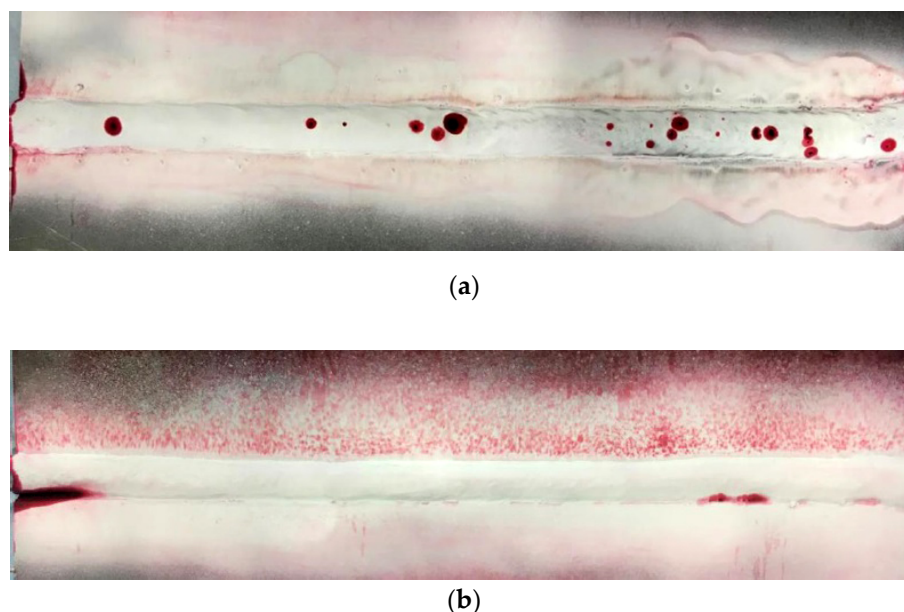
The view of specimens after PT are presented in Figure 6. The presence of pores (specimen SW) and undercut (specimen SA) observed during VT has been confirmed in PT. Both of the mentioned tests allow observing only imperfections that occurred on the surface of the welded joints. Due to this reason, other NDT were performed.

**Figure 6.** View of specimens after PT: (a) specimen SW and (b) Specimen SA.

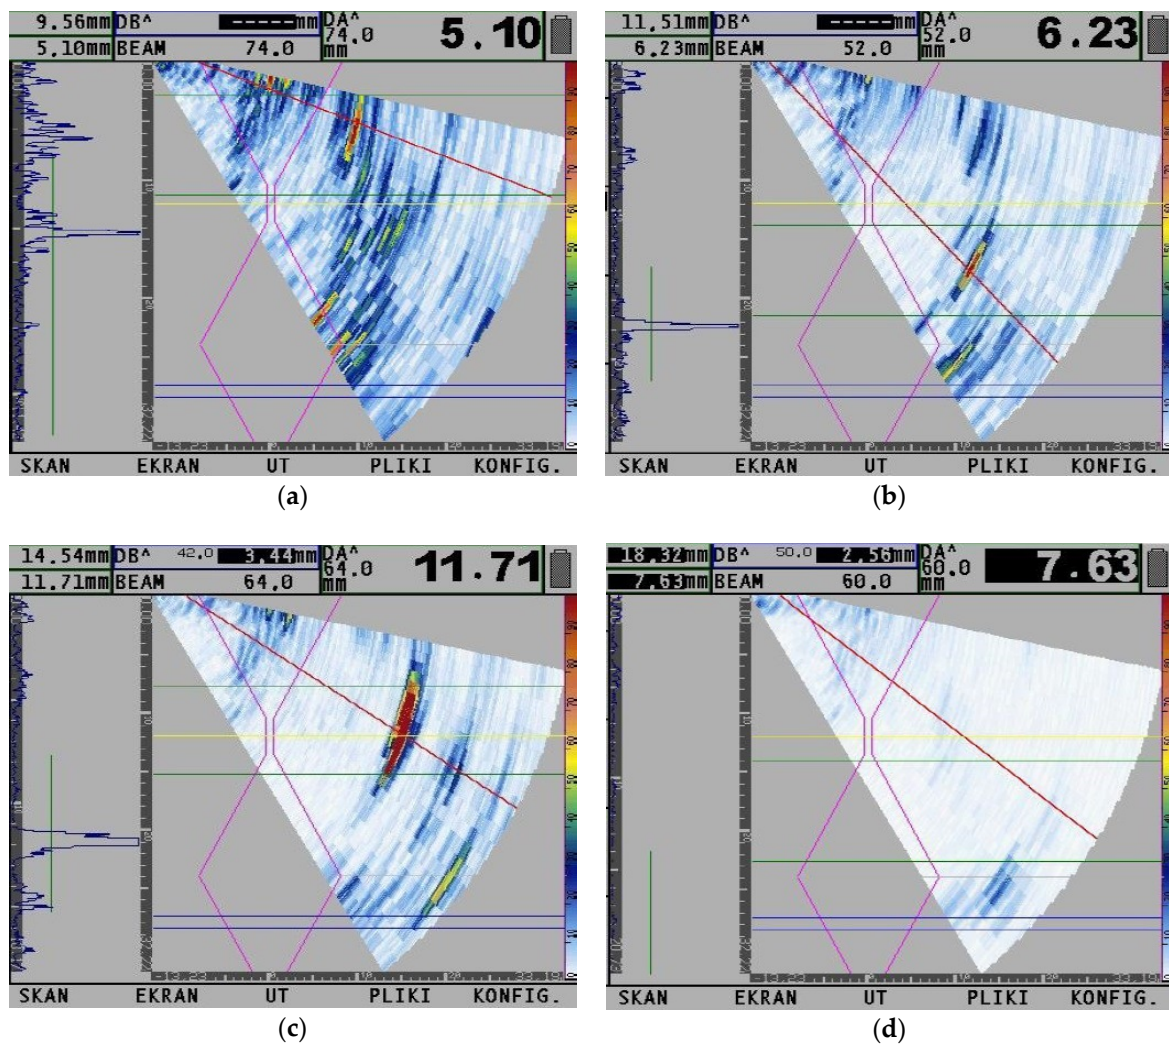
Figure 8 presents the results of UT by PA technology. Tests were performed in areas with the highest number of indications observed during RT (specimen SW) and in the area of indication and area without any indication in the specimens welded in the air (specimen SA). For a specimen welded by the local cavity method, the differences were observed near the beginning and near the end of the joint. In the beginning, the pores were located through the whole thickness of the specimen (Figure 8a). Their number was similar from beginning of the joint to the 203 mm of its length. In the rest of the joint (from 203 to 350 mm), this number decreased, and pores changed their shape to linear. This confirmed results from RT. They were located near the root area of the weld (Figure 8b). The joint welded in the air is characterized by a lack of penetration at depth 2.5–3.8 mm (Figure 8c). However, an area without any imperfection was observed in specimen SA (Figure 8d).

**Figure 8.** Results of the ultrasonic test (UT) by phased array (PA) technology: (a) beginning area of specimen SW; (b) finishing area of specimen SW; (c) lack of fusion area in specimen SA and (d) the area without imperfections in specimen SA.

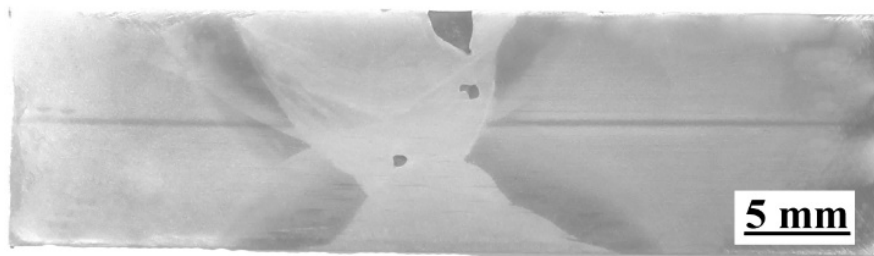
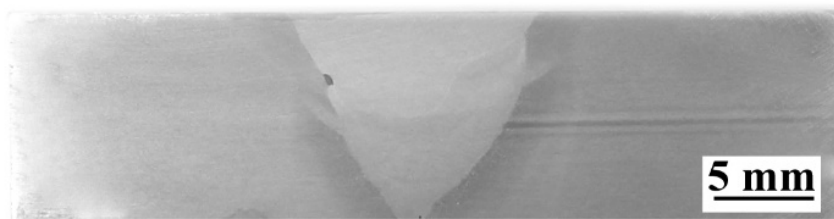
Macroscopic photographs are presented in Figure 9. Cross-sections in two specimens for macroscopic testing were located in areas characterized by the presence of imperfections, which were observed in NDT. Macroscopic testing of specimen SW showed one open surface pore and two pores located in the weld metal (Figure 9a). In specimen performed in the air, the pore was found in the fusion line in the area, where lack of fusion was observed during NDT. No cracks were found in both investigated joints.

**Figure 9.** Results of macroscopic testing: (a) specimen SW and (b) specimen SA.

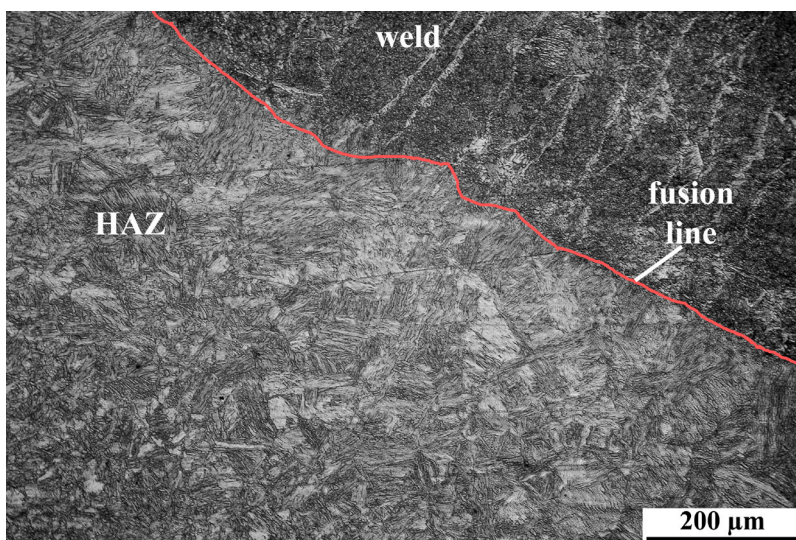
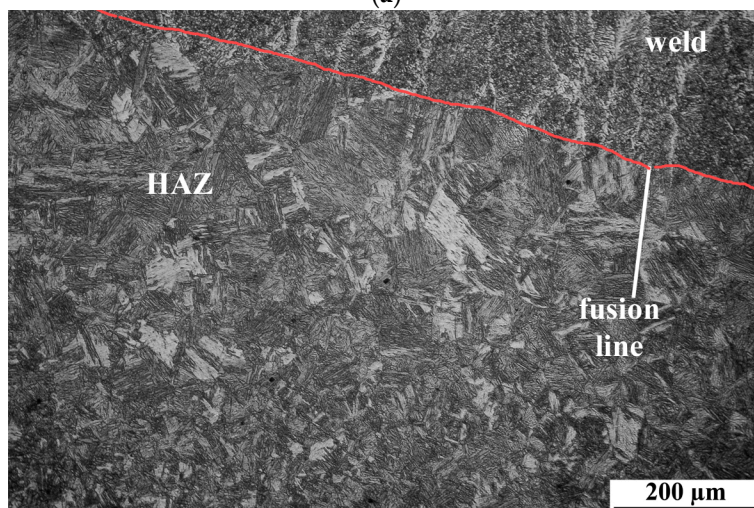
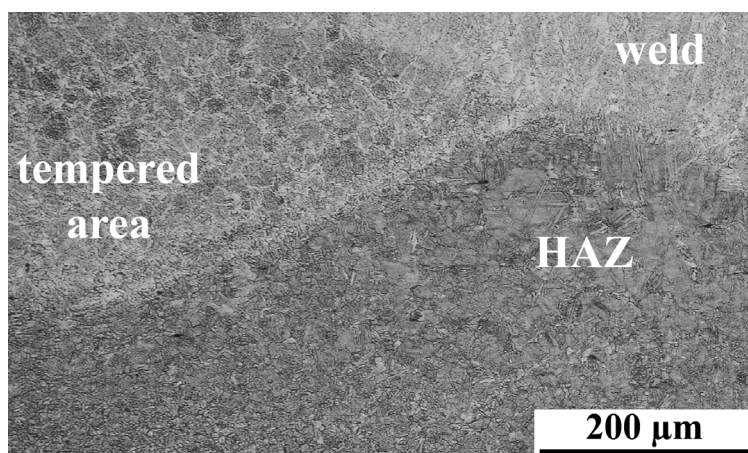
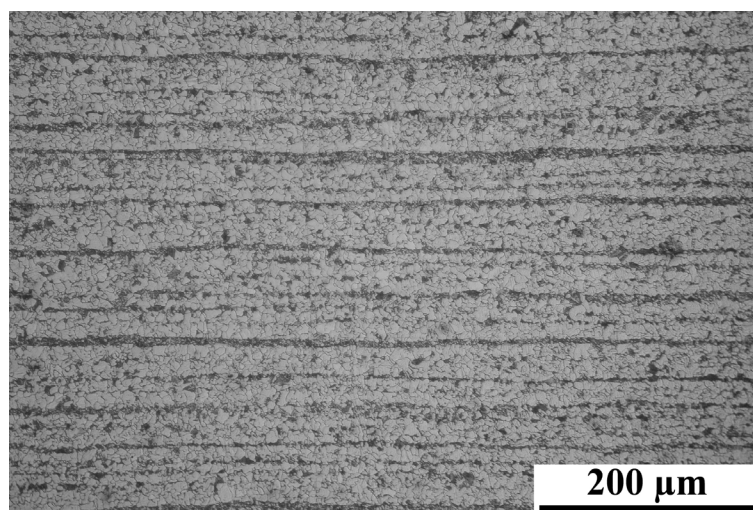
The microstructures of the specimens welded in different environments are shown in Figure 10. During microscopic testing, the differences were observed for specimens welded in the air and in water. Water as a welding environment increases the cooling rate. It resulted in the formation of complex structures in the HAZ. The microstructure in HAZ of specimen SA consists of a mixture of martensite and bainite (Figure 10a). Specimen SW welded in the water is characterized by the typical structures formed in this environment. The microstructure in HAZ is coarse-grained and exhibits a martensitic morphology (Figure 10b). The weld metal of both specimens was built of dendrites. The strong effect of tempering of brittle structures in HAZ has been observed in the middle of specimen SW (Figure 10c). The heat from the weld passes has accumulated in this area, which provides the tempering of microstructures. A similar effect was presented in our further investigations [18]. The results of microscopic testing of the joint (HAZ) performed on S460N steel welded in the water by the wet welding method were presented in previous investigations [39,55]. In the presented experiments [39,55], cold cracks were found in the HAZ of the joint performed in the high cooling rate conditions. However, during the microscopic testing of specimen SW, no cracks were found. This showed the advantages of local cavity welding in comparison to the wet welding process in thermal and metallurgical conditions. The microstructure of the S460N steel is composed of banded ferrite and banded pearlite (Figure 10d).

**Figure 10.** Optical micrographs of: (a) specimen SA; (b) specimen SW; (c) middle area of specimen SW—the tempering effect and (d) S460N microstructure.

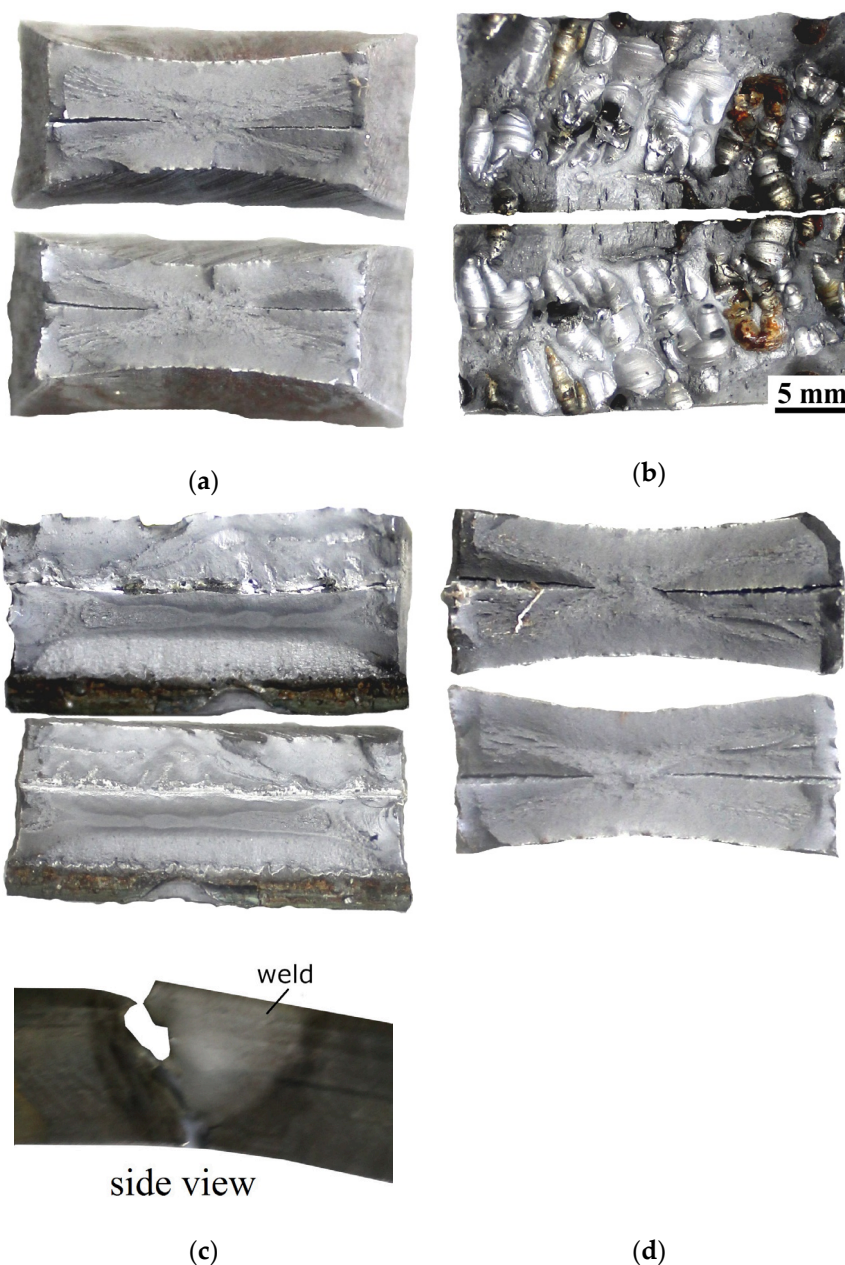
The results of tensile strength are presented in Table 4. The photographs of the fracture are presented in Figure 11. Following the EN 10025-3:2019 standard [56], the minimum tensile strength for S460N steel should be equal to 520 MPa, which is the required value for the presented investigation. From each welded joint, two samples were tested. One sample from each specimen was cut in the area near the beginning of the joint and one in the area close to the end of the specimen. Two of the samples from the joint performed by local cavity welding were cut in areas characterized by the presence of pores. During the tensile test, samples cut near the end of the joint were broken in the BM. It suggests that the number of pores did not significantly decrease tensile strength of this area (specimen SW). The broken area was characterized by plastic behavior during breaking (Figure 11a). This is common for steel BM. The second sample, which was cut near the beginning of the joint, has broken in the weld metal and did not obtain the required tensile strength (520 MPa), which was calculated as 503 MPa. The pores in this sample are located near 60% of the cross-section of the broken area (Figure 11b). One of the samples (specimen SA) was located in an area where a lack of fusion was found during NDT. During the tensile test this specimen broke at the fusion line (Figure 11c). The second sample from specimen SA was cut in the area without any observed imperfections, and it broke in the BM. The cross-section was characterized by plastic behavior during the test (Figure 11d). It was stated in the literature that tensile strength is strongly connected with the storage conditions of the filler material [57]. Different conditions may change the mechanical properties of the welded joint. However, in the presented paper, both specimens were welded with the same welding wire. This allows us to make the statement that the number of imperfections have a higher influence on the tensile strength of the welded joint than the welding environment. The tensile strength of samples from specimens welded in the water (567 MPa) and the air (570 MPa), which have broken in the BM, are characterized by a similar tensile strength value. Also, the elongation of samples without imperfections is similar. Underwater welding generates brittle microstructures such as martensite and bainite in the HAZ [27–30]. These structures are characterized by higher mechanical properties than structures generated during welding in the air. It resulted in the tensile strength of joints performed in different environments. Even the presence of many imperfections allowed us to obtain similar tensile strength for samples from different joints.

**Figure 11.** The fracture surface of the broken area during tensile testing: (a) Sample 1 from specimen SW, broken in base material (BM); (b) Sample 2 from specimen SW, broken in the weld; (c) Sample 1 from specimen SA, broken in the fusion line; and (d) Sample 2 from specimen SA, broken in the BM.

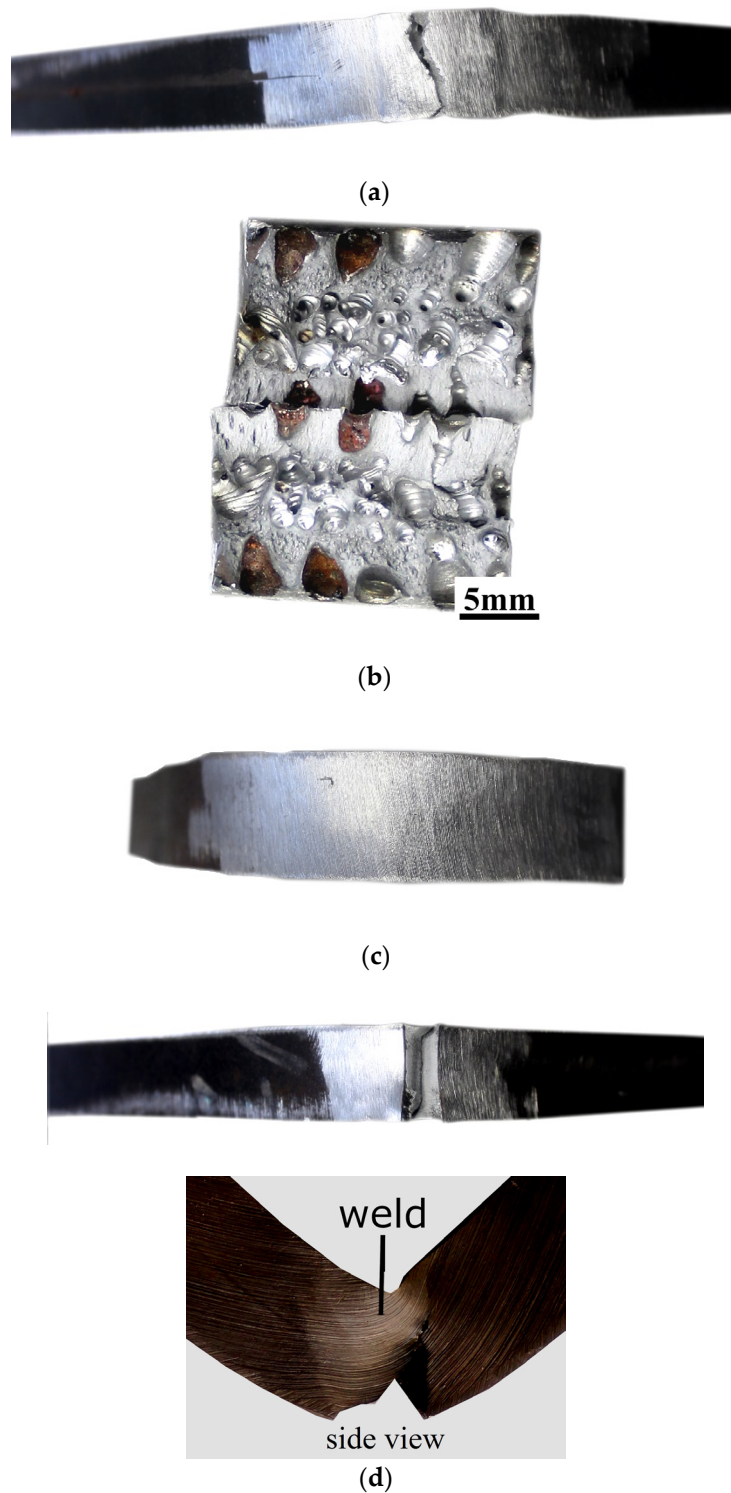
**Figure 12.** Specimens after bending test: (a) Sample 3 performed in the water, bent with tensile from the root of the weld; (b) Sample 4 performed in the water, bent with tensile from the face of the weld; (c) Sample 2 performed in the air, bent with tensile from the root of the weld; (d) Sample 3 performed in the air, bent with tensile from the root of the weld.

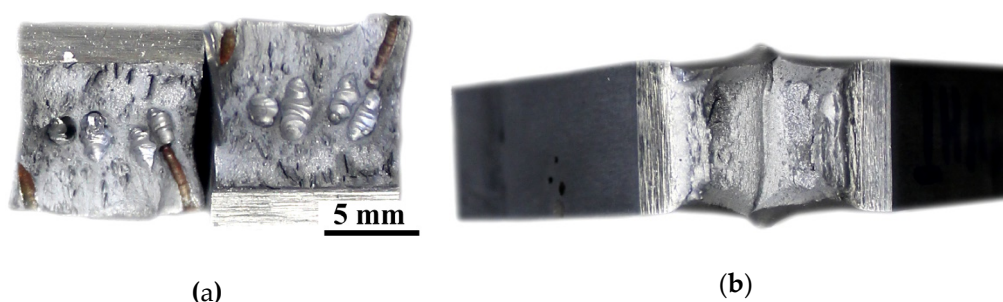
The results of the Charpy impact test are presented in Table 6. The exemplary photographs of samples after the test are presented in Figure 13. The results showed significant differences in weld

metal impact strength (Samples 1 and 2). Both samples from the joint welded by the local cavity method have been broken into two parts after the impact test. They are characterized by an impact in the range of 39.2 to 54.9 J/cm<sup>2</sup>. Only one specimen from the joint performed in the air broke into two parts, with impact strength 113.8 J/cm<sup>2</sup>. The second one did not break. For samples with a V-notch located in the HAZ (Samples 3 and 4), the results were similar. One sample was made in the water, and in the air broke after the Charpy test, and one was in one piece. The fractography observation showed that the weld metal of specimen SW is characterized by high porosity (Figure 13a). Observation of samples with a V-notch located in the HAZ did not show significant differences. The cross-section showed areas with the typical mechanism of brittle and ductile fractures. It confirmed the statement from the bending test. Świerczyńska et al. [59] stated that the impact strength of the welded joint depends on the storage conditions of filler materials. In the presented paper, this factor was eliminated by using the same welding wire. It provided the same conditions for preparing the specimens. Results of mechanical properties tests allow drawing the following conclusion. In making welded joints that ensure tightness only (e.g., repair of the watercraft patting), porosity does not affect the operational properties, which was stated earlier in the literature [60]. High porosity cannot occur in the welded joints in the case of requirements related to the transfer of loads resulting from bending and torsional stresses.

**Figure 13.** Cross-sections of samples after the Charpy impact test: (a) Sample 1, specimen SW, broken in the weld; and (b) Sample 3, specimen SA.
