INFLUENCE OF PROCESS OF STRAIGHTENING SHIP HULL STRUCTURE MADE OF 316L STAINLESS STEEL ON CORROSION RESISTANCE AND MECHANICAL PROPERTIES

Keywords: 316L steel, flame straightening, corrosion resistance, mechanical properties

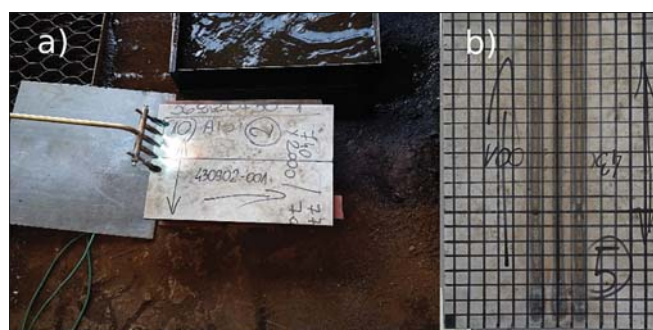
Fig. 2. Test plate during straightening process (a) and surface after process (b)

Eight test plates were provided for testing: two reference ones made of material not subjected to flame straightening (reference material), three straightened and naturally cooled ones, and three straightened and water-cooled ones (All panels had dimensions of 300×450 mm and a thickness of 10 mm. Straightening was carried out using triple flame burners. Figure 2 shows the plate during straightening. The straightening direction was perpendicular to the rolling direction.
