# Characterization of fracture process in polyolefin fibre-reinforced concrete using ultrasonic waves and digital image correlation

This study explores the monitoring of the fracture process in concrete beams and aims to characterize the evolution of damage in polyolefin fibre-reinforced concrete beams by utilizing the integrated application of two measurement techniques, digital image correlation and ultrasonic testing. The interpretation of registered wave time histories data was provided by the calculation of the magnitude-phase-composite metrics. An efficient procedure for the determination of strain field and the identification of crack height was subsequently developed. The results of the study show that the energy and phase shifts of ultrasonic waves can be used as autonomous damage indicators in a system for the real-time monitoring of a fracture process.

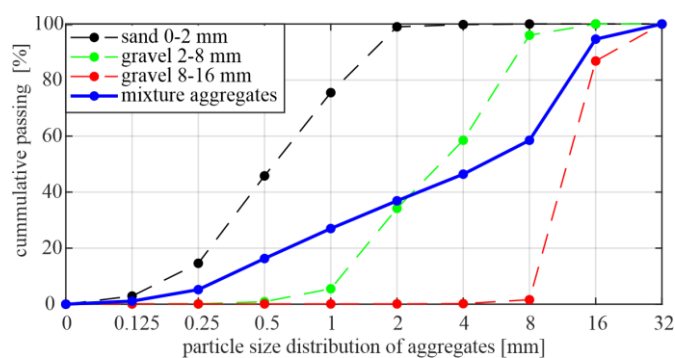
Figure 1. Aggregate grain distribution curves for particles with sizes 0–2 mm, 2–8 mm and 8–16 mm, and the mixture aggregates

Concrete strength class C30/37 was assumed. Granulation of mineral aggregates (Figure 1) was selected such that the mixtures had a good workability. The amounts of concrete mixture components were determined by the analytical–experimental method. In all tests, the same composition of concrete was used: CEM I 42.5R (380 kg/m<sup>3</sup>), water (165 kg/m<sup>3</sup>), sand 0–2 (648 kg/m<sup>3</sup>), gravel 2–8 (426 kg/m<sup>3</sup>), gravel 8–16 (754 kg/m<sup>3</sup>), polycarboxylate ether (PCE) super-plasticizer (0.8 % of cement content). Four concrete mixtures were produced: one control mixture without fibres (mixture #000) and three mixtures with different contents of macro polymer fibres equal to 2 kg/m<sup>3</sup> (mixture #002), 4 kg/m<sup>3</sup> (mixture #004) and 6 kg/m<sup>3</sup> (mixture #006).

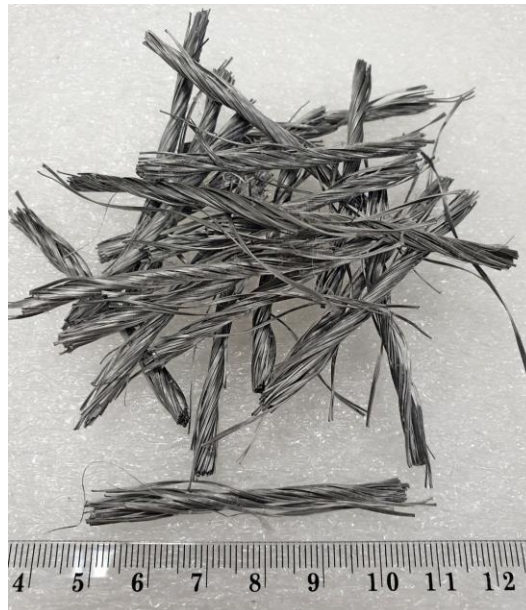
Figure 2. Photograph of twisted-bundle macro-polyolefin fibres

The macro polymer fibres were used as reinforcement. The properties of fibres are given in Table 3. The fibres are made of polyolefin and produced as twisted-bundles of a length of 54 mm (Figure 2).
