# Effect of Thermal Treatment and Erosion Aggressiveness on Resistance of S235JR Steel to Cavitation and Slurry

Alicja K. Krella <sup>1,\*</sup>, Dominika E. Zakrzewska <sup>1</sup>, Marta H. Buszko <sup>1</sup> and Artur Marchewicz <sup>1</sup>

Institute of Fluid Flow Machinery PAS, Fiszerka 14, Gdańsk, Poland; dzakrzewska@imp.gda.pl (D.E.Z.); mbuszko@imp.gda.pl (M.H.B.); artur.marchewicz@imp.gda.pl (A.M.)

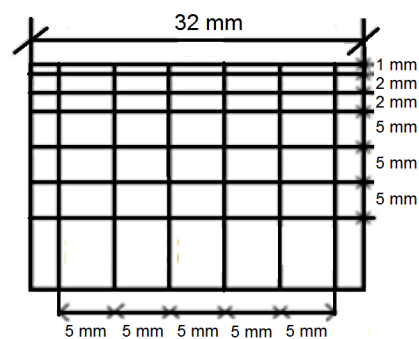
**Figure 5.** The scheme of the network for surface roughness measurements.

The distributions of surface roughness along the network shown in Figure 5 that developed during the entire cavitation erosion tests are shown in Figures 12 and 13, respectively for S235JR-AR and S235JR-TT steel. In order to show the effect of flow conditions on the roughness, the same maximum Ra value was used in the color bar despite the different maximum Ra values. During the slurry test, the entire surface of the specimens was uniformly eroded, so five measurements of the Ra parameter were taken after each exposure. The development of the Ra surface roughness parameter is shown in Figure 14.
