Article

# Effect of Thermal Treatment and Erosion Aggressiveness on Resistance of S235JR Steel to Cavitation and Slurry

Alicja K. Krella <sup>1,\*</sup>, Dominika E. Zakrzewska <sup>1</sup>, Marta H. Buszko <sup>1</sup> and Artur Marchewicz <sup>1</sup>

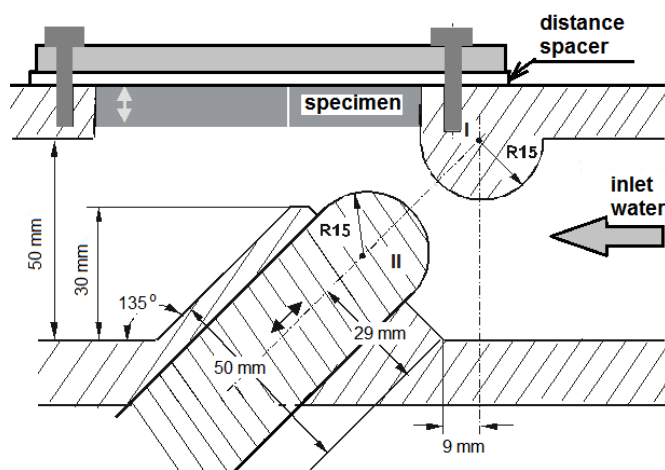
**Figure 1.** Scheme of the cavitation tunnel.

In order to investigate the effect of cavitation intensity on the erosion process, four tests were carried out using a cavitation tunnel equipped with a system of barricades. The scheme of the cavitation tunnel is shown in Figure 1 and it has been described by Krella et al. [18]. As a working fluid tap water with a temperature of  $20 \pm 2$  °C was used. The intensity of cavitation is governed by the fluid flow rate, which is controlled by the inlet and outlet pressures, which in turn are regulated by the inlet and outlet valves. Flow speed was measured using a portable ultrasonic flowmeter Fluxus® model ADM 6725 (FLEXIM, Edgewood, NY, US) with a measurement accuracy of  $\pm 0.5\%$  of the measured value. In the presented investigations, the water flow velocities were 35 m/s, 37.9 m/s, 40.5 m/s, and 43 m/s in the slot between the barricades. The total duration of the test was 600 min.
