Agnieszka TUBIS¹, Mateusz RYDLEWSKI¹, Marcin BUDZYŃSKI²
¹Wrocław University of Science and Technology (Politechnika Wroclawska)
²Gdańsk University of Technology (Politechnika Gdańska)

SAFETY AND FUNCTIONALITY ASSESSMENT OF TRAM LOOPS IN WROCLAW

Abstract: *The article presents the implementation of the ISFTL method proposed by the authors consisting in an indicator assessment of the safety and functionality of tram loops. Five tram loops located in Wrocław were analyzed. Each of these loops has different characteristics. The components of each assessment are described in detail and further directions for improving the proposed assessment are indicated.*

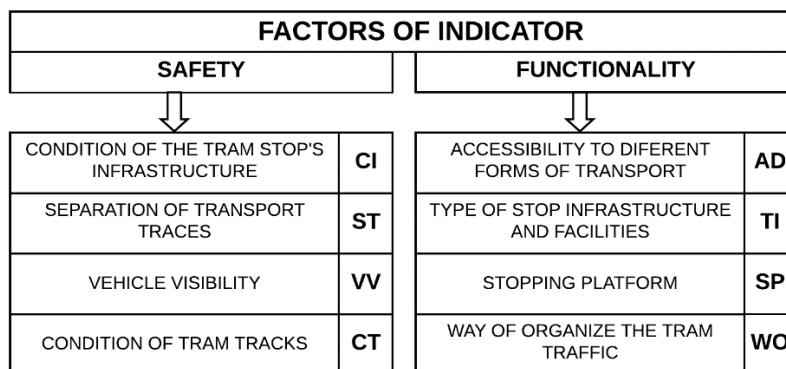
Fig. 1. Components of assessment factors for the ISFTL method, based on [14]

The method proposed in [14] involves the determination of two independent indicators relating to the assessment of safety and functionality of tram loops. The idea of the method is to evaluate each of the loops in the area of 4 different criteria, which for both indicators are presented in fig. 1.

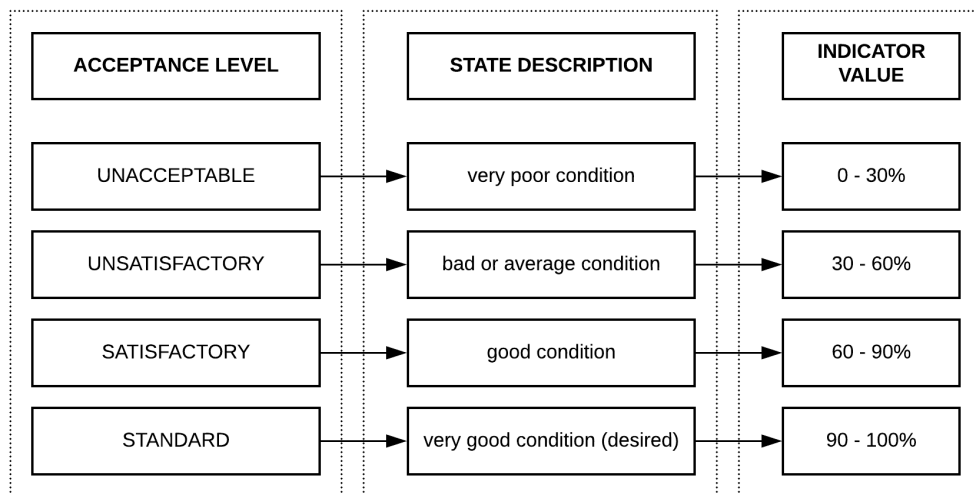
Fig. 3. Acceptance levels for the percentage values of safety and functionality indicators of tram loops

For the determined percentage values of the ISTL and IFTL indicators, the levels of acceptance of meeting a given evaluation criterion were determined depending on the percentage value of the indicators of safety or functionality of the tram loop. In fig. 3, a diagram with specific acceptance levels is presented.

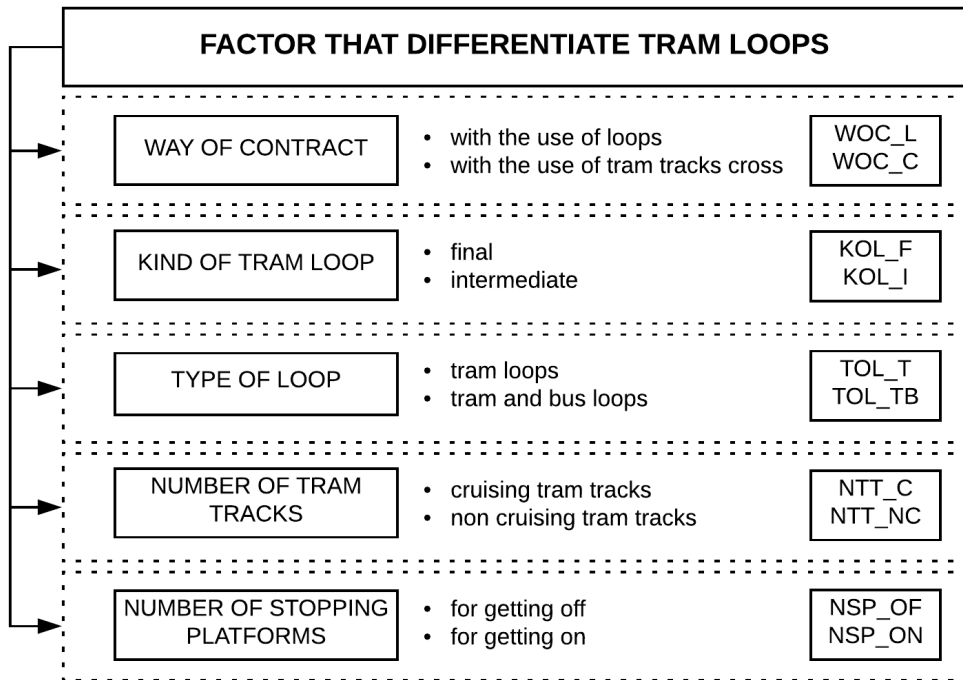
Fig. 4. Factor that differentiates tram loops

The field study was conducted in December 2019. In tab 1. are presenting the most important parameters of the analyzed tram loops taken into account during the analysis and detailed information describing the factors differentiating the tram loops (fig. 4). As an additional parameter - NL - the number of lines served on a given loop as of 31.12.2019 was also given.

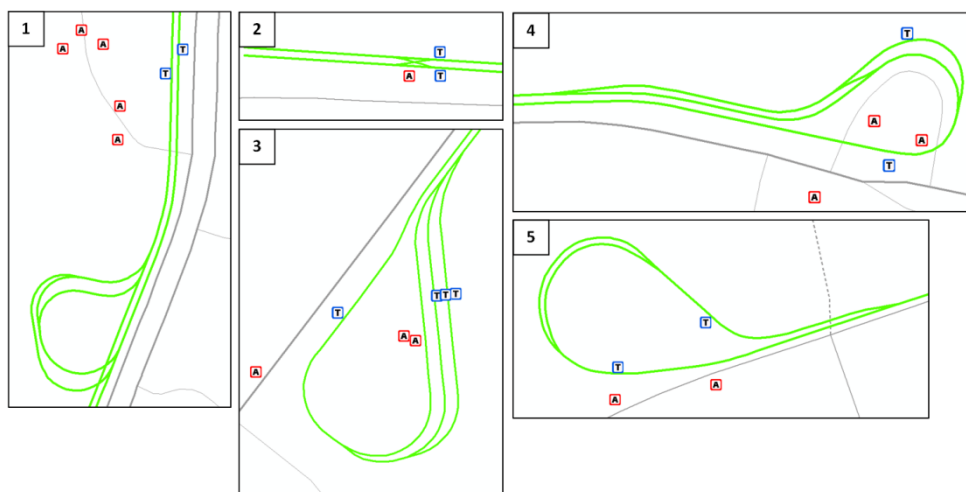
Fig. 5. Diagrams of rated tram loops

Figure 5 presents diagrams of the analyzed tram loops, respectively: 1 – Krzyki, 2 – Gaj, 3 – Oporów, 4 – Sępolno, 5 – Klecina. In the diagrams, the lines correspond to the axes of tram tracks and the markings in the squares with the letters A and T indicate the locations of the stops.

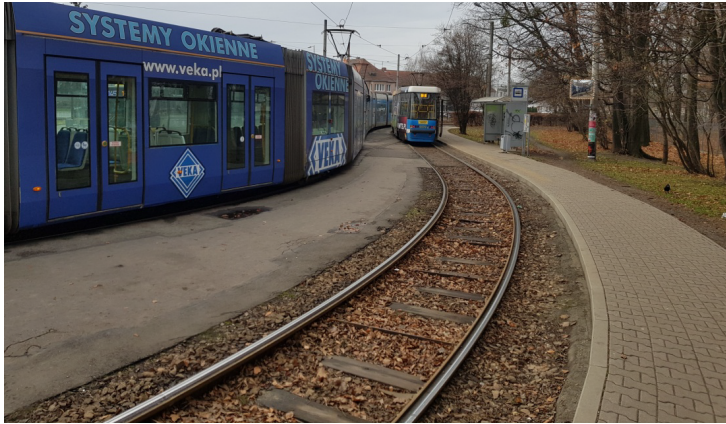
Fig. 7. Tram platform stops located in Sępolno tram loop in Wrocław (Poland)

The Sępolno loop (fig. 7) has the lowest values of ISTL and IFTL indicators. Both in the case of the safety and functionality assessment, the conducted tests showed a very bad condition of both parameters, classifying the loops at the unacceptable level in both areas of the assessment. During the audit carried out at the loop it was observed that the condition of the tram track is in poor condition. The surface of pedestrian and bicycle routes is in very poor technical condition, the pavements are uneven and have cavities. In the loop area, there are no pedestrian crossings and pavements separated from the tram track. There is also a lack of bicycle traffic separation. The Sępolno loop meets all requirements only in terms of accessibility to different forms of transport and visibility of tram trains in the area of the loop. In the case of functional indicator parameters, there is a lack of adaptation of bus platforms and infrastructure. There are no shelters, benches and dynamic passenger information boards on the loop. Platforms are not adapted for the disabled. The platform for passengers who getting on is too short. And the number of platforms for passenger who getting on is not adapted to the number of tram lines which serving loops.

The results indicate that the Sępólno loop is an example where it is necessary to carry out repair and modernization works aimed at improving the safety of users and the functionality of the facility. Analyzes indicate a significant risk of adverse events, including those threatening the health and life of users. One loop that has obtained the maximum indicator value (only in terms of security) is the Klecina loop.

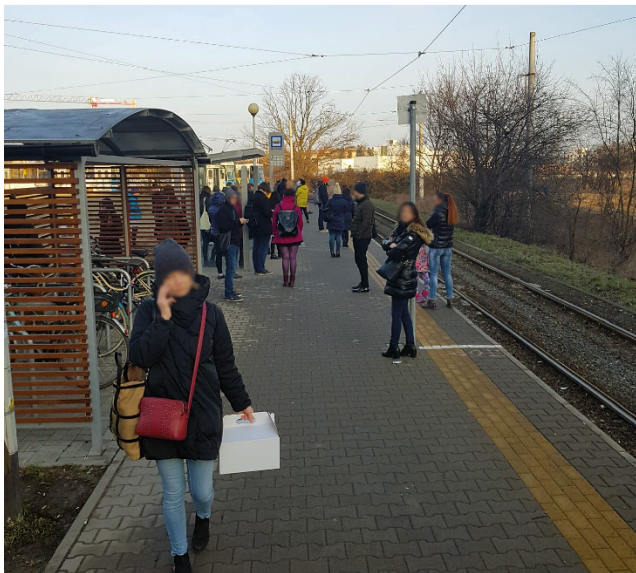
Fig. 8. Tram platform stop for getting on located in Klecina tram loop in Wrocław (Poland)

The Klecina loop (fig. 8.) is an example of a tram loop where the direction change takes place differently than on typical loops. As a standard, tramway traffic on the loop runs counter-clockwise and stops are located on the outside of the tram track. In the case of the Klecina loop, the tram traffic is clockwise and the stops are located inside the loop. The awarded point values depend on the selected parameters for: accessibility to different forms of transport (AD) - no P&R parking, the distance from the city bike station is about 80 m, bus stops located at the street adjacent to the loop at a short distance from the stop; type of stop infrastructure and facilities (TI) - no dynamic passenger information boards, service outlets and the ticket machine is located outside the tram loop.

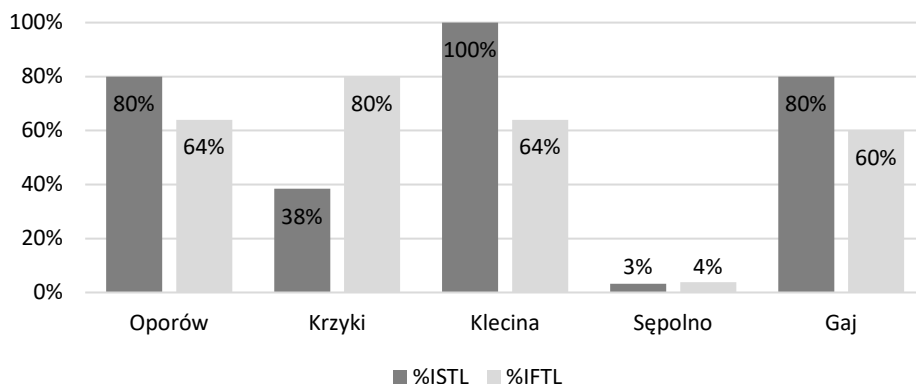
Fig. 9. Percentage values of ISTL and IFTL indicators for selected tram loops in Wrocław (Poland)

Based on the results obtained in accordance with formula (3), shows the ranking of individual loops. Figure 9 presents a graph with the percentages of safety and functionality indicator of the analyzed tram loops.
