SAFETY AND FUNCTIONALITY ASSESSMENT OF TRAM LOOPS IN WROCLAW

Abstract: *The article presents the implementation of the ISFTL method proposed by the authors consisting in an indicator assessment of the safety and functionality of tram loops. Five tram loops located in Wrocław were analyzed. Each of these loops has different characteristics. The components of each assessment are described in detail and further directions for improving the proposed assessment are indicated.*

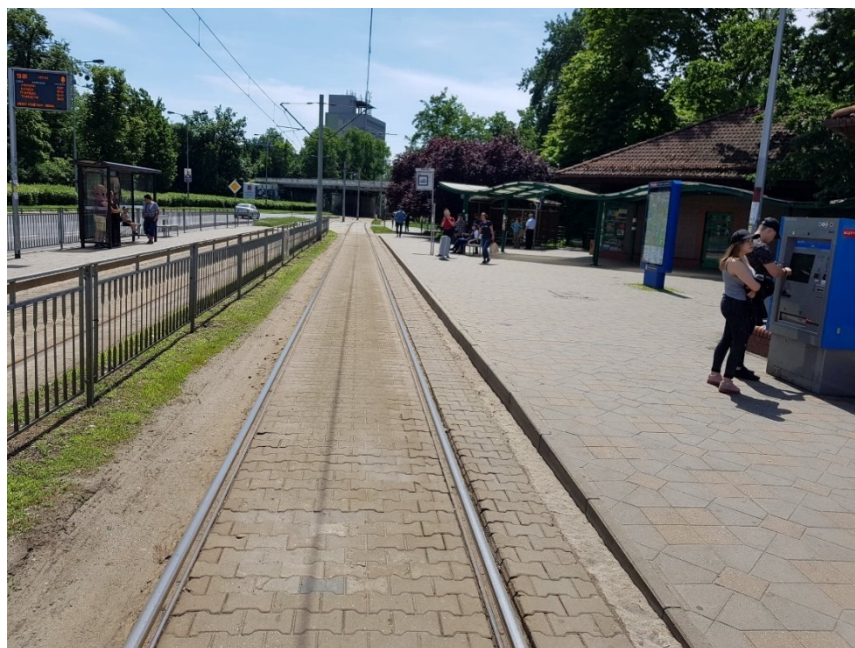
The measurements carried out allowed for the conclusion that the Krzyki loop (fig. 6) has a low level of safety compliance. The first aspect is the condition of the pavement surface, which is not adequate. There are individual defects and unevenness. In the case of the separation of transport traces (ST), no pedestrian crossing through the tram track was identified and there was a clear problem in separating pedestrian and cyclist streams. The entire length of the stop leads as a road to the bicycle parking lot which can lead to dangerous situations in the cyclist-pedestrian relationship. The technical condition of the track is assessed as satisfactory. In terms of the functionality of the loop, the evaluation result is satisfactory.

Fig. 6. Tram platform stops located in Krzyki tram loop in Wrocław (Poland)
