Agnieszka TUBIS¹, Mateusz RYDLEWSKI¹, Marcin BUDZYŃSKI²
¹Wrocław University of Science and Technology (Politechnika Wroclawska)
²Gdańsk University of Technology (Politechnika Gdańska)

SAFETY AND FUNCTIONALITY ASSESSMENT OF TRAM LOOPS IN WROCLAW

Abstract: *The article presents the implementation of the ISFTL method proposed by the authors consisting in an indicator assessment of the safety and functionality of tram loops. Five tram loops located in Wrocław were analyzed. Each of these loops has different characteristics. The components of each assessment are described in detail and further directions for improving the proposed assessment are indicated.*

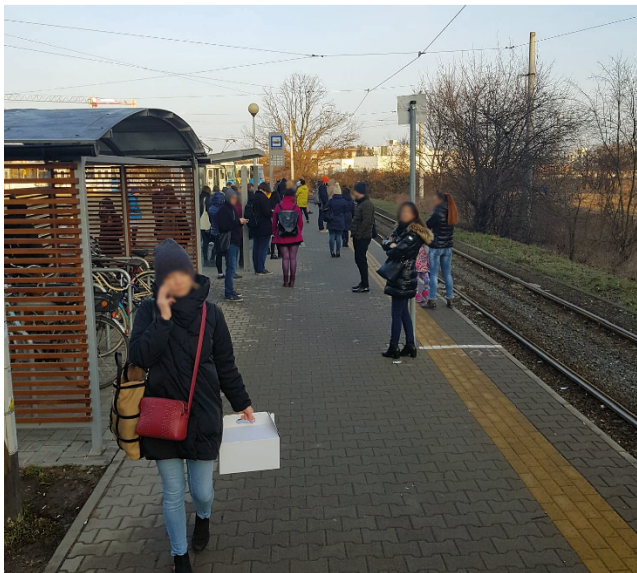
The Klecina loop (fig. 8.) is an example of a tram loop where the direction change takes place differently than on typical loops. As a standard, tramway traffic on the loop runs counter-clockwise and stops are located on the outside of the tram track. In the case of the Klecina loop, the tram traffic is clockwise and the stops are located inside the loop. The awarded point values depend on the selected parameters for: accessibility to different forms of transport (AD) - no P&R parking, the distance from the city bike station is about 80 m, bus stops located at the street adjacent to the loop at a short distance from the stop; type of stop infrastructure and facilities (TI) - no dynamic passenger information boards, service outlets and the ticket machine is located outside the tram loop.

Fig. 8. Tram platform stop for getting on located in Klecina tram loop in Wrocław (Poland)
