Revitalization of Residential Buildings Dating Back to the Late 19th and Early 20th Century on the Example of “Willa Halina” in Sopot (Poland)

Abstract: Residential buildings dating back to the late 19th and early 20th century constitute an important element of the urban composition of many European cities, often determining their overall spatial expression. These buildings often require revitalization and sometimes also reconstruction or extension. Such activities make it possible to restore historical buildings to their former glory, but also to create new architecture, inscribed in the context of the place, yet bearing witness to modern times. Revitalization of historically and architecturally valuable but technically degraded residential buildings is one of the important elements of maintaining and sometimes rebuilding the image of modern cities and their sustainable development. However, revitalization activities require solving many problems of conservational nature, especially issues related to preserving the authenticity of the existing tissue, ways of reconstructing lost elements, and connecting historical architecture with contemporary architecture. Historic residential

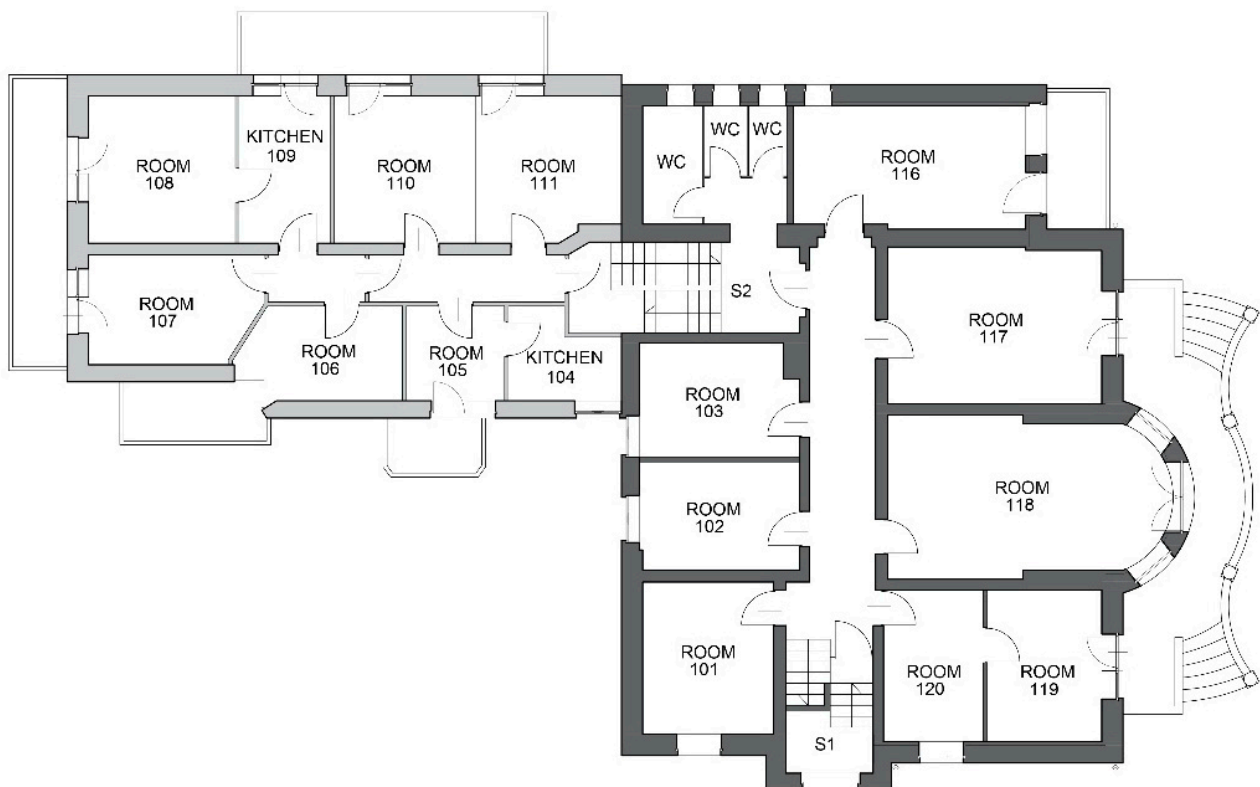
In this condition, the villa survived until World War II. After the war, the villa changed owners several times and served as a multi-family residential building; however, its external appearance has not suffered much damage, apart from minor losses of architectural detail. In the 1950s, the building's interior was functionally divided into several small apartments and an annex of rather low architectural value was added to the villa's western side, creating dissonance with the finished and refined architectural form of the main building (Figure 8).

Figure 8. Willa Halina ground floor plan; building inventory 1999. Source: A. Taraszkiewicz.

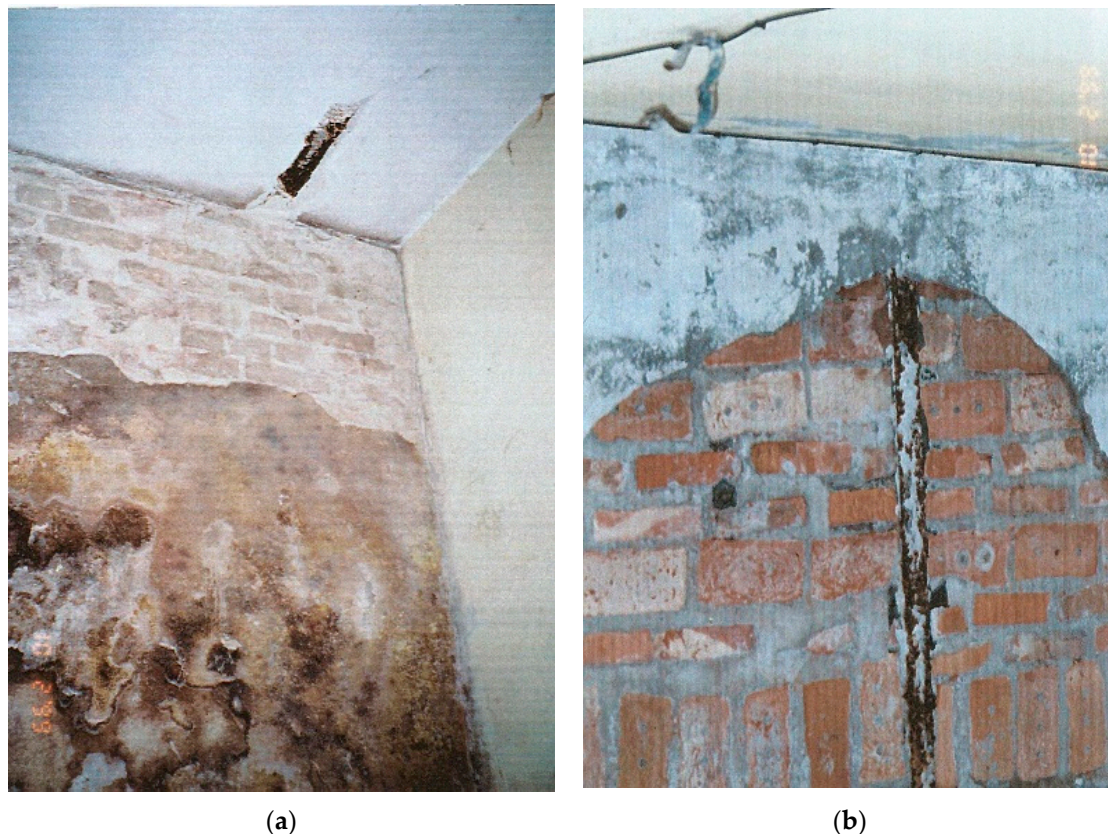
The multitude of users and the lack of proper care for the building caused its technical condition to deteriorate from year to year. There was severe degradation of the wooden ceiling beams and brick walls. There was fungus and severe dampness (Figure 9). Particularly serious technical degradation concerned the annex, whose technical condition could be described as woeful. As a result, by the end of the 20th century, the building was abandoned by residents and awaited revitalization.

Figure 9. Willa Halina, view of degraded structural elements. (a) Mold on the outside wall; (b) moisture and corrosion of internal wall elements. Source: FORT Taraszkiewicz Architekci.

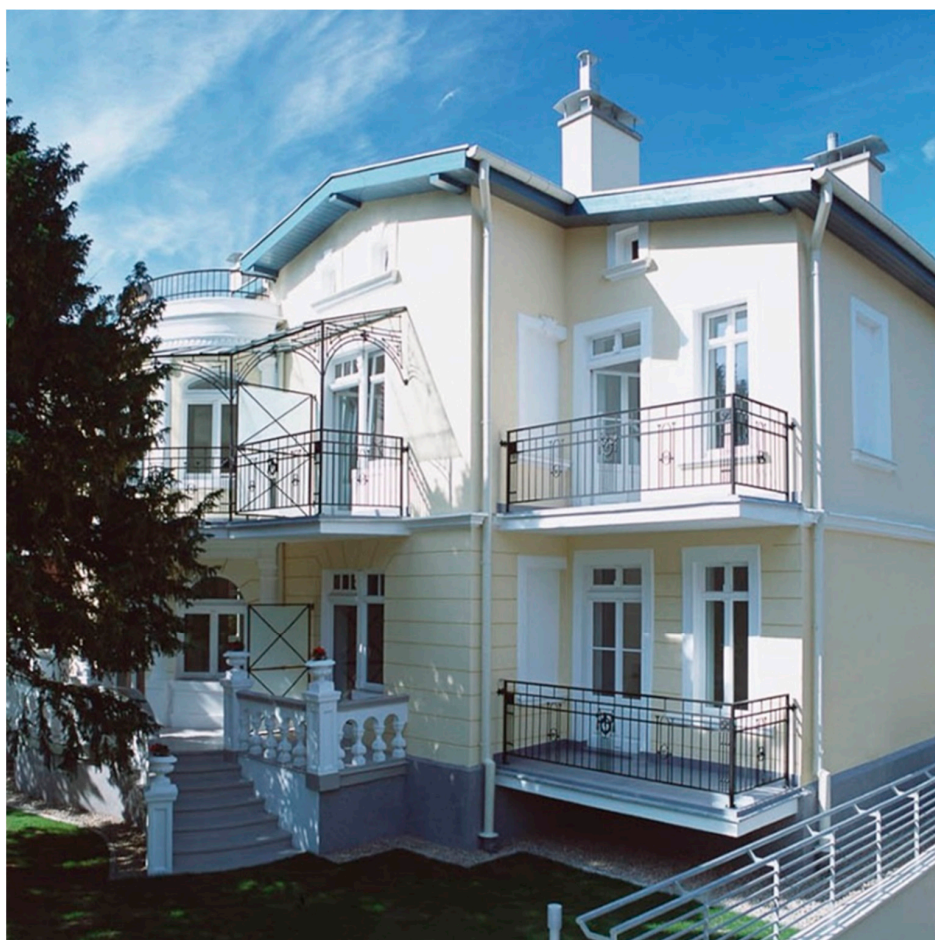
Utmost care was taken in the revitalization process of the external elevations of the historic part of the villa. As mentioned earlier, the decision was made to renovate the main body of the building, completely preserving its historical external shape and carefully restoring the colors and damaged architectural details. The stratigraphic research showed that the villa had light beige plaster with architectural elements such as cornices, half-columns, and window bands painted white. In the course of revitalization, the original colors were recreated, but where a reconstructed element appeared, the colors were a tone lighter so that the original element could be distinguished from the reconstructed one. Elements of the wooden roof such as rafters and wind braces, as completely new elements, were designed in their historical shape but in grey-blue coloring that differs significantly from the original and from the coloring of similar elements found in other historical buildings in Sopot. The preserved steel elements, such as the balustrades of the balcony or the structure of the glass canopy, were protected against corrosion and painted in graphite colour according to the stratigraphic research. The necessary additions to the steel elements were painted a tone lighter than the original elements to distinguish them (Figure 13).

Figure 13. Historical part of Willa Halina. Front elevation after revitalization. Source: FORT Taraszkiewicz Architekci.

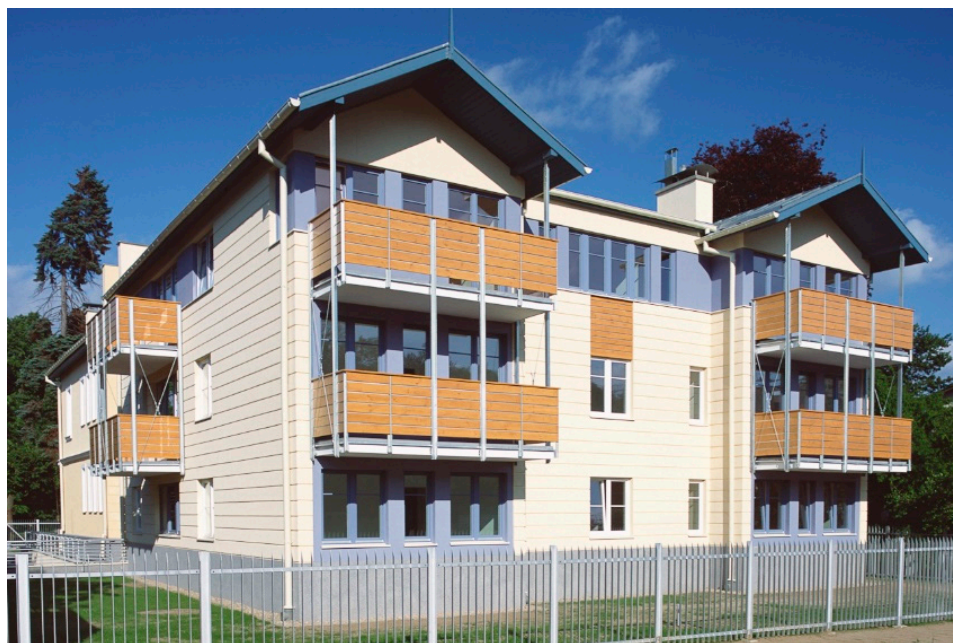
The added part was designed in a completely different, modern style. Although the scale and symmetry of the gable façade match the historical part, and although elements from the region's culture appear in it, its spatial solutions are thoroughly contemporary, clearly pointing to the time when the extended part was built. The modern character of this architecture is evidenced by the modern materials and technologies used as well as "fresh" architectural details in the form of elements made of galvanized rolled steel, simple in their form wooden balustrades, or stainless-steel cords linking balcony elements. The entire composition is complemented by strip windows and contemporary colors (Figure 14). Noteworthy here are also: the compact (similar in plan to a square) body of the added part ensuring an optimum energy balance, high-class insulation materials, modern construction technologies neutral for the environment and human health, and emission-free installation systems, including electric heating.

Figure 14. Extended part of Willa Halina. Source: FORT Taraszkiewicz Architekci.

In the case of additions and extensions to historic buildings, it is consistent with the Venice Charter to create new building elements whose atmosphere corresponds to the *genius loci*, but whose architecture is thoroughly contemporary and whose historical references are in no way direct transfers or borrowings from past eras. Such new architectural creations are being created in many European historic cities. The contemporary expression of this architecture is determined by such elements as the articulation of facades, which is characteristic of our times and often draws on the achievements of the international style, contemporary architectural detail, and the modern materials and construction technologies used, which are visible in the facades [30], (Figure 14).

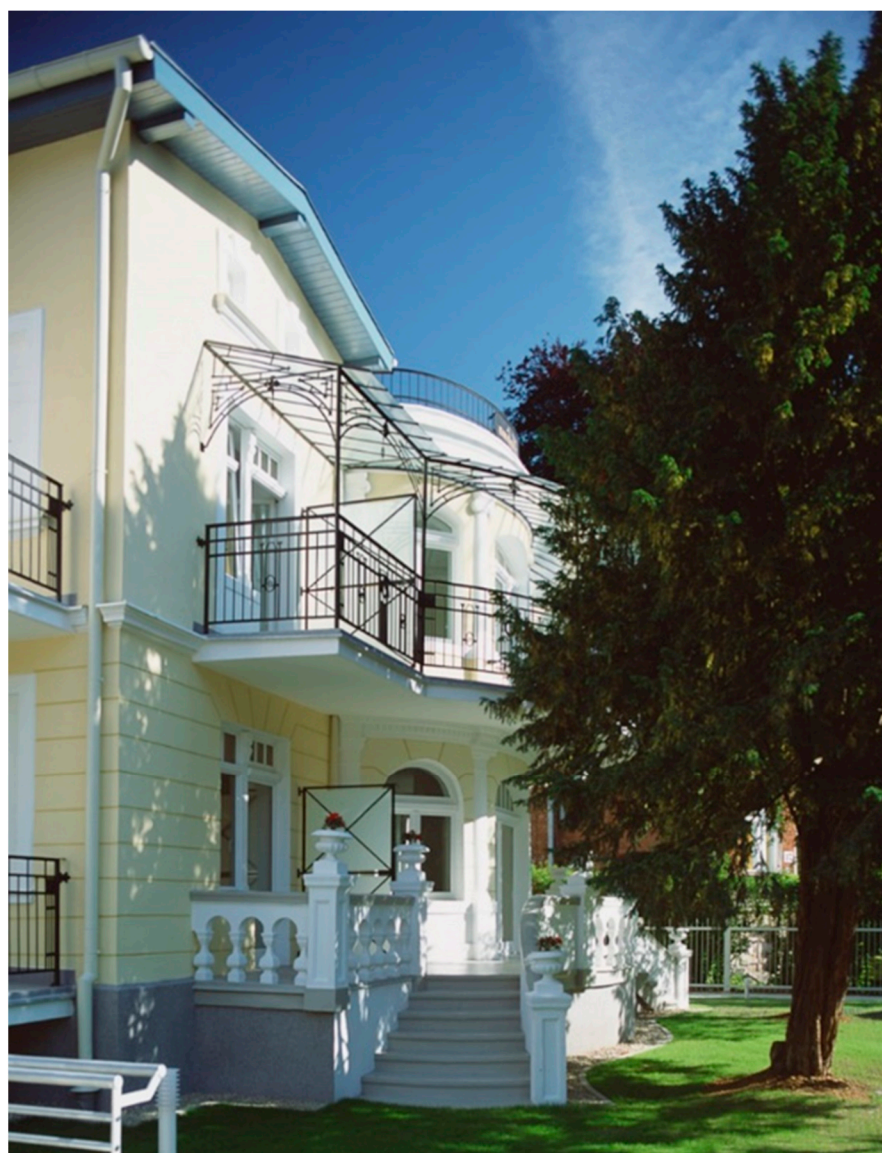
An element complementing the revitalization design of Willa Halina was the arrangement of its surroundings. There is a pedestrian access to the main entrance of the building paved with stone slabs; a modern-form exit ramp from the underground garage has been designed and the rest of the area has been planned as a vast lawn, serving as a kind of rain garden for rainwater retention. An important part of the revitalization of the villa's surroundings was saving the two magnificent, heavily damaged and neglected yew trees flanking the main façade of the building which had been planted here in 1896 by the first owner according to a design by Walter Schulz. Although these yews have now reached a size that makes it difficult to see the front elevation of the villa, they are an important element of its urban composition and at the same time a living testimony to the urban and architectural ideas of the late nineteenth century, as well as an embodiment of the contemporary ideas of sustainable development, in which nature conservation is one of the basic elements [52,53] (Figure 16).

Figure 16. The historical part of Willa Halina. Front elevation after revitalization. Source: FORT Taraszkiewicz Architekci.
