Research paper

On analysis of double-impact test of 1500-kg vehicle into w-beam guardrail system

Keywords: crash test, TB32, w-beam guardrail, numerical simulations, double-impact, crashworthiness

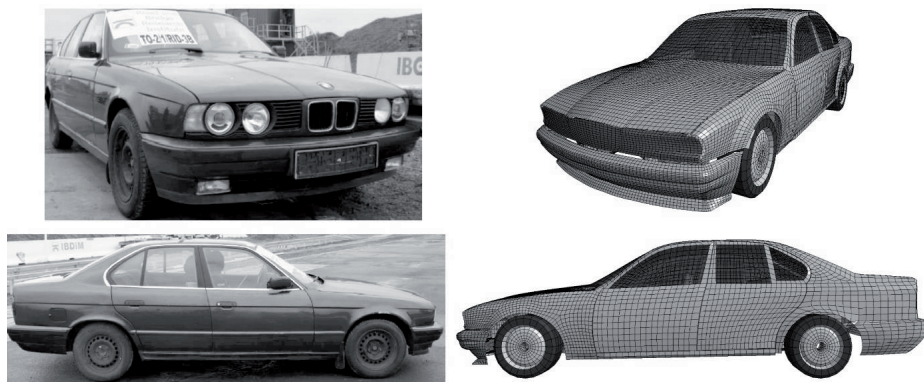
Fig. 4. Comparison between the full-scale BMW vehicle and corresponding numerical model

In the numerical simulations as well as in the full-scale crash test, the BMW e34 520 model was used. The numerical model consists of 29 172 nodes and 28 011 finite elements. The most important vehicle's parameters are summarized in table 1. The general comparison between the actual vehicle and corresponding numerical model is depicted in Fig. 4.
