Research paper

On analysis of double-impact test of 1500-kg vehicle into w-beam guardrail system

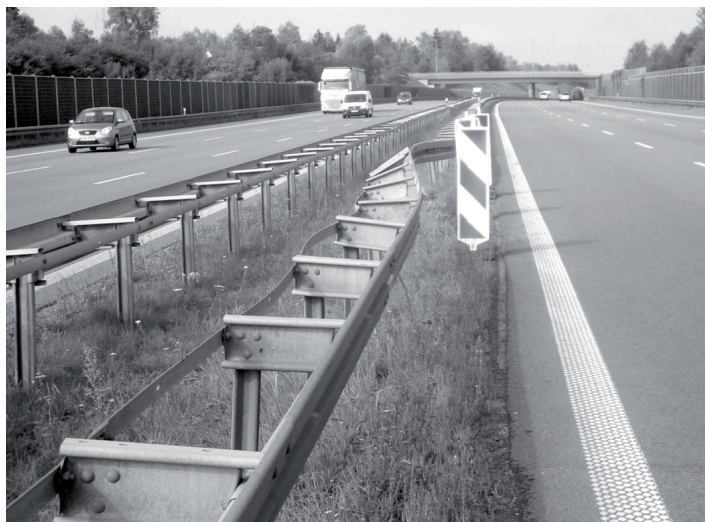
Fig. 1. View of damaged road barrier as a result of vehicle impact, impact angle was approx. 8 degrees
(source: GDDKiA)

Considering Case no. 0, numerical simulation was conducted and the numerical model was validated against the full-scale crash test. The parameters of the test correspond to the TB32 crash test where the angle of impact was reduced from 20 degrees to 7 degrees (1500 kg, 110 km/h, 7°). In the remainder of the paper this test will be also referred to as the “modified TB32 test”. The change in the impact angle was motivated by the need to obtain small damage to the barrier. Impacts at such an angle are frequently found on roads, see Fig. 1.
