## Research paper

# On analysis of double-impact test of 1500-kg vehicle into w-beam guardrail system

**Keywords:** crash test, TB32, w-beam guardrail, numerical simulations, double-impact, crashworthiness

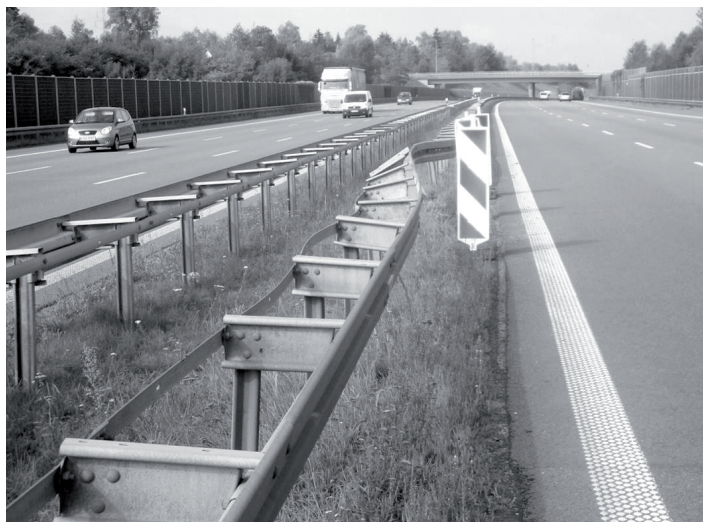
Fig. 1. View of damaged road barrier as a result of vehicle impact, impact angle was approx. 8 degrees  
(source: GDDKiA)

Considering Case no. 0, numerical simulation was conducted and the numerical model was validated against the full-scale crash test. The parameters of the test correspond to the TB32 crash test where the angle of impact was reduced from 20 degrees to 7 degrees (1500 kg, 110 km/h, 7°). In the remainder of the paper this test will be also referred to as the “modified TB32 test”. The change in the impact angle was motivated by the need to obtain small damage to the barrier. Impacts at such an angle are frequently found on roads, see Fig. 1.

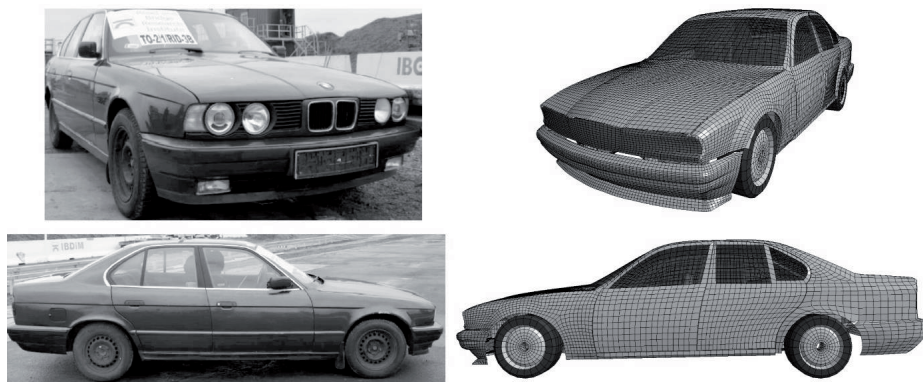
Fig. 4. Comparison between the full-scale BMW vehicle and corresponding numerical model

In the numerical simulations as well as in the full-scale crash test, the BMW e34 520 model was used. The numerical model consists of 29 172 nodes and 28 011 finite elements. The most important vehicle's parameters are summarized in table 1. The general comparison between the actual vehicle and corresponding numerical model is depicted in Fig. 4.
