Article

Analysis of the Possibility of Using New Types of Protective Coatings and Abrasion-Resistant Linings under the Operating Conditions of the Spiral Classifier at KGHM Polska Miedź S.A. Ore Concentration Plant

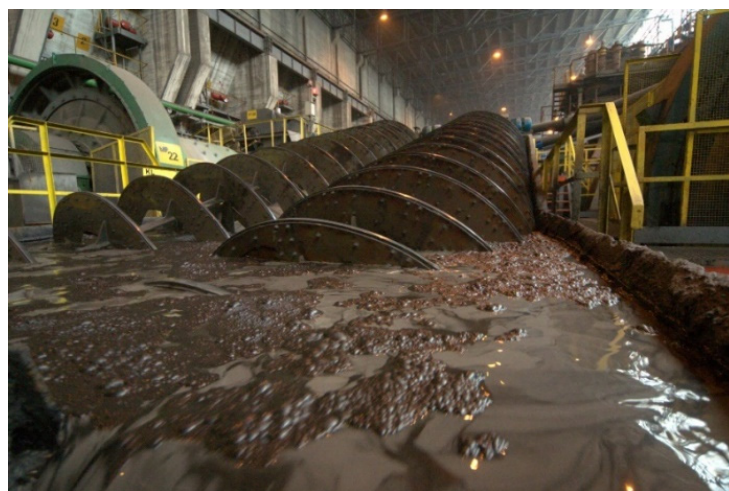
Figure 1. View of a working two-winding classifier.

Corrosion-erosion phenomena may occur on the working surfaces of the spiral where there is continuous contact (friction) with the ground feed (Figure 1). The research is therefore focused on protective materials in the form of paint coatings and wear-resistant linings.

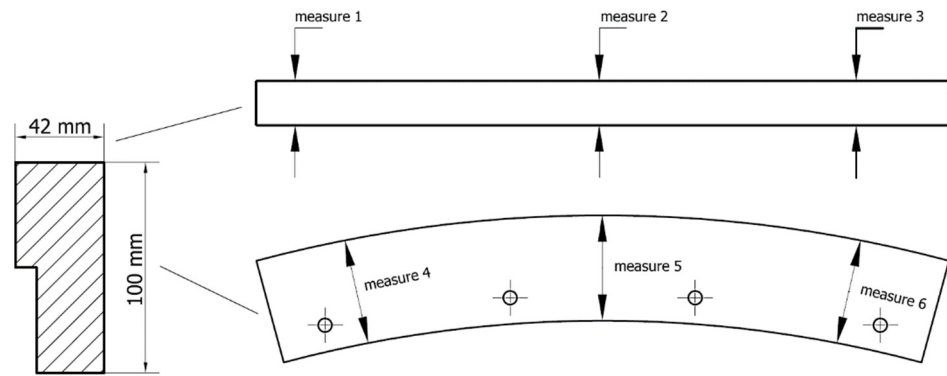
Figure 18. Measurement points for the wear of the classifier lining. Side section (measurements 1, 2 and 3). Frontal part (measurements 4, 5 and 6).

Measurements of the degrees of wear of the spiral-mounted linings were taken according to the points indicated in the sketch below (Figure 18). A view of the linings after exposure is illustrated in Figure 19.
