# Analysis of the Possibility of Using New Types of Protective Coatings and Abrasion-Resistant Linings under the Operating Conditions of the Spiral Classifier at KGHM Polska Miedź S.A. Ore Concentration Plant

**Keywords:** corrosion-erosion; spiral classifier; paint coatings; wear-resistant linings; rotational wear tester; wear resistance tests; electrochemical impedance spectroscopy (EIS)

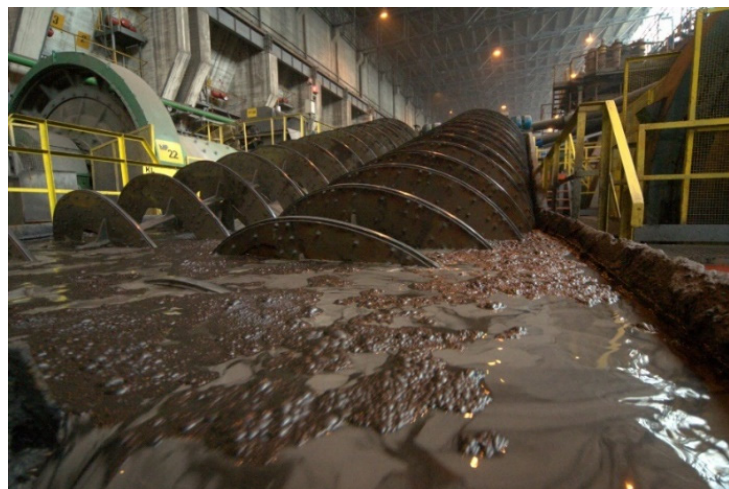
**Figure 1.** View of a working two-winding classifier.

Corrosion-erosion phenomena may occur on the working surfaces of the spiral where there is continuous contact (friction) with the ground feed (Figure 1). The research is therefore focused on protective materials in the form of paint coatings and wear-resistant linings.

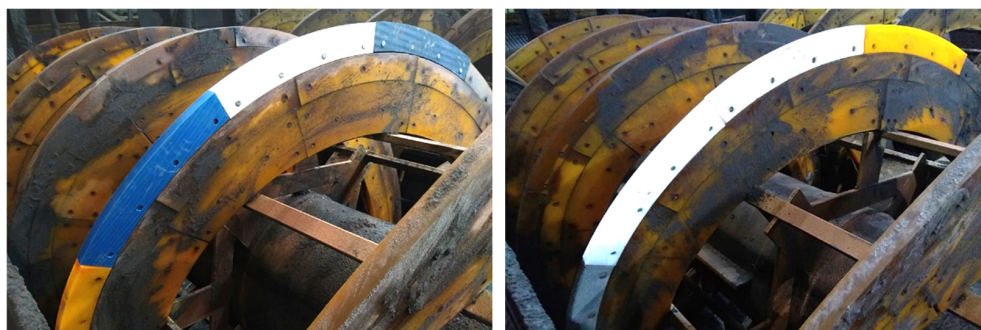
Figure 6. View of the installed test linings—before starting the test.

The base (comparison) lining was the current polyurethane lining. The tested linings were exposed under normal operating conditions of the spiral classifier (Figure 6).

The duration of the test was set at 10 months. During this time, the classifier with technology number K-211 worked 6387 h, while the average working time of one classifier working in the Polkowice area in 2020 was nearly 7500 h. During this period, an estimated 90,5850 Mg of dredged material in the form of an aqueous slurry with a density from 1500 to 1650 g/dm<sup>3</sup> was directed to the classifier, of which approximately 500,000 Mg was transported through the classifier linings, including test linings, towards the spillway.
