Article

Study on Microstructure and Mechanical Properties of Laser Welded Dissimilar Joint of P91 Steel and INCOLOY 800HT Nickel Alloy

Abstract: This investigation attempts to explore the weld characteristics of a laser welded dissimilar joint of ferritic/martensitic 9Cr-1Mo-V-Nb (P91) steel and Incoloy 800HT austenitic nickel alloy. This dissimilar joint is essential in power generating nuclear and thermal plants operating at 600–650 °C. In such critical operating conditions, it is essential for a dissimilar joint to preserve its characteristics and be free from any kind of defect. The difference between the physical properties of P91 and Incoloy 800HT makes their weldability challenging. Thus, the need for detailed characterization of this dissimilar weld arises. The present work intends to explore the usage of an unconventional welding process (i.e., laser beam welding) and its effect on the joint's characteristics. The single-pass laser welding technique was employed to obtain maximum penetration through the keyhole mode. The welded joint morphology and mechanical properties were studied in as-welded (AW) and post-weld heat treatment (PWHT) conditions. The macro-optical exami

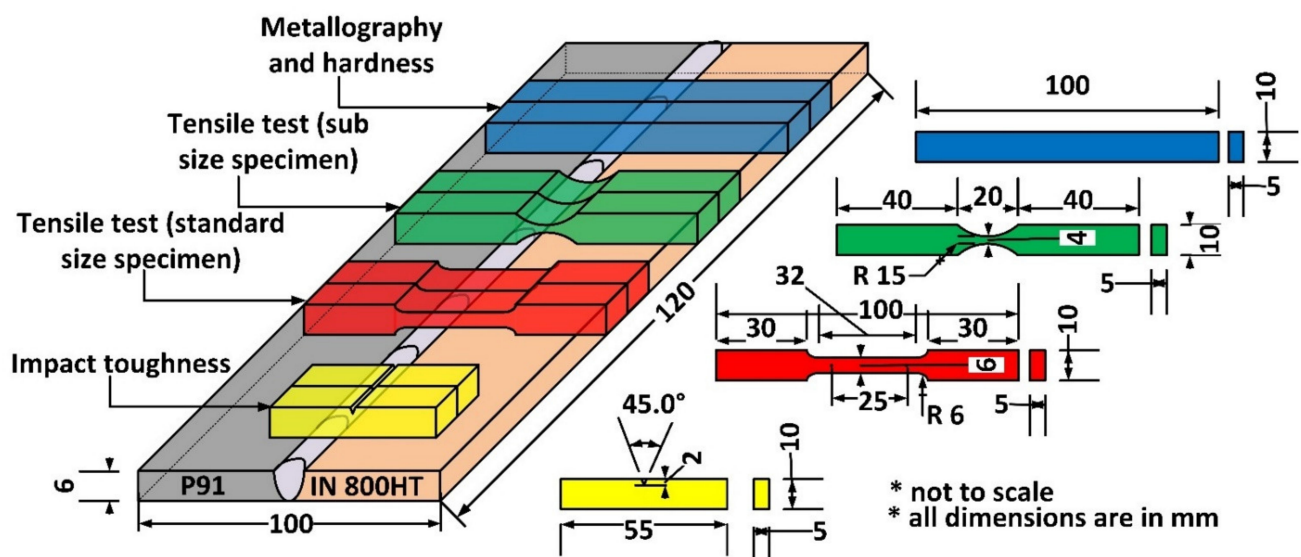
Figure 1. Schematic representing the extracted specimen's dimensions.

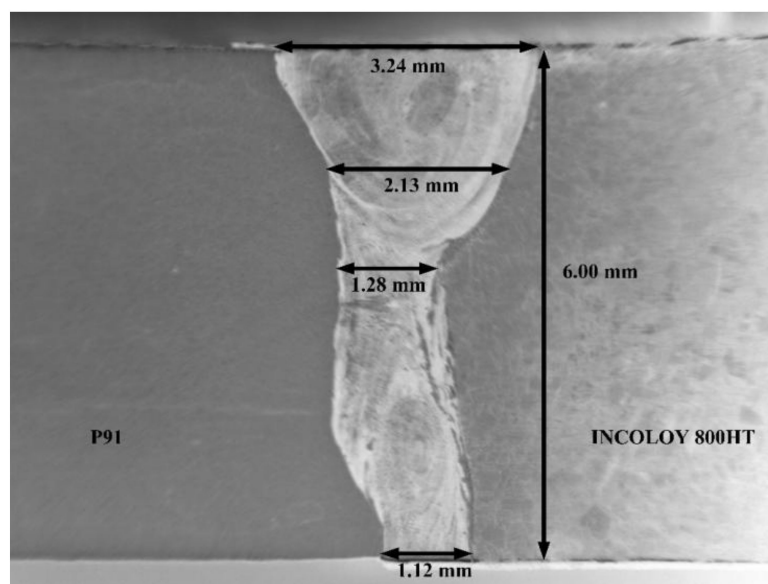
**Figure 3.** Macrograph of the laser weld bead.

The macrograph of the weld cross-section representing the weld bead geometry in Figure 3 hints at the keyhole mode of penetration caused by vapor pressure under high heat energy input in laser welding. Complete penetration with a narrow weld bead was obtained, as per the macrograph. Due to heat transfer and conduction, a grain size gradient was formed along the weldments. The weldment obtained and its different zones can be further characterized in detail.

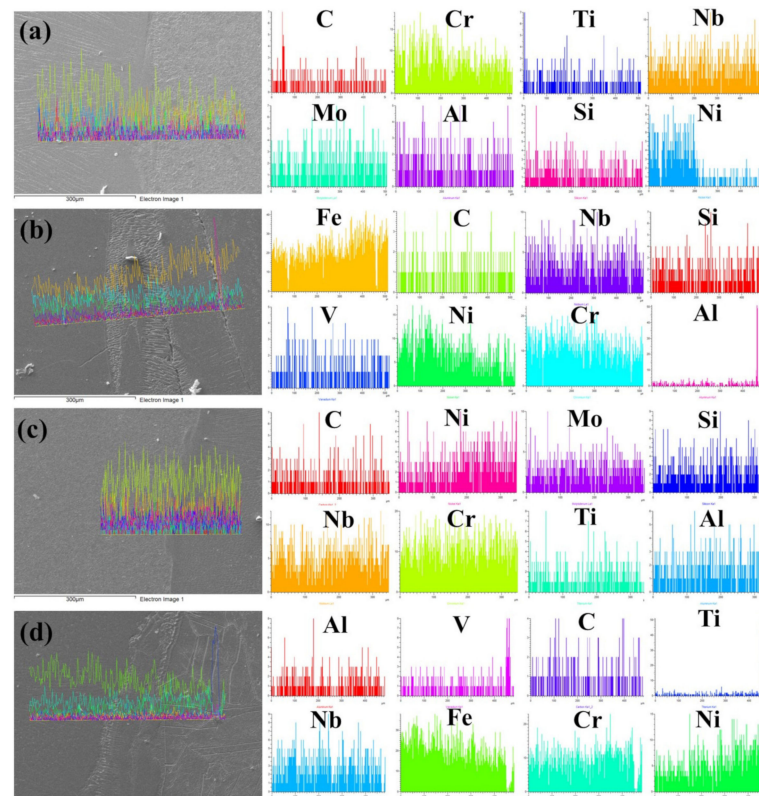
Figure 7. Line map EDS analyses along (a) AW P91 weld fusion boundary; (b) AW Incoloy 800HT weld fusion boundary; (c) PWHT P91 weld fusion boundary; and (d) PWHT Incoloy 800HT weld fusion boundary.

As weld fusion boundaries are crucial sites for solute segregation to occur, further analysis of elemental distribution across them was done through EDS linear spectra. Figure 7a has shown a decrease in nickel and chromium composition from weld to base metal P91 in the AW condition, which corresponds to the P91 composition. A slightly increased Mo concentration in the unmixed zone near the fusion boundary was observed. A sudden carbon peak suggests the presence of carbide particle precipitate in the weld zone. If this is noticed to be corresponding to a carbon peak, there is Si peak emerging which could be indicative of M_6C formation. In the Incoloy 800HT interface, as shown in Figure 7b,

expected peaks were obtained for Ni, Cr, and Fe, as per the metal composition. A sudden increased appearance of Al could confirm the presence of the γ' phase. Interestingly, the PWHT weld fusion boundary of P91, shown in Figure 7c, does not show any significant change in compositional behavior, but a constant distribution of chromium across the weld fusion boundary was witnessed. In the PWHT weld fusion boundary of Incoloy 800HT (Figure 7d), all elements confirm the discussed behavior, and no particular change corresponding to the PWHT was observed. However, in Incoloy 800HT HAZ, a rise in V and Ti can be seen at the spotted precipitate, but no change or peak in carbon concentration was present corresponding to a Ti rise. This confirms the presence of the TiN particles.

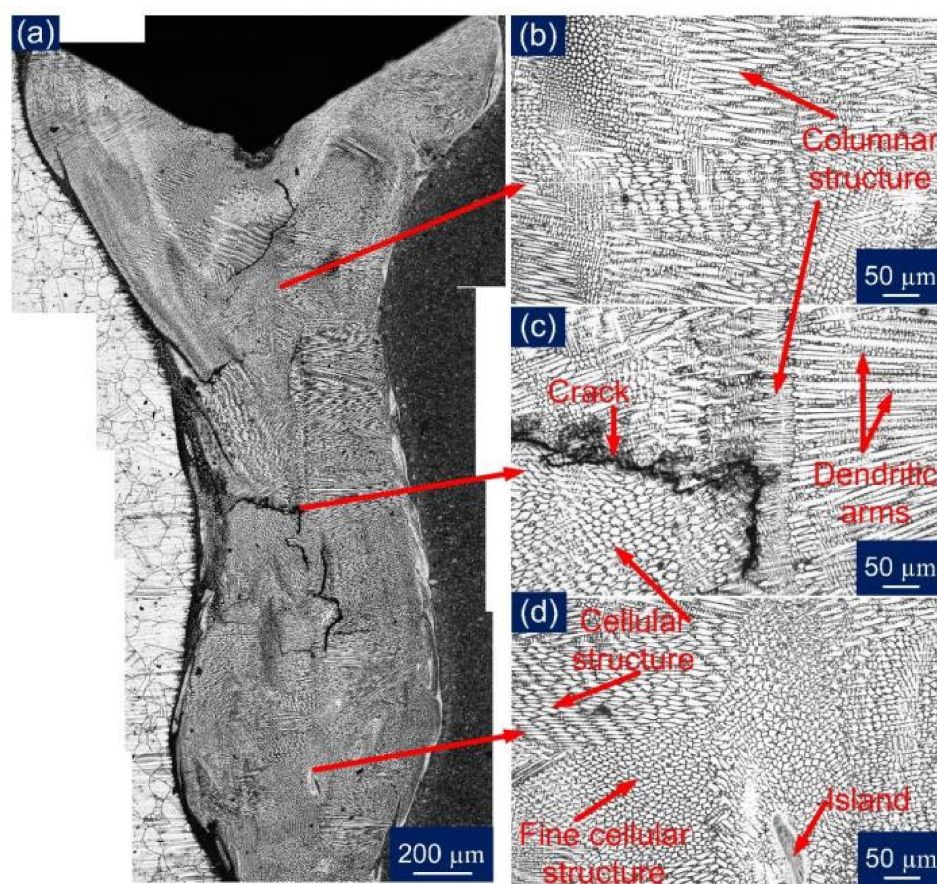
Figure 8. Optical images for: (a) WFZ in AW condition; (b) top WFZ; (c) WFZ mixed zone; (d) bottom WFZ.

The optical images were captured for the entire WFZ for detailed analysis, as shown in Figure 8. The different austenitic structures obtained in the austenitic matrix of the WFZ can be categorized on the basis of the solidification mode. The solidified microstructure in the WFZ is controlled by the growth rate (R), temperature gradient (G), degree of the constitutional supercooling, and alloy composition. The ratio G/R determines the solidification mode, and G^*R influences the size of the structure. The growth occurs from unmelted solid grains of the base metal; hence the G/R ratio is higher at the fusion boundary. The degree of constitutional supercooling affects the temperature gradient, transforming the solidification mode to form cellular, columnar, and equiaxed dendrites. The solidification tends to proceed from the interface to the WFZ. Similarly, different dendritic structures were obtained in the WFZ. It can be perceived, from Figure 8a, that in the formation of the different structures throughout the WFZ, the columnar growth predominated near the base metal interface, and the solidification mode then changed to the cellular and fine cellular structure in the WFZ. Figure 8b depicts a mixed zone in the WFZ where different dendritic morphologies exist. The dendritic arms and inter-dendritic cores

can also be observed where segregation of alloying elements occurs. Figure 8c illustrates the solidification cracking phenomenon observed along the solidified grain boundary (SGB). The dominant presence of different cellular structures and an unmixed zone ‘island’ (Figure 8d) were also spotted near the bottom of the WFZ. The different cells or dendrites were separated by a boundary that has a different composition from the bulk weld fusion zone, due to solute redistribution known as the solidification subgrain boundary (SSGB). The intersection boundary of such a similar group of subgrains or cells can be described as a solidification grain boundary. At the same time, a high-angle misorientation SGB whose crystallographic component migrates away from its compositional component can be described as a migrated grain boundary (MGB).

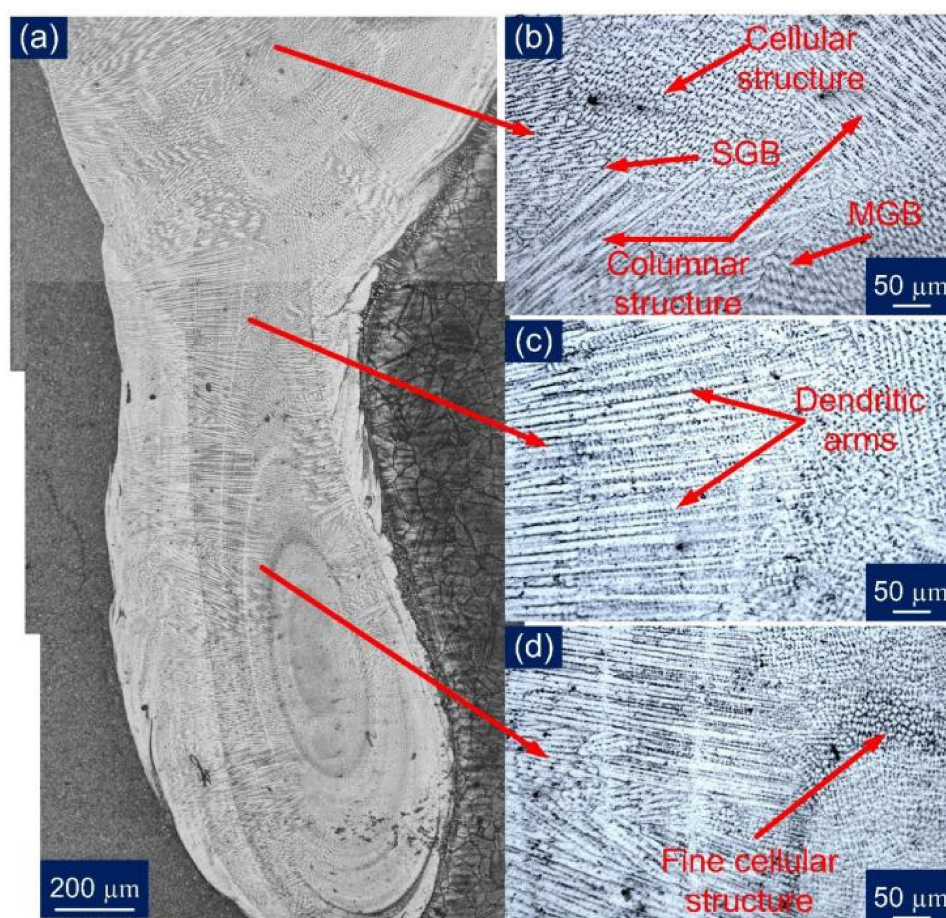
Figure 9. Optical images for: (a) WFZ in PWHT condition; (b) top of the WFZ; (c) WFZ mixed zone; (d) bottom WFZ.

Further, the comparative analysis was completed for a PWHT WFZ. However, being austenitic in nature, it did not respond to PWHT. From a stitched Figure 9a, though, it can be assumed that cracks were not present along the overall weld length, as no sign of cracks were there in the few specimens observed. Figure 9b–d also confirms the presence of discussed solidification modes as in the observed top WFZ groups of cellular and columnar structures are indicated with SGB and MGB. It was concluded, from the optical image study, that inhomogeneity was present in the WFZ to a significant extent; hence the inter-dendritic areas were further characterized using EDS analysis.

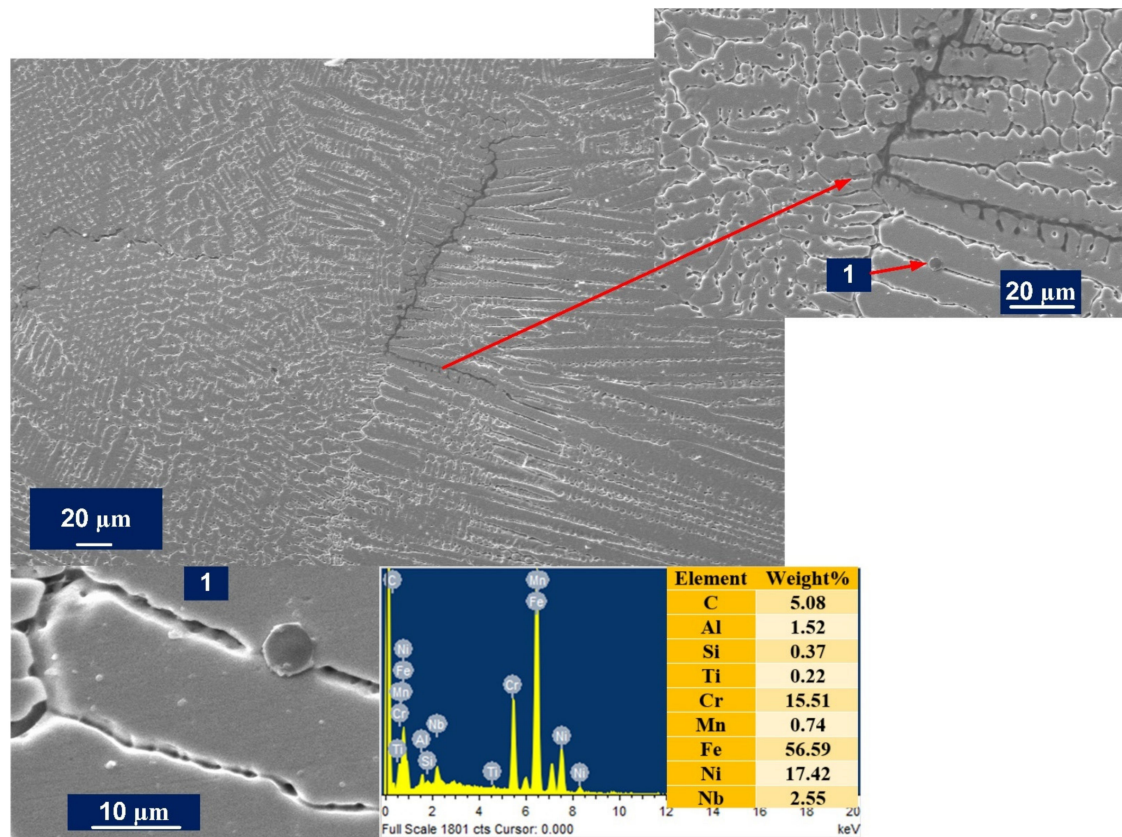
Figure 10. SEM micrograph cracks in AW specimen WFZ and EDS spectra of precipitate observed in the dendritic core region.

The solidification cracks were observed in the WFZ along the grain boundaries, as shown in Figure 10, and the EDS analysis suggests the particle might be a chromium carbide. However, Figure 9a indicates no cracks in the WFZ. This could suggest the cracks were not uniformly distributed along the welded joint. In Figure 8a, the crater at the very top indicates that, under the sudden shock of the high temperature at the start, the initial location under the focus of the laser beam—the area to be joined—might have

experienced cracking, possibly in a limited area only. The major cause for this could be the presence of low melting eutectic constituents forming elements, i.e., Nb, Ti, and Si. However, no liquation cracking was observed in the HAZ, due to the fine and coarse microstructural differences of the base metals. During solidification, the segregation of Nb occurred in the dendritic areas, as shown in Figure 11. As the eutectic reaction occurs, the formation of γ /NbC and γ /Laves constituents is reported to take place and this expands the solidification temperature range, leading to uneven cooling and cracking [47]. Nickel has a high affinity for sulfur to form nickel sulfide (NiS) along the grain boundaries and is considered to be the main cause of hot cracking in Incoloy 800HT during welding [17]. Type 1A cracks were observed in the weld region only, and no crack formation was witnessed in the HAZ regions of either parent metal. More cracks were observed in the weld region near to Incoloy 800HT side interface, which again reflects the susceptibility of Incoloy 800HT to hot cracking.

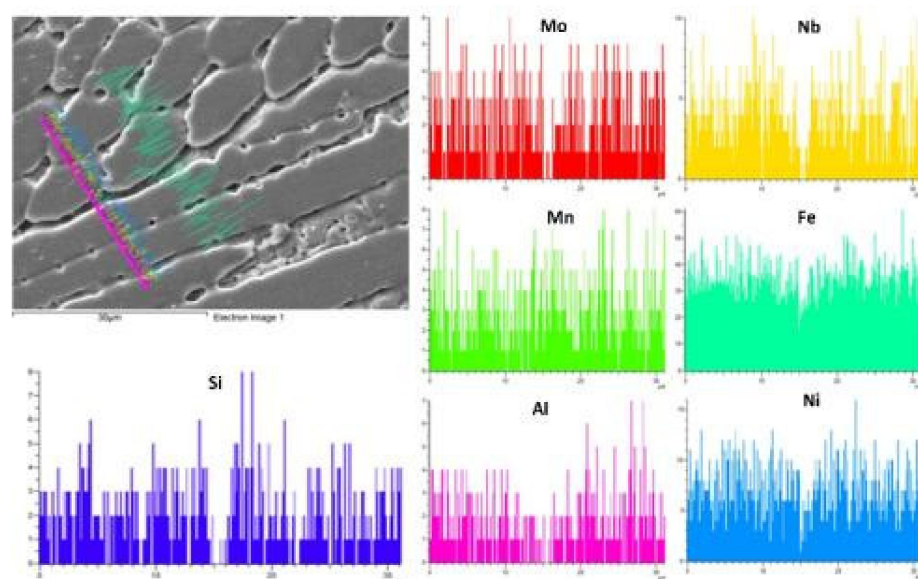
Figure 11. Line map EDS analysis across the interdendritic cores in the weld region.

In Figure 11, the microsegregation of Mo, Si, and Fe along dendritic core and subgrain boundaries in the interdendritic region can be observed. Meanwhile, the P91 side of WFZ majorly evolved elongated cellular and columnar dendrites. The fusion structures were formed as per the solidification rate, which is affected by the material's physical and chemical properties and, also, the keyhole mode. Rapid heating and cooling causes the cellular structure to change into a dendritic structure. The keyhole causes a low transfer of heat through the interface to the base metal, which also creates thermally generated stresses. In the weld region, grain boundaries were found to be rich in Ti, Si, and Nb concentrations. These elements tend to produce complex solidification temperature changes at the grain boundaries. Si concentration which was segregated, as shown in Figure 11, was found in

higher concentrations in fusion zone, and this plays a crucial role in hot cracking. As the columnar dendritic structure was observed in the WFZ in a large quantity, it is possible that the cracks were observed alongside them, as depicted in Figure 10. Carbon affects the formation of a higher columnar dendritic structure, which causes partial dissolution of precipitates. Fewer precipitates were observed in the WFZ as Ti consumed C present and its carbide transferred in the molten pool and accumulated near the Type II boundary.

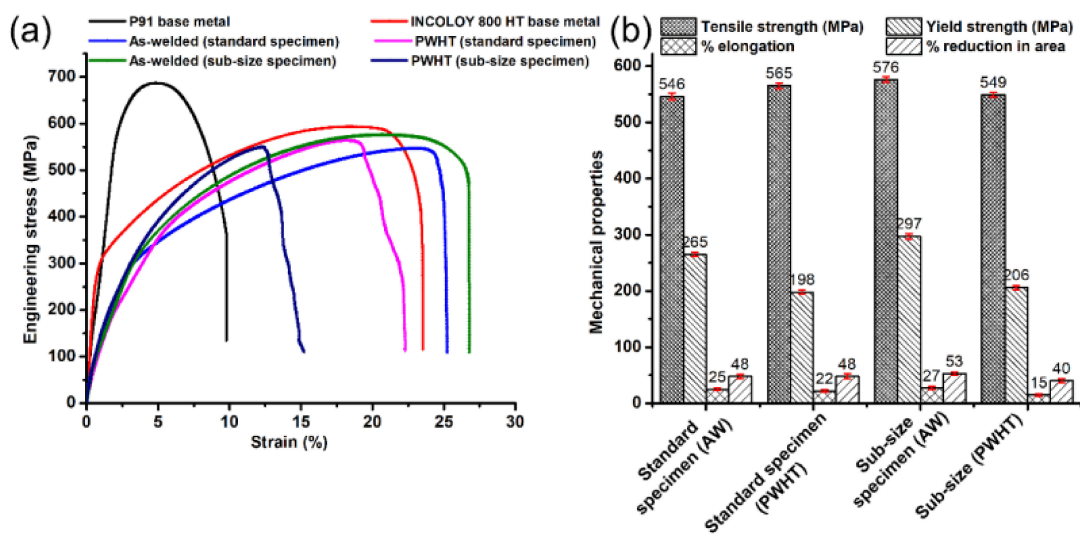
Figure 12. (a) Engineering stress-strain curves for performed tensile tests, (b) variation in mechanical properties for different conditions of the welded joint.

The tensile tests were conducted on the transverse tensile specimen, and the test results are mentioned in Table 4. The trend of stress and strain can be observed and compared through the engineering stress-strain obtained, as shown in Figure 12a. The variation in tensile properties is shown in Figure 12b. The tensile strength of the AW joint (standard specimen) was measured 546 ± 6 MPa, which was lower than the tensile strength of both the base metal P91 (687 ± 8 MPa) and Incoloy 800HT (593 ± 5 MPa). In the AW condition, the fracture was observed in the region of the Incoloy 800HT HAZ, as shown in Table 5. After the PWHT, the fracture occurred in the region of the Incoloy 800 HT base metal with a tensile strength of 576 ± 5 MPa, which was still lower than the P91 and Incoloy 800 HT base metal. However, a fracture from the region of the Incoloy 800 HT base metal ensures that the joint is safe for USC boiler service after the PWHT. The percentage (%) elongation of the welded joint was also measured and found to be higher than the Incoloy 800 HT base metal for both AW ($25 \pm 2\%$) and PWHT ($27 \pm 3\%$) conditions. The yield strength of the welded joint was measured as 265 ± 4 MPa and 297 ± 5 MPa for the AW and PWHT joint, which was close to the yield strength value of the Incoloy 800HT base metal (285 ± 4 MPa). Base metals exhibited the highest tensile and yield strength, while the welded specimens have shown resembling results, which are reported in another study [48]. For a sub-size specimen, the fracture was observed in the center region of the WFZ, and the strength was measured as 565 ± 5 MPa and 549 ± 4 MPa for AW and PWHT conditions, respectively. The failure from the center region of the WFZ might be due to the presence of the solidification cracks, which showed the sudden propagation just after the yielding. Still, with the lower yield strength observed in AW and PWHT conditions, tensile strength was obtained in the reported range. This might suggest that the cracks were only dominant near the starting region of the weld bead due to the instability caused by the initiation of the keyhole and high heat input, or the liquid metal may have filled the cracks to slightly heal them, as represented in Figure 13a. It can be visualized from Figure 13b that there was backfilling as the major compositional elements in the area mapping analysis were evenly distributed in the region. Figure 14a–c depicts the crack along with the columnar dendritic microstructure, and the magnified view of the region shows the re-solidification in the crack Figure 14b–d [44]. The percentage of elongation measured for sub-size specimens were 198 ± 3 MPa and 206 ± 4 MPa for AW and PWHT, respectively, which was lower than the corresponding values of a standard tensile specimen. The percentage of elongation was also measured as lower than the standard tensile specimen, and was $22 \pm 2\%$ and $15 \pm 2\%$ for the AW and PWHT joint (Figure 12b).

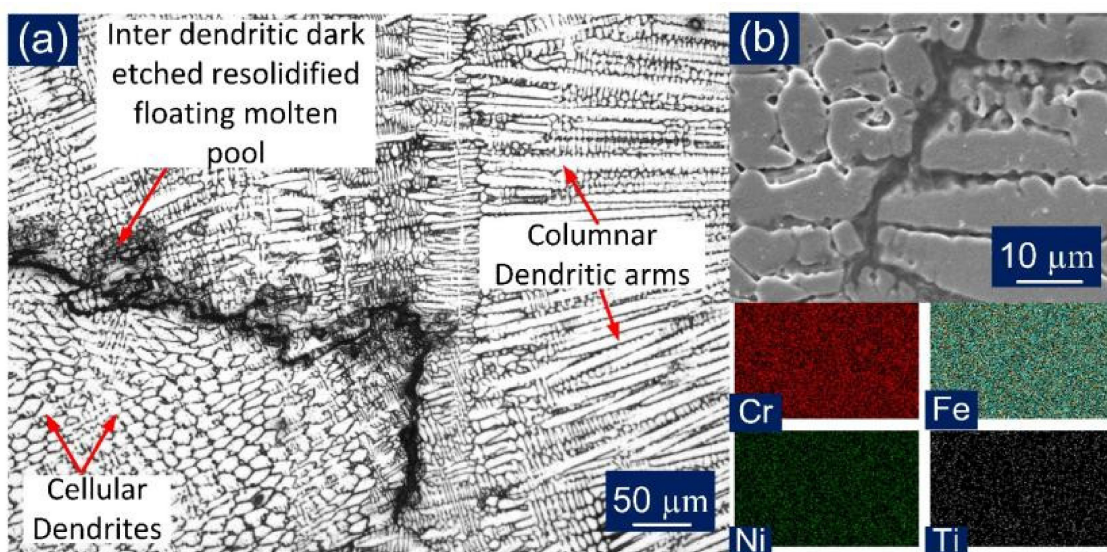
Figure 13. (a)The incomplete healing process in the surrounding of the crack in the AW WFZ; (b) EDS area mapping data.

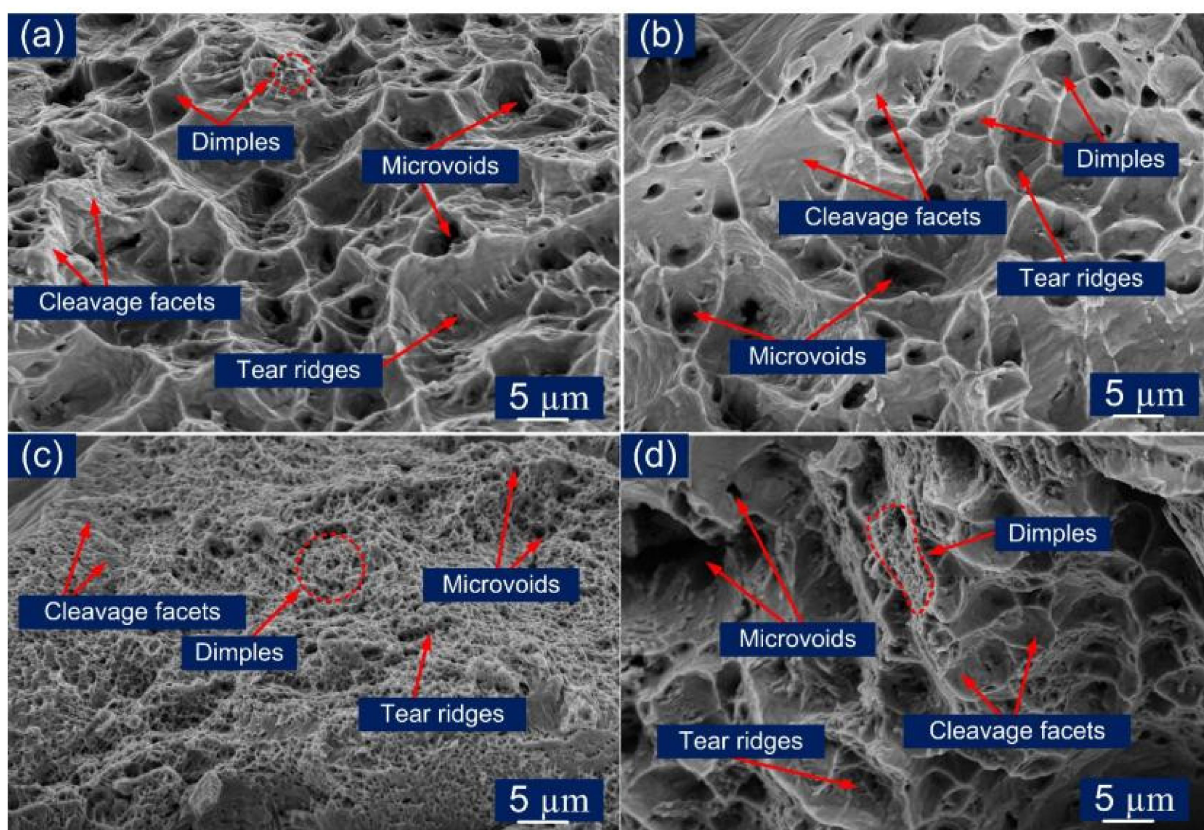
Figure 15. SEM fractography micrographs of (a) standard AW specimen, (b) standard PWHT specimen, (c) sub-size AW specimen, (d) sub-size PWHT specimen.

The fractured tensile specimen was also analyzed using the FE-SEM and is presented in Figure 15. The presence of the dimples at the fracture surface also supports the results (% elongation) that were obtained through the tensile tests. Figure 15a,b shows that failure from a ductile mode of fracture occurs in standard size specimens with Incoloy 800HT HAZ (AW) and the base metal (PWHT), as dimples were uniformly distributed. The fractured specimen in AW and PWHT conditions exhibits ductile dimples of varying size and depth, microvoids of varying size and depth, and tear ridges. The PWHT fractured specimen also shows the presence of a few brittle areas, i.e., cleavage facets (Figure 15b). While sub-size AW and PWHT specimens failing due to weld had experienced the intergranular and transgranular types of fracture, the presence of fewer dimples suggests slight ductile behavior (Figure 15c,d). The appearance of the fracture surface also supports the tensile test results. The fracture surface for the AW specimen exhibits a large area of the cleavage facets (Figure 15c), while after the PWHT, both fine dimples and microvoids were observed, along with the cleavage facets (Figure 15d).

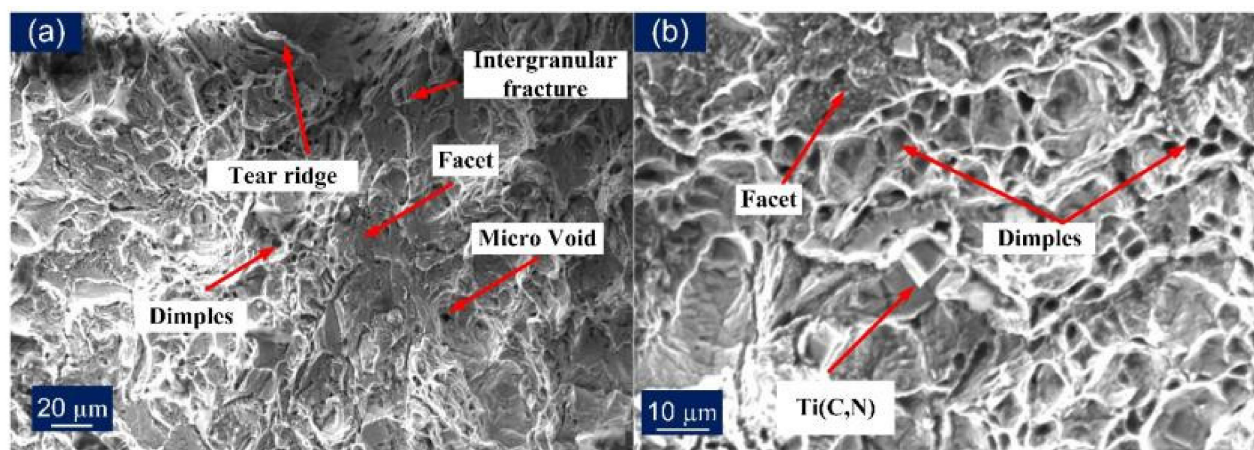
Figure 18. SEM fractography micrograph of specimens broken during Charpy impact toughness test (a) AW (impact at WFZ), (b) PWHT (impact at WFZ).
