Article

Study on Microstructure and Mechanical Properties of Laser Welded Dissimilar Joint of P91 Steel and INCOLOY 800HT Nickel Alloy

Abstract: This investigation attempts to explore the weld characteristics of a laser welded dissimilar joint of ferritic/martensitic 9Cr-1Mo-V-Nb (P91) steel and Incoloy 800HT austenitic nickel alloy. This dissimilar joint is essential in power generating nuclear and thermal plants operating at 600–650 °C. In such critical operating conditions, it is essential for a dissimilar joint to preserve its characteristics and be free from any kind of defect. The difference between the physical properties of P91 and Incoloy 800HT makes their weldability challenging. Thus, the need for detailed characterization of this dissimilar weld arises. The present work intends to explore the usage of an unconventional welding process (i.e., laser beam welding) and its effect on the joint's characteristics. The single-pass laser welding technique was employed to obtain maximum penetration through the keyhole mode. The welded joint morphology and mechanical properties were studied in as-welded (AW) and post-weld heat treatment (PWHT) conditions. The macro-optical exami

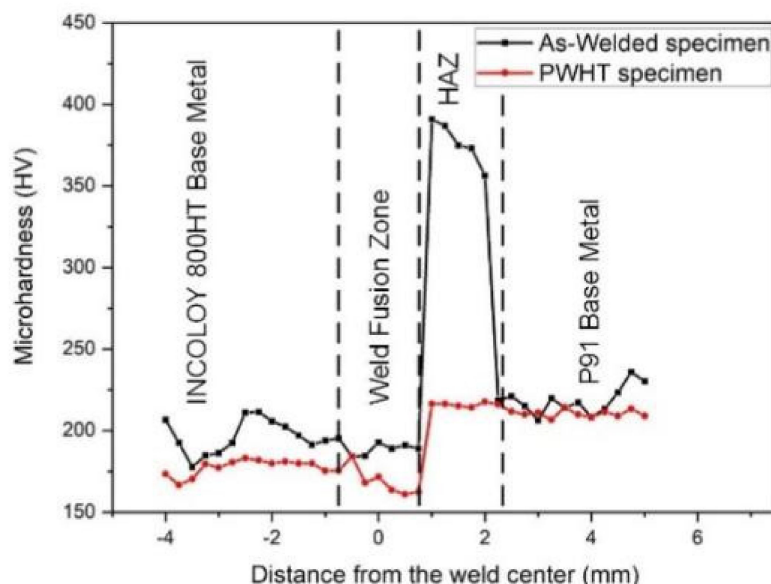
Figure 16. Microhardness variation obtained for AW and PWHT weldments.

The inhomogeneity in the microstructure obtained, due to the welding of dissimilar metals, impacts the mechanical property of the welds joint. Hence, microhardness analysis was conducted for the categorized welding zones. The comparison was done in the AW and PWHT states, as illustrated in Figure 16. The obtained microhardness for the base P91 and Incoloy 800HT was 245 ± 5 HV and 189 ± 5 HV, respectively. A comparatively lower hardness of 187 ± 3 HV was observed in the weld fusion zone of the AW joint, which was attributed to the austenitic microstructure and segregation of the alloying elements at the inter-dendritic boundaries. A uniform hardness variation was measured in the WFZ except for the Incoloy 800HT, which showed a slight increase in hardness that could be attributed to the formation of the unmixed zone due to differences in melting temperatures of parent base metals. As is apparent in the illustration, a notable variation in the measured hardness is evident along the weldment. The AW P91 side HAZ showed a significant increment in hardness with a peak hardness of 391 HV near the fusion boundary, i.e., CGHAZ. With the P91 CGHAZ being martensitic in nature, a higher hardness due to the presence of a slightly higher alloying concentration of Mo, W, C, and N was shown. The complete dissolution of MX and $M_{23}C_6$ precipitates in the region P91 CGHAZ formed under high temperature ($\gg A_{c3}$) increases the percentage of carbon and nitrogen in the solution matrix, hence causing the increase in hardness by solid solution strengthening. A similar observation has also been reported for P91 CGHAZ [36,49]. However, the hardness of P91 CGHAZ in the fusion welded joint was reported as much higher than the laser beam welded joint [29,50,51]. Gradually, a lower hardness in P91 FGHAZ was observed, varying from 387 HV to 356 HV with an average of 373 ± 12 . The incomplete dissolution of the precipitates in FGHAZ as a result of the lower peak temperature ($\geq A_{c3}$) might be the cause of the poorer hardness in P91 FGHAZ than in the P91 CGHAZ. The minimum hardness in P91 HAZ was measured in ICHAZ, which experienced the temperature in between A_{c1}

and A_{c3} . The poor hardness of 218 HV in P91 ICHAZ was attributed to the re-tempering of martensite, grain and precipitate coarsening. In the AW condition, the carbide and nitride precipitates imparted the hardness to Incoloy 800HT, but being austenitic in nature, it exhibited a comparatively lower hardness than P91 and did not show any significant variation. Owing to this property of Incoloy 800HT, the HAZ hardness was measured as 195 HV, which is closely comparable to the Incoloy 800HT base metal hardness.

The tempering of the welded joint showed a significant effect on the hardness value of the P91 HAZ, while the hardness of the WFZ and Incoloy 800HT HAZ remained unaffected. After PWHT, the lowering in the hardness of P91 HAZ was significantly due to the tempering of martensite. The dissolved precipitates in the AW condition resurfaced while tempering. Hence, the CGHAZ of P91 after PWHT depicted a sharp decline of 174 HV in hardness compared to the AW state. A drastic reduction in the hardness of the P91 FGHAZ was also measured, with a hardness of 356 HV. However, the hardness of the P91 ICHAZ remains unaffected, and it was 218 HV. A similar trend of the hardness variation in P91 HAZ was also reported by Pandey et al. [52]. While theoretically, austenitic Incoloy 800HT and WFZ do not respond to PWHT, a slight reduction can be observed in the Incoloy 800HT side and even in the WFZ. This might be due to softening by carbide dissolution [44]. In addition, it might be argued that this reduction in hardness is due to ageing [45]. It can be concluded that PWHT is successful in reducing the hardness in the martensitic HAZ and reducing the hardness variation along the weldment.
