Article

Study on Microstructure and Mechanical Properties of Laser Welded Dissimilar Joint of P91 Steel and INCOLOY 800HT Nickel Alloy

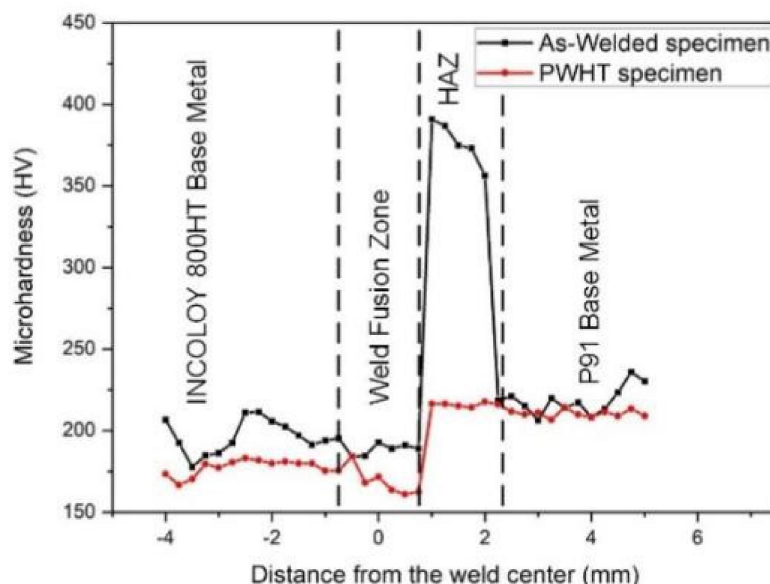
Figure 16. Microhardness variation obtained for AW and PWHT weldments.

The inhomogeneity in the microstructure obtained, due to the welding of dissimilar metals, impacts the mechanical property of the welds joint. Hence, microhardness analysis was conducted for the categorized welding zones. The comparison was done in the AW and PWHT states, as illustrated in Figure 16. The obtained microhardness for the base P91 and Incoloy 800HT was 245 ± 5 HV and 189 ± 5 HV, respectively. A comparatively lower hardness of 187 ± 3 HV was observed in the weld fusion zone of the AW joint, which was attributed to the austenitic microstructure and segregation of the alloying elements at the inter-dendritic boundaries. A uniform hardness variation was measured in the WFZ except for the Incoloy 800HT, which showed a slight increase in hardness that could be attributed to the formation of the unmixed zone due to differences in melting temperatures of parent base metals. As is apparent in the illustration, a notable variation in the measured hardness is evident along the weldment. The AW P91 side HAZ showed a significant increment in hardness with a peak hardness of 391 HV near the fusion boundary, i.e., CGHAZ. With the P91 CGHAZ being martensitic in nature, a higher hardness due to the presence of a slightly higher alloying concentration of Mo, W, C, and N was shown. The complete dissolution of MX and $M_{23}C_6$ precipitates in the region P91 CGHAZ formed under high temperature ($\gg A_{c3}$) increases the percentage of carbon and nitrogen in the solution matrix, hence causing the increase in hardness by solid solution strengthening. A similar observation has also been reported for P91 CGHAZ [36,49]. However, the hardness of P91 CGHAZ in the fusion welded joint was reported as much higher than the laser beam welded joint [29,50,51]. Gradually, a lower hardness in P91 FGHAZ was observed, varying from 387 HV to 356 HV with an average of 373 ± 12 . The incomplete dissolution of the precipitates in FGHAZ as a result of the lower peak temperature ($\geq A_{c3}$) might be the cause of the poorer hardness in P91 FGHAZ than in the P91 CGHAZ. The minimum hardness in P91 HAZ was measured in ICHAZ, which experienced the temperature in between A_{c1}

and A_{c3} . The poor hardness of 218 HV in P91 ICHAZ was attributed to the re-tempering of martensite, grain and precipitate coarsening. In the AW condition, the carbide and nitride precipitates imparted the hardness to Incoloy 800HT, but being austenitic in nature, it exhibited a comparatively lower hardness than P91 and did not show any significant variation. Owing to this property of Incoloy 800HT, the HAZ hardness was measured as 195 HV, which is closely comparable to the Incoloy 800HT base metal hardness.

The tempering of the welded joint showed a significant effect on the hardness value of the P91 HAZ, while the hardness of the WFZ and Incoloy 800HT HAZ remained unaffected. After PWHT, the lowering in the hardness of P91 HAZ was significantly due to the tempering of martensite. The dissolved precipitates in the AW condition resurfaced while tempering. Hence, the CGHAZ of P91 after PWHT depicted a sharp decline of 174 HV in hardness compared to the AW state. A drastic reduction in the hardness of the P91 FGHAZ was also measured, with a hardness of 356 HV. However, the hardness of the P91 ICHAZ remains unaffected, and it was 218 HV. A similar trend of the hardness variation in P91 HAZ was also reported by Pandey et al. [52]. While theoretically, austenitic Incoloy 800HT and WFZ do not respond to PWHT, a slight reduction can be observed in the Incoloy 800HT side and even in the WFZ. This might be due to softening by carbide dissolution [44]. In addition, it might be argued that this reduction in hardness is due to ageing [45]. It can be concluded that PWHT is successful in reducing the hardness in the martensitic HAZ and reducing the hardness variation along the weldment.
