Analysis of the state of preservation the historic arcaded houses in Vistula Delta listed in the National Inventory of Historical Monuments

Abstract: Historic arcaded houses are part of the material heritage of the Vistula Delta. Unfortunately, their number is decreasing year by year. The article is the result of a query of available sources and field research carried out by the author in 2015-2020. The paper presents the current state of preservation the historic arcaded houses in Vistula Delta listed in the National Inventory of Historical Monuments. Criteria for the selection of test objects are described. The author has prepared a tabular list of arcaded houses with information about their location, type according to Kloepfel statistics, date of construction, technical condition and functions. The summary of the analysis are pie charts with a statistical presentation of the data collected by the author during the research.

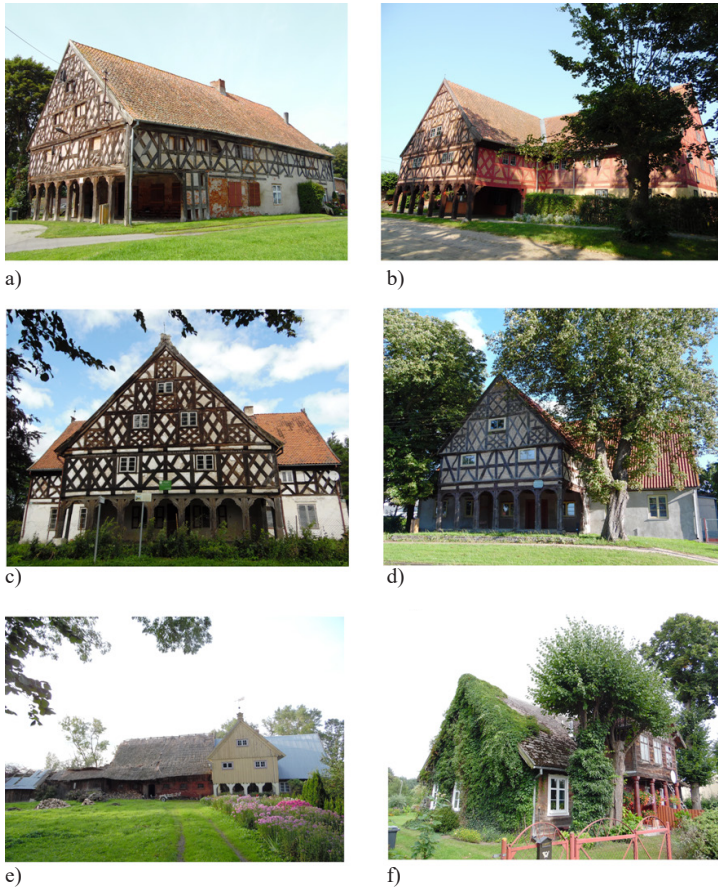
Fig. 1. Types of arcaded houses: a) type I house in Klecie, b) type II house in Trutnowy, c) type II-III house in Stalewo no.14, d) type III house in Koszwały, e) type III house in Markusy, f) type III house in Mikoszewo no. 68 (photo by the author)

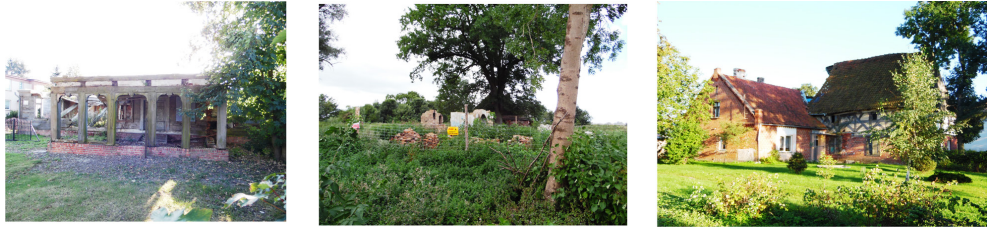
houses in Lasowice Małe (Fig. 2a)²¹, Kławki (Fig. 2b)²² and Świerki (Fig. 2c)²³. The list of historical monuments (as of 2015) also includes an arcaded house in Złotów, which burned down in 2014²⁴.

Fig. 2. Destruction of arcaded houses: a) Lasowice Małe, b) Kławki, c) Świerki (*photo by the author*)

²¹ The house is in ruins. Only part of the ground floor of the building has survived (as of 2016).

²² The house was demolished, in 2016 there was only a chimney.

²³ The house is partially destroyed (1/3 of the roof collapsed).

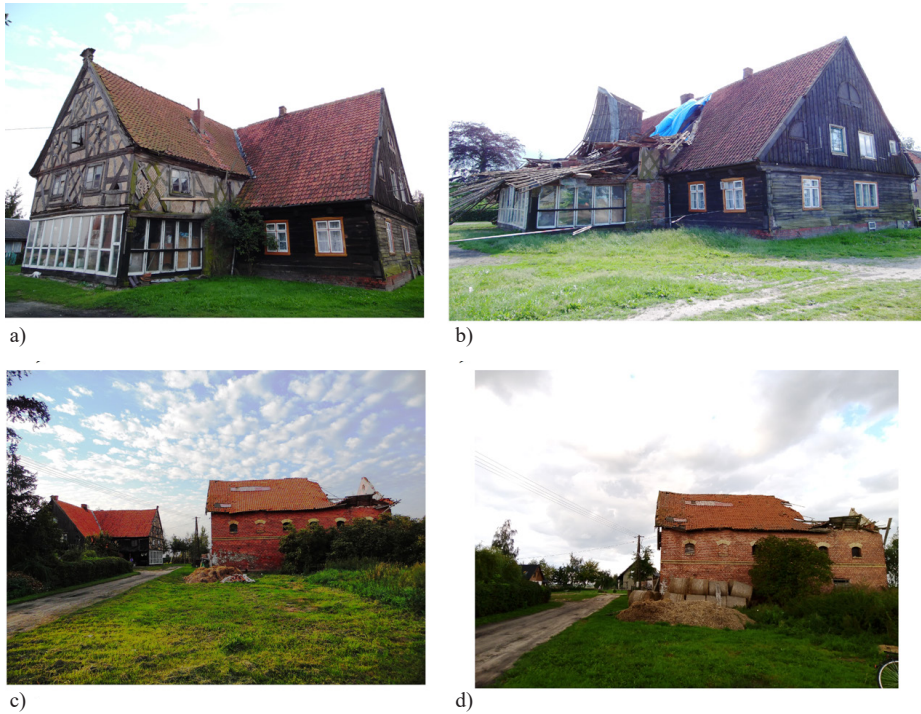
During five years of research, the state of preservation decreased by one monument (Fig. 3a). In 2017, the house in Izbiska from 1778 was completely destroyed²⁵. In May 2017, as a result of a strong wind, the arcade collapsed (Fig. 3b), in November 2017 the house burned down. No attempt was made to rebuild it (Fig. 3c, d)²⁶.

²⁵ In 2016, the author measured the geometry of the break as well as the height and cross-sections of the columns.

²⁶ In 2020, only the foundations of the house and construction rubble from its demolition are left.

Fig. 3. Destruction of the arcaded house in Izbiska: a) August 2016, b) June 2017, c) view of the farm – August 2016, d) view of the farm – September 2020 (*photo by the author*)

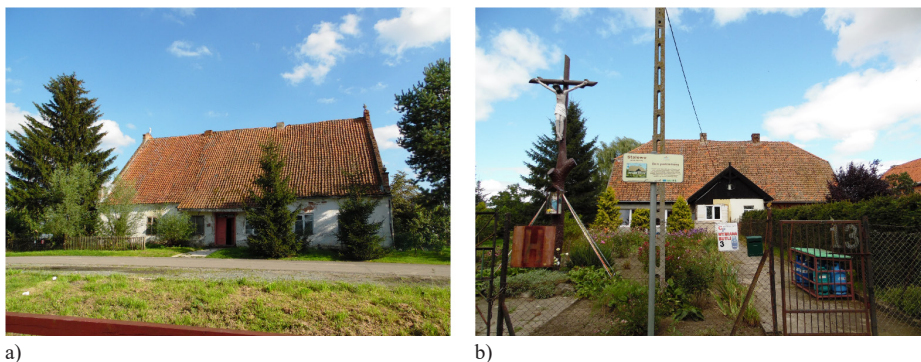
Some houses have lost their avant-corps as a result of breakdowns or reconstructions and are no longer arcaded houses. Examples of such activities are houses in Marynowe no. 23/25 (Fig. 4a) and Stalewo no. 18 (Fig. 4b)²⁷.

Fig. 4. Houses in: a) Maynowy no. 23/25 b) Stalewo no. 18 (*photo by the author*)

²⁷ The house was heavily rebuilt, completely lost its features of an arcaded house, decorations were removed.

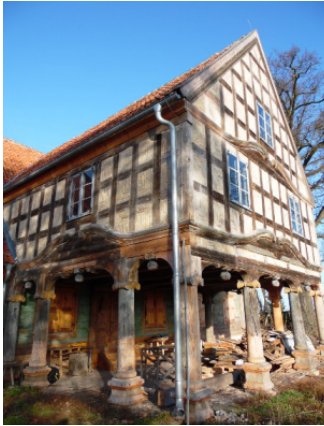
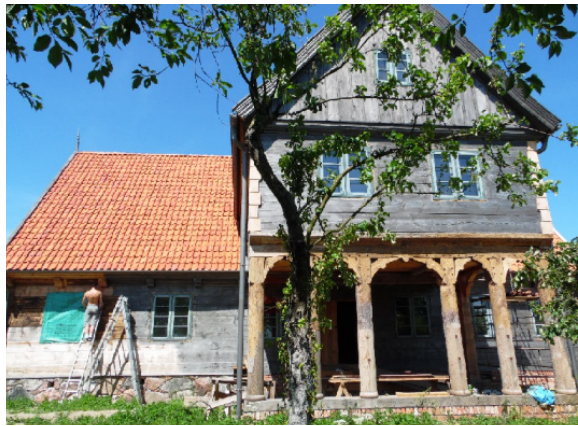
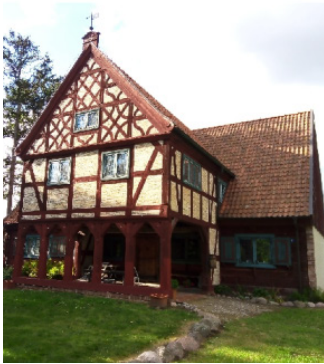
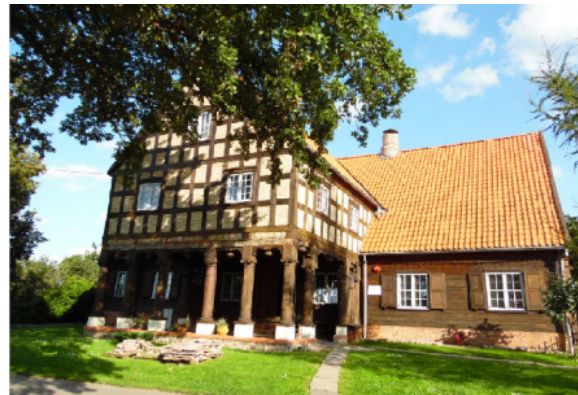
Fig. 5. Arcaded houses in: a) Orłowo no. 66, during construction and conservation works in 2015, b) Miko-szewo no. 55, during construction and conservation works in 2017, c) Przemysław no. 4, d) Marynowy no. 19 / 19a (photo by the author)

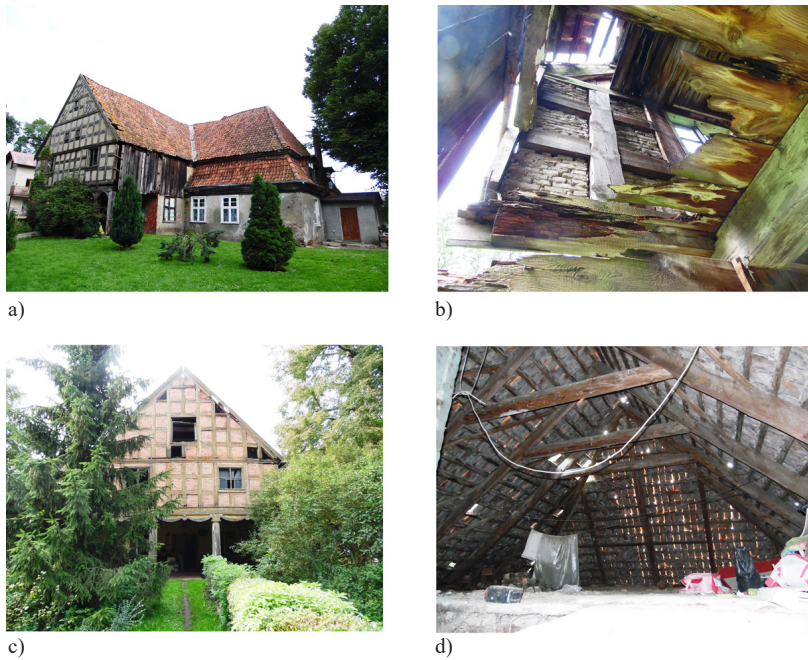
12 houses (27.91%) are in a very good technical condition, 19 houses are in a good condition (44.19%), 10 houses are in sufficient condition (23.26%), 2 houses are in insufficient condition (4.65%) – monuments in Steblewo (Fig. 6) (Graph 3).

Fig. 6. Houses in: a) Steblewo 22/24, b) Steblewo 22/24 the catastrophic condition of the gable wall of the portico, c) Steblewo 15/17, d) Steblewo 15/17 leaking roofing (*photo by the author*)

This number is likely to decrease within a few years. Two houses in Steblewo require immediate construction and conservation works. Their technical condition is insufficient. Lack of adequate funds for repairs and little involvement of the owners in saving them will result in the loss of more monuments from the 18th century.

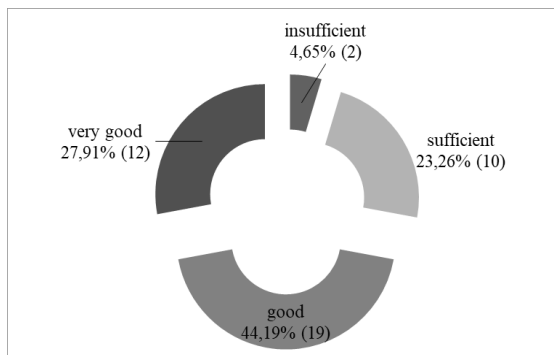
Graph 3. Technical condition of arcaded houses, as of 2020 (*author's study*)
