Aleksander Piwek*, Tomasz Jażdżewski**

The room above the porte cochère of the Kwidzyn castle in the times of the Pomesanian chapter

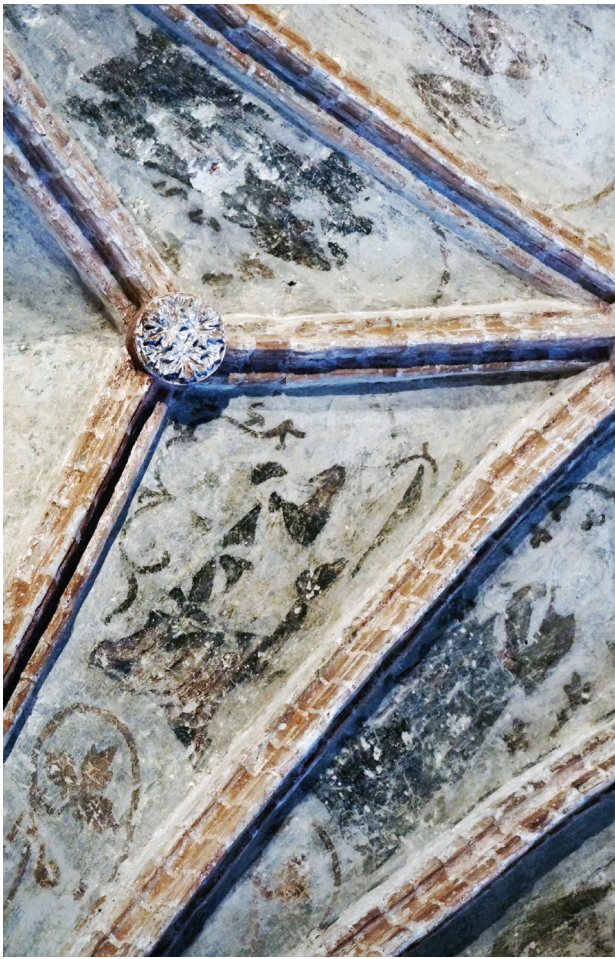
Fig. 9. Part of the northern bay vault with traces of exposed polychrome (2nd quarter of the 15th century?) (photo by A. Piwek)

The completely uncovered polychromes (Fig. 9) indicate the sacral function of the room and the time of its creation. It is assumed that they were made between 1400 and 1450 [10, pp. 8, 9], although this is not the only possibility¹³. Their sacral content (figures of saints) corresponds with the new use of the hall. Their appearance only on the vaulting of the northern bay has not been explained yet. The suggested reason is the start of the war in 1409 [9, p. 8] and its consequences. There is also another explanation. When a wooden partition is placed in the middle of the interior, it separates parts intended for users of different status – the clergy and the castle servants.

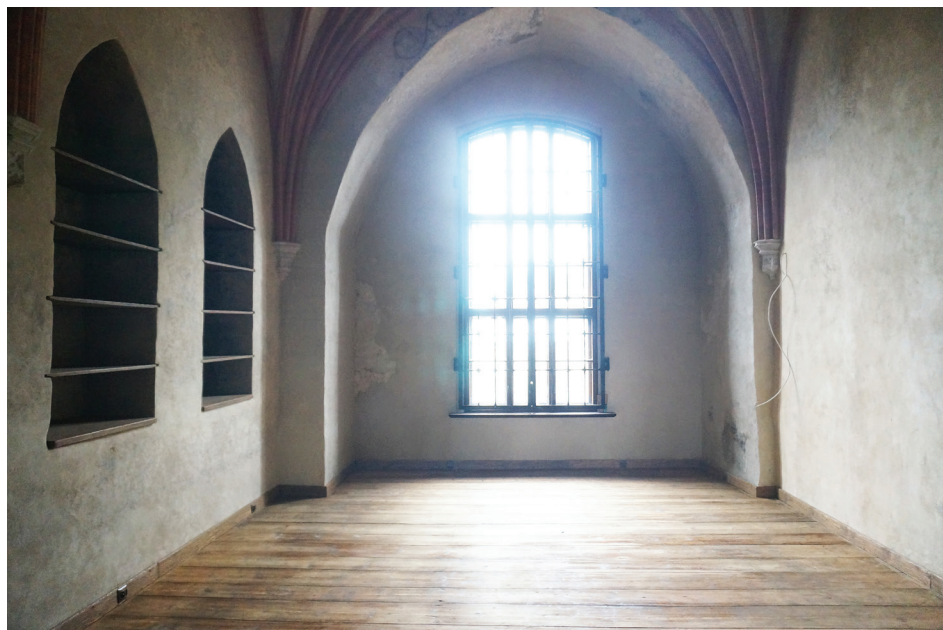
Fig. 10. Northward view of the interior of the room above the porte cochère at the end of conservation work (September 2017) (photo by A. Piwek)
