Aleksander Piwek*, Tomasz Jażdżewski**

The room above the porte cochère of the Kwidzyn castle in the times of the Pomesanian chapter

This article presents the history of the construction of the room above the porte cochère in the northern wing of the Kwidzyn castle in the times of the Pomesanian chapter. The findings presented here were derived from the architectural and stratigraphic research and analysis of archival materials conducted in 2017. According to these findings, the room was built in the first stage of erecting the castle. In the following centuries, it underwent architectural changes corresponding to the new needs of the castle's inhabitants. The preserved traces testify that it had several successive functions from the 14th to the 16th century, so far not fully recognised and explained: a watchtower, court office or chamber, or even a chapel. Much of the knowledge about it is contained in the stratification of the walls and the reconstructions of historical transformations from the medieval period. In later times, the room was spared significant damage and still constitutes a valuable source of knowledge about the castle's history.

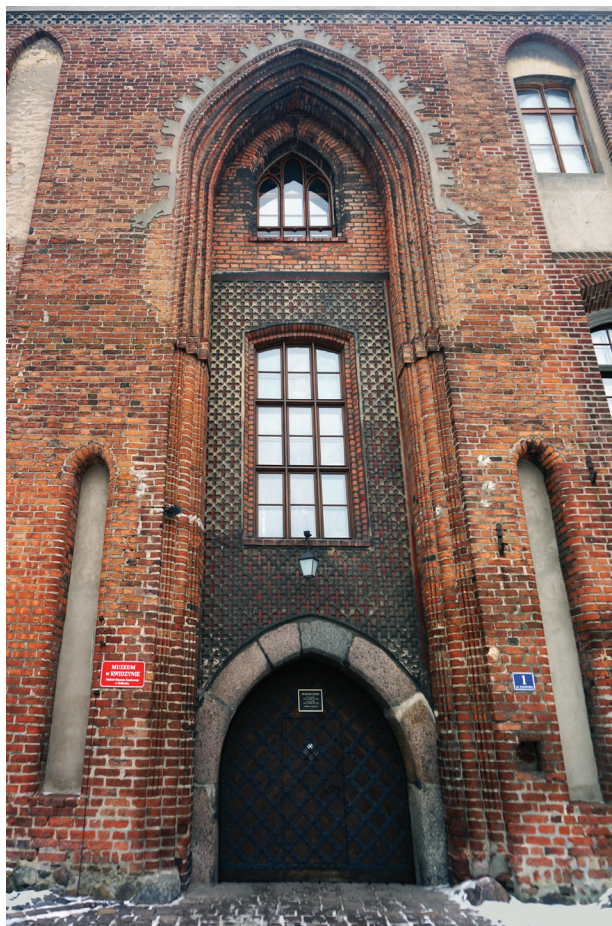
Fig. 2. View of the entrance and the rooms located above from the north (photo by A. Piwek)

one). A low porte cochère located in the northern wing led to the interior of the complex (Figs. 1, 2). Above it, there was a room whose history was connected not only with the porte cochère but also with the fate of the castle inhabitants. Their aspirations and needs significantly influenced its interior.

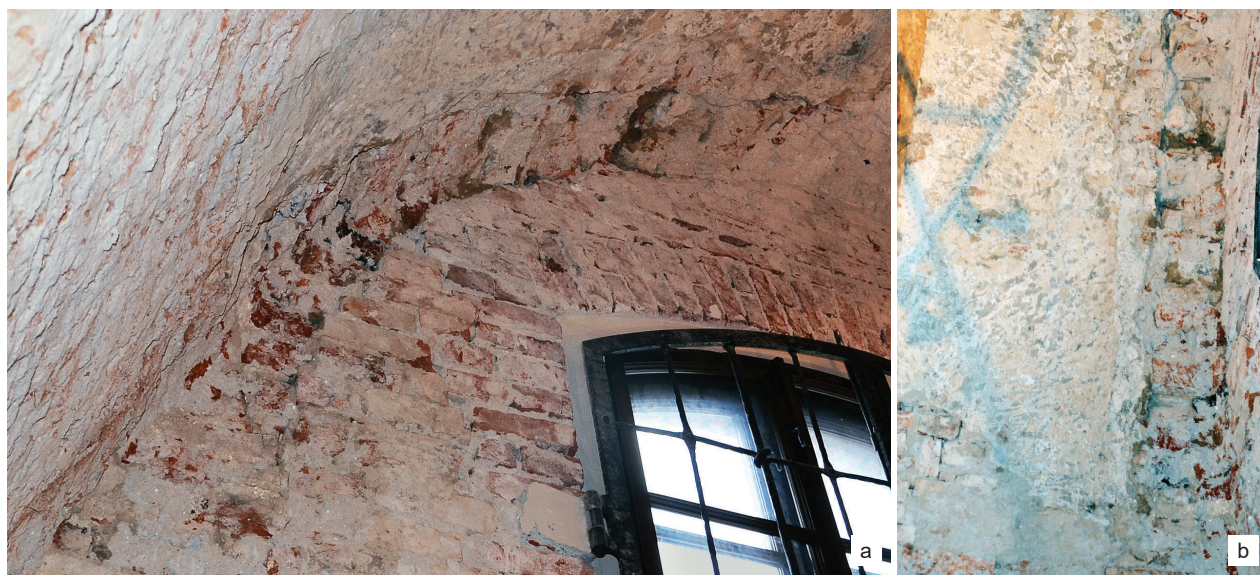
Fig. 4. Remains of the original recess in the northern wall (with a window):

- a) fragment of the arch (disappearing in the middle of the vault) at the junction with the cover of the widened recess,
 - b) part of the medieval widened recess arch with traces of the narrowing of the northern wall (strip of bricks by the window wall)
- (photo by A. Piwek)

etrating (in the middle of the recess) its lintel (Fig. 4a). The ogival arch of the recess has a strip of chipped bricks, approx. 15 cm wide, separated by a joint at the window wall (Fig. 4b).
