# EXPERIMENTAL RESEARCH ON INSUFFICIENT WATER LUBRICATION OF MARINE STERN TUBE JOURNAL BEARING WITH ELASTIC POLYMER BUSH

Agnieszka Barszczewska  
Gdańsk University of Technology, Poland

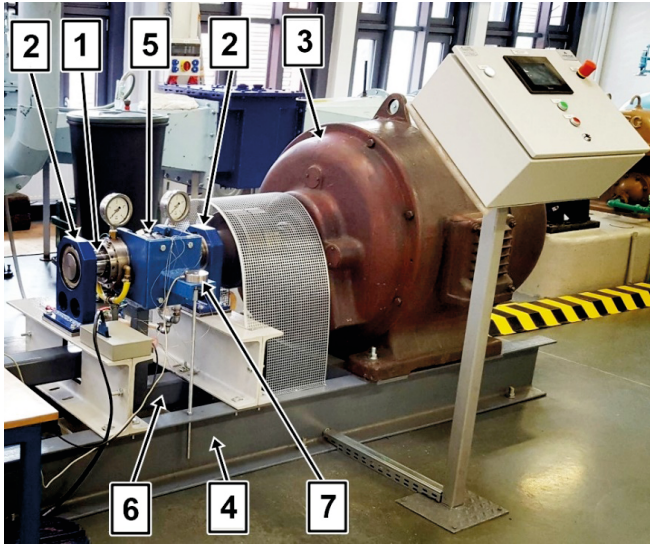
Fig. 2. High-power test rig, 1 – main shaft, 2 – rolling bearing, 3 – electric motor 220 kW, 4 – test rig frame, 5 – bearing unit, 6 – radial force application unit, 7 – force sensor for measuring moment of friction.

A new built test-rig made it possible to investigate real-scale bearings with a shaft diameter of 100 mm at high power propulsion (Fig. 2). The test rig's shaft is made of chromium-nickel steel EN 1.4310 with roughness Ra 0.32 µm as it is required in marine propeller shafts. The test rig is equipped with a 220 kW electric motor, with the maximum rotational speed of 1100 rev/min and nominal torque of 2600 Nm. Thus, the simulated conditions resemble those present on a small ship where the transmitted power is high enough to destroy the bearing.

The test rig (Fig. 2) consists of a shaft 100 mm in diameter (1) supported by two self-aligning bearings (2) and driven by an electric motor (3). The motor and the rolling bearings were mounted on the test rig frame (4). The tested bearing unit (5) was placed on the shaft between the two rolling bearings. Loads were applied on the tested bearing using a lever (6) from which weight discs were suspended. Measurement of the friction torque was obtained through a force sensor (7), which was mounted on the bearing set using a clamp with an arm.

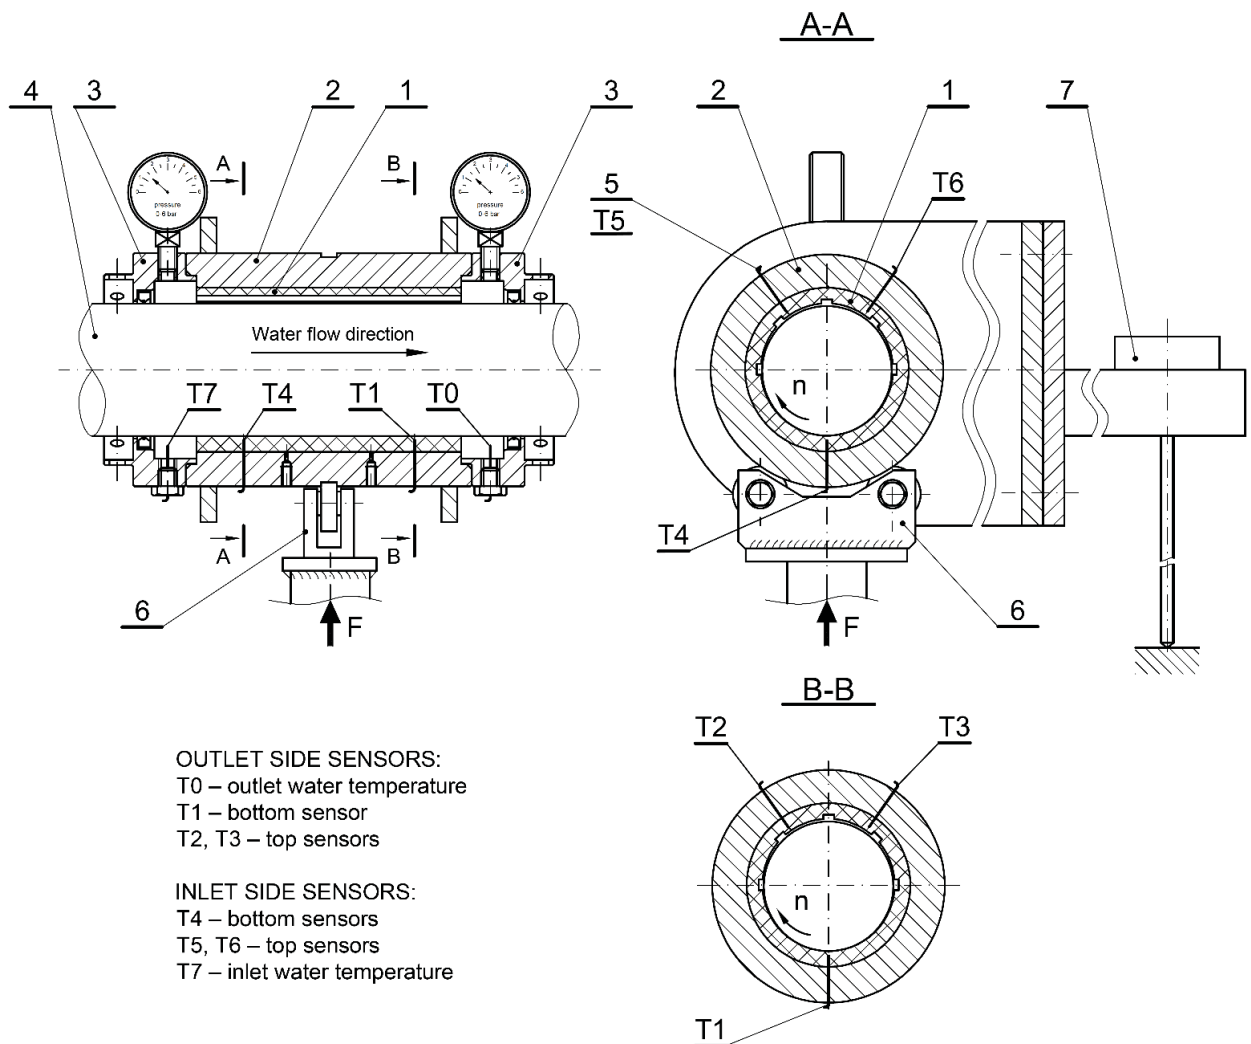
Fig. 3. Tested bearing unit: 1 – tested polymer bush, 2 – steel housing, 3 – covers with sealing, 4 – stainless steel main shaft, 5 – thermocouples (T0~T7), 6 – radial force application unit, 7 – arm and sensor for measuring moment of friction.

The tested bearing unit (Fig. 3. Tested bearing unit: 1 – tested polymer bush, 2 – steel housing, 3 – covers with sealing, 4 – stainless steel main shaft, 5 – thermocouples (T0~T7), 6 – radial force application unit, 7 – arm and sensor for measuring moment of friction.) consists of the tested bush (1) which was installed in a steel housing using a thermo-compression method (2), as well as two steel covers (3) with sealing.

During the tests continuous measurement of the bearing temperature was conducted at eight measurement points (Fig. 3. Tested bearing unit: 1 – tested polymer bush, 2- steel housing, 3 – covers with sealing, 4 – stainless steel main shaft, 5 – thermocouples (T0~T7), 6 – radial force application unit, 7 – arm and sensor for measuring moment of friction., pos. 5). Two thermocouples (T0 and T7) were installed in the bearing covers (3) in order to provide constant water temperature monitoring at the inflow and outflow of the bearing. The remaining six (T1~T6) were placed in openings distributed radially along the bush circumference in two cross-sections: A-A – water inlet side (T4, T5, T6), B-B – water outlet side (T1, T2, T3). Two sensors (T1 and T4) were placed in the lower part of the bush, and the remaining ones (T2, T3, T5, T6) in the upper part between the lubrication grooves. The openings in the bearing, in which the temperature sensors were placed, were of a depth that allowed the thermocouple tip to be positioned 3 mm under the sliding surface of the bush. Type K thermocouples with an exposed junction of  $\varnothing 0.8$  mm in diameter were employed, allowing, in the opinion of the author, for relatively quick recording of sudden temperature changes, which is especially significant in recording dynamic temperature changes [48].

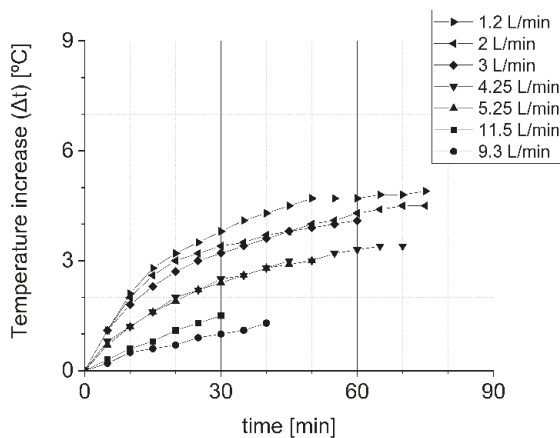
Fig. 4. Temperature increase diagram for bearing with elastic polymer bush. Test conditions: pressure=0.2 MPa, shaft revolution speed =10 rev/s, water flow=1.2~11.5 L/min.

Fig. 4 presents the temperature increase for the bearing operating at the water flow of 11.5 to 1.2 L/min and Fig. 5 presents the results for the bearing operating at the no-water flow condition.

During the operation of the bearing at the water flow intensity of 11.5 to 1.2 L/min, no sudden changes in motion resistance levels were observed, and each of the eight temperature sensors indicated the same rise in temperature. Therefore, the indications of only one sensor are presented and the level of friction torque is omitted (Fig. 4).

It may be noticed in Fig. 4 that the maximum temperature increase was recorded for the water flow of 1.2 L/min, amounting to 5°C after 60 minutes of bearing operation. Additionally it can be observed that the temperatures inside the bearing are stabilising and the bearing unit is moving towards thermal equilibrium.

It would be expected that as the water flow through the bearing increases, the temperature in the bearing decreases. However, in this study, the temperature increase was larger when the water flow was 11.5 than 9.3 L/min. The reason was the fact that the ambient temperature during the test at the water flow 11.5 L/min was 3°C higher than during the remaining tests. This ambient temperature difference played an important role, because the cooling water in the tank had the same temperature as the surroundings.

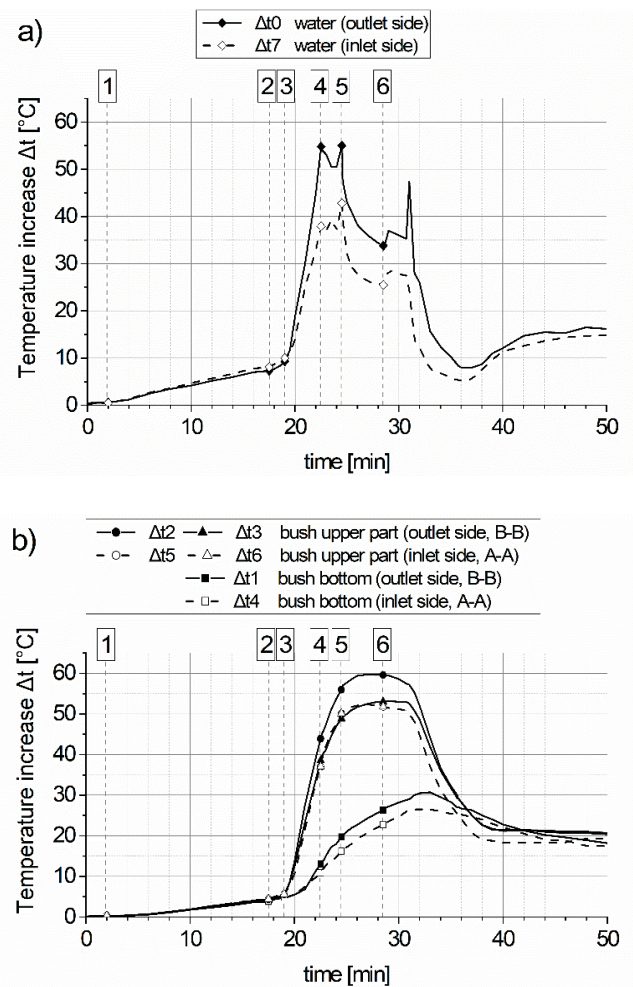
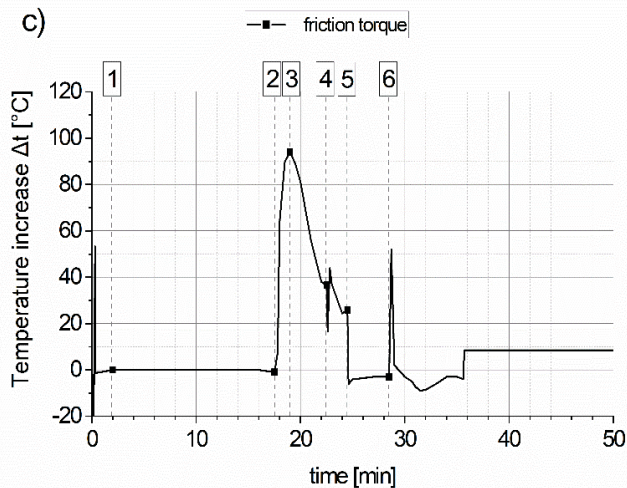
Fig. 5. Temperature and friction torque increase diagrams for bearing with elastic polymer bush. Test conditions: pressure=0.2 MPa, shaft revolution speed =10 rev/s, water flow=0 L/min. a) Water temperature increase diagram, b) Bush temperature increase diagram, c) Friction torque increase diagram, 1 - turning off the water flow, 2 - sudden increase in motion resistance, 3 - limiting shaft revolution speed to 100 rev/s and attempting to turn on the water flow, 4 - another attempt to turn on the water flow, 5 - stopping electric motor, 6 - momentary activation of the electric motor.

During the test conducted at the load of 0.2 MPa and no-water flow, bush damage due to overheating took place (Fig. 5). The presumption of the author was to terminate the test if the temperature in the bearing exceeded 50°C, meaning a temperature increase not greater than 30°C or if a concerning increase in the motion resistance was observed. The results of that test are presented in Fig. 5.

The process of simulating a malfunction was initiated by closing off the water flow through the bearing (1). Shutting off the water flow (1) resulted in a temperature increase of the water and the bush. The water temperatures on the inlet and outlet sides of the bearing were increasing at the same rate, and from the moment of closing the valve they were slightly higher than the bush temperatures (measured 3 mm underneath the sliding surface).

When motion resistance had increased (2), the author decided to continue testing, since the water temperature increased by only 8°C from the simulation start and did not exceed assumed 30°C. In less than two minutes temperature differentiation in the bearing was observed (3) and at this moment the valves were opened, the pump transporting water to the bearing was activated, and the revolution speed of the motor reduced from 10 to 1.7 rev/s (100 rev/min). The motion resistance started to decrease, but unfortunately no-water flow through the bush was observed and the bush and the water temperatures were increasing at a very rapid pace (segment 3-4).

According to the author, the flow of water through the bearing was impossible (3), since there was no clearance between the bush and the journal, and the lubrication grooves were blocked by the melted polymer. Additionally, inlet water temperature sensor did not indicate any inflow of fresh water (lack of temperature drop). Water flow was observed after second attempt at activation of the pump (4), resulting in a momentary drop of the water temperatures. The electric motor was turned off at (5) and turned on for a moment at (6).

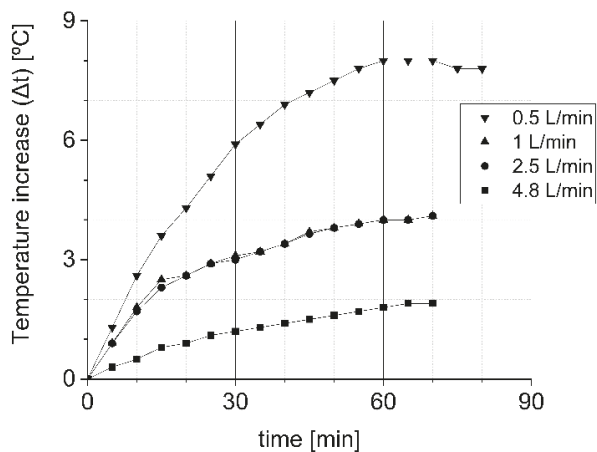
Fig. 7. Temperature increase diagram for bearing with elastic polymer bush. Test conditions: pressure=0.3 MPa, shaft revolution speed =10 rev/s, water flow=0.5~4.8 L/min.

It was decided to start the test for the load of 0.3 MPa at the water flow intensity of approx. 5 L/min (Fig. 7), assuming that at higher intensities the bearing will continue to operate properly for a period of 60 minutes, since the temperature and motion resistance values did not cause concern at low loads (0.2 MPa) and the water flows above zero (Fig. 4).

During the operation of the bearing at the water flow intensity of 4.8 to 0.5 L/min and load of 0.3 MPa, no sudden changes in motion resistance levels were observed, and each of the eight temperature sensors indicated the same rise in temperature. Therefore, the indications of only one sensor are presented and the level of friction torque is omitted (Fig. 7).

Similarly to the test results for the loads of 0.2 MPa, the temperatures inside the bearing are stabilising and the bearing unit is moving towards thermal equilibrium. The maximum temperature increase was recorded for the water flow of 0.5 L/min, amounting to 8°C after 60 minutes of bearing operation.

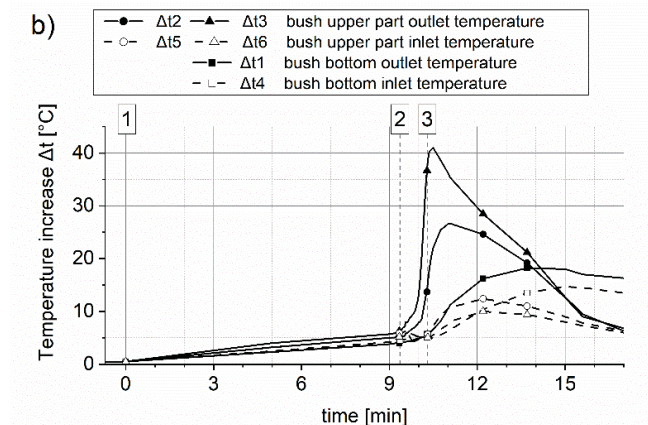
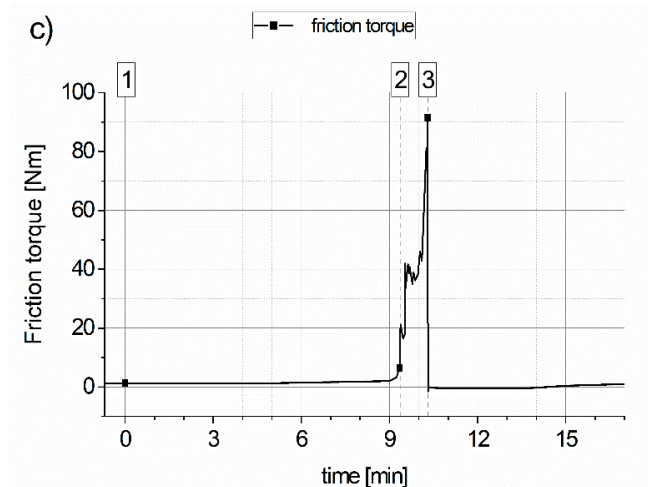
Fig. 8. Temperature and friction torque increase diagrams for bearing with elastic polymer bush. Test conditions: pressure=0.3 MPa, shaft revolution speed =10 rev/s, water flow=0 L/min. a) Water temperature increase diagram, b) Bush temperature increase diagram, c) Friction torque increase diagram, 1 - closing the water flow, 2 - sudden increase in the resistance of motion, 3 - stopping motor's operation.

The results of the test conducted at 0.3 MPa in the conditions of no-water flow are presented in Fig. 8.

Following the closing of the water flow (1), the temperatures of the water and the bush rise at a similar rate. After approx. 9 minutes into the test, a sudden rise in the resistance of motion occurs (2), thus the valves are being opened and the water pump turned on. This resulted in bringing down the temperatures on the inlet side of the bearing ( $\Delta t5$ ,  $\Delta t6$ ,  $\Delta t7$ ), but also in a sudden increase of the temperatures at the outlet ( $\Delta t0$ ,  $\Delta t2$ ,  $\Delta t3$ ). These temperature changes concerns the water and the upper part of the bearing, where lubricating grooves are placed. The outlet temperatures increase is a result of pushing out the hot water from the bearing and it might be additionally affected by water backflow phenomenon [49]. The opening of the fresh water flow did not affect the temperatures at the bottom of the bush ( $\Delta t1$ ,  $\Delta t4$ ), since water mainly flowed through the lubrication grooves.

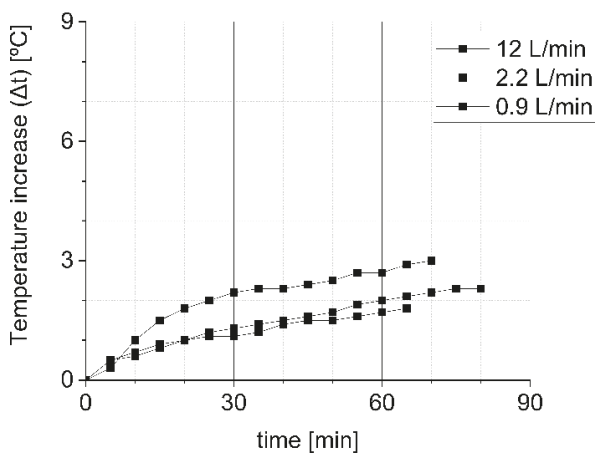
Fig. 9. Temperature increase diagram for bearing with elastic polymer bush. Test conditions: pressure=0.4 MPa, shaft revolution speed =10 rev/s, water flow=0.9-12 L/min.

Taking into account that the radial clearance of the bearing might have been altered in the previous tests, it was decided to verify whether the bearing would be able to work at the load of 0.4 MPa and a flow of 12 L/min (Fig. 9). As it turned out, the bearing was able to operate for the set period of time (60 min) without an excessive temperature increase (2°C). Moreover, the bearing underwent further tests at 2.2 and 0.9 L/min, during which neither sudden changes in the resistance of motion nor large temperature increases were observed for the period of 60 minutes.

The fact is that the temperatures were no longer increasing in a degressive way, which may be symptomatic of temperature instability in the system and the occurrence of mixed friction in the bearing.
