# EXPERIMENTAL RESEARCH ON INSUFFICIENT WATER LUBRICATION OF MARINE STERN TUBE JOURNAL BEARING WITH ELASTIC POLYMER BUSH

Agnieszka Barszczewska  
Gdańsk University of Technology, Poland

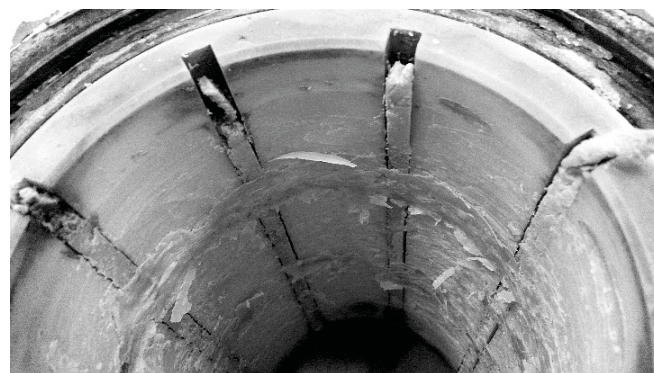
Fig. 1. Elastomer bush melted during the laboratory test. Test conditions: load: 0.2 MPa, speed 10 rev/s, water flow 0 L/min.

When the bearing and the shaft are not capable of transferring out the heat from the friction zone, local contact between the surfaces of the bush and the journal occurs. If water flow is not resumed, seizure and rapid wear of the bush along its entire length occurs [19]. An example of a damaged polymer bush due to limited lubricating water flow is shown in Fig. 1.

The tested bearing was able to work properly for established time at marginal water flows, but probably not without any wear. Both tested bushes had undergone melting and hydrolysis (Fig. 1). The deep cracks in the sliding surface, characteristic of the hydrolysis process, indicates that the bushes had been subjected to the long-term exposure to water at a temperature of at least 50°C. Thus, the process of hydrolytic degradation of the bushes could have already occurred during tests at the water flows greater than 0 L/min.

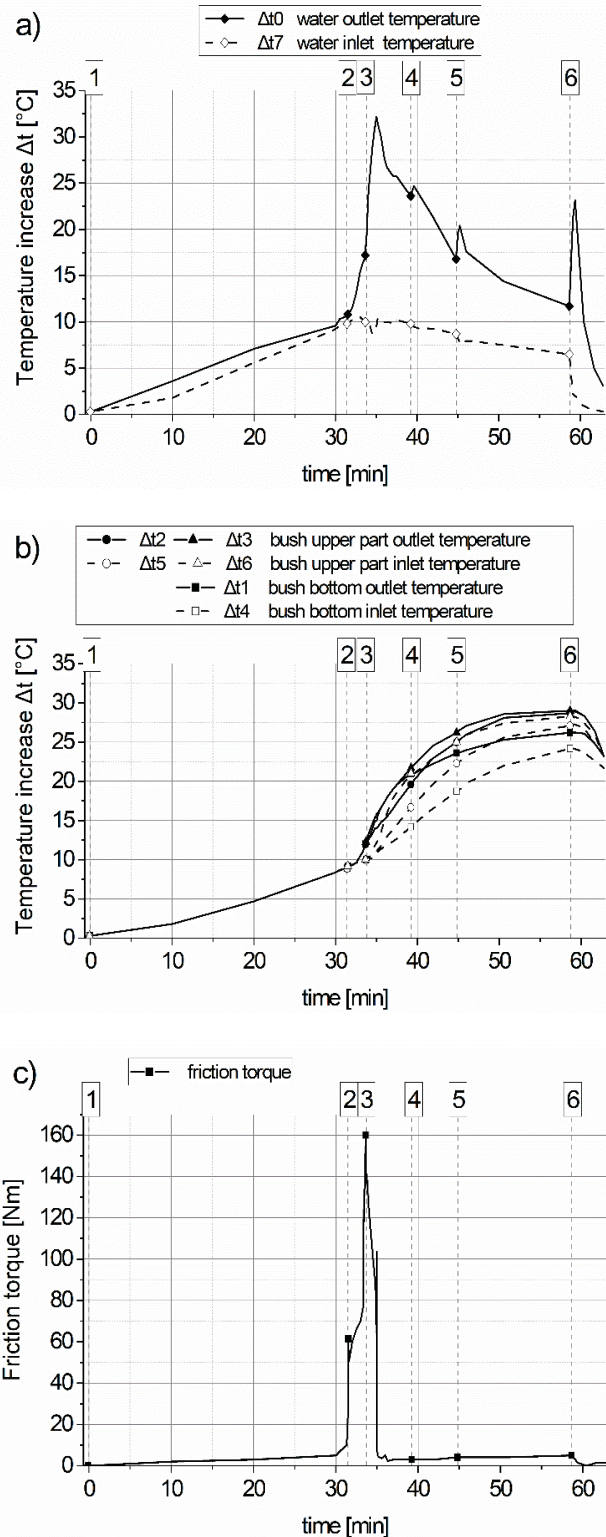
Fig. 10. Temperature and friction torque increase diagrams for bearing with elastic polymer bush. Test conditions: pressure=0.4 MPa, shaft revolution speed =10 rev/s, water flow=0 L/min. a) Water temperature increase diagram, b) Bush temperature increase diagram, c) Friction torque increase diagram, 1 - closing the water flow, 2 - sudden increase in the resistance of motion, turning the pump on, pushing out of the cover sealing by steaming water, 3 - stopping the motor, 4, 5, 6 - attempts at turning the water flow on.

The final test consisted of investigating the bearing's behaviour at loads of 0.4 MPa and conditions of no-water flow (Fig. 10).

From the moment of closing the water flow through the bearing (1) the water temperature was growing faster than the bearing temperature. After 30 minutes of the bearing's operation at 0.4 MPa sudden increase in the resistance of motion was observed (2). At this point, the valves were opened and the water pump was turned on. Just a few seconds later the cover sealing was pushed out (on the outlet side) by steaming water (2). The steaming water began to leak out and, despite activating the pump, no-water flow through the bearing was observed. A moment later the motor was turned off (3). After switching the electric motor off, several attempts were made to activate the water pump (4,5). It was only after about 30

minutes from the moment of pushing the sealing out that the water flow through the bearing finally took place (6).

The test demonstrates that the temperature of the water inside the bearing must have been 100°C, despite the fact that the outlet water temperature sensor indicated only 33°C just a moment before the sealing was pushed out.
