# INFLUENCE OF SOLID PARTICLE CONTAMINATION ON THE WEAR PROCESS IN WATER LUBRICATED MARINE STRUT BEARINGS WITH NBR AND PTFE BUSHES

Ewa Piątkowska

Gdańsk University of Technology, Poland

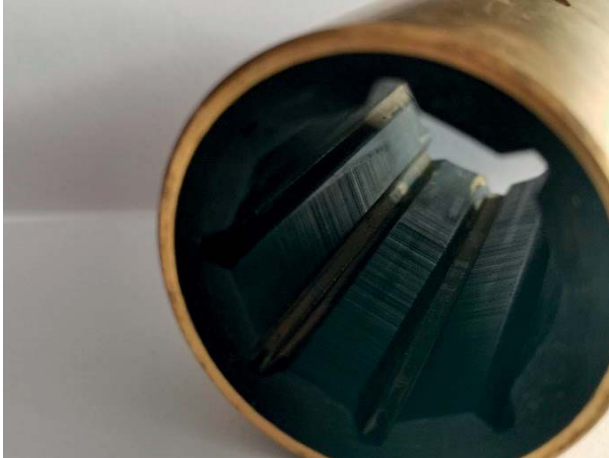
Fig. 4. The NBR sliding bush (C)

The observations were also made for the NBR and PTFE sliding sleeves. The surface condition after cooperation with a steel journal lubricated with water containing solid particles is shown in Figures 4 and 5 for the NBR and PTFE, respectively.

Traces of wear caused by friction are visible on both internal surfaces of the bushings. The circumferential grooves were the result of sand particles getting between the shaft journal and the bush, but deeper grooves were seen in the NBR bush. As for the journals, the rubber bushings had the greatest wear in the middle of the bushing and at the edge of the load application. On the other hand, the wear of the PTFE bushings was evenly distributed over the entire surface of the joint. Inside, there were visible fragmented sand particles embedded in the longitudinal grooves, which could have

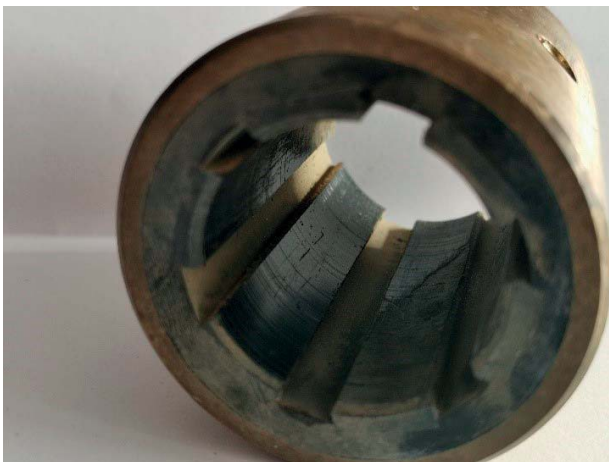
Fig. 5. The PTFE sliding bush (B)

caused detachment the upper layer of the sleeve material, as shown in Figure 5.
