Contemporary Architectural Design in the Context of Historic Remains: The Case of the Old City of Gdańsk

A. Taraszkievicz, K. Grębowski, K. Taraszkievicz & J. Przewłócki

To cite this article: A. Taraszkievicz, K. Grębowski, K. Taraszkievicz & J. Przewłócki (2021) Contemporary Architectural Design in the Context of Historic Remains: The Case of the Old City of Gdańsk, *Heritage & Society*, 14:1, 1-19, DOI: [10.1080/2159032X.2021.2016051](https://doi.org/10.1080/2159032X.2021.2016051)

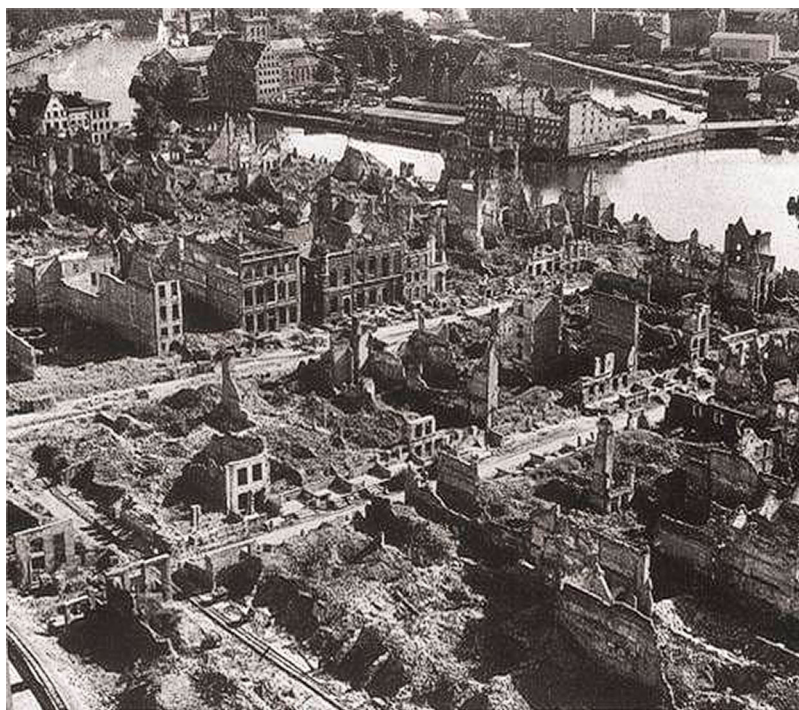
Figure 1. Photograph of damage in Gdańsk after the Second World War. Source: (Cieślak and Biernat 1994)

buildings that might be found on-site. These problems are at their most acute in cities which have suffered significant war damage. Such cities include Gdańsk, where the destruction of buildings in the city center during World War II reached almost 90% (Figure 1).

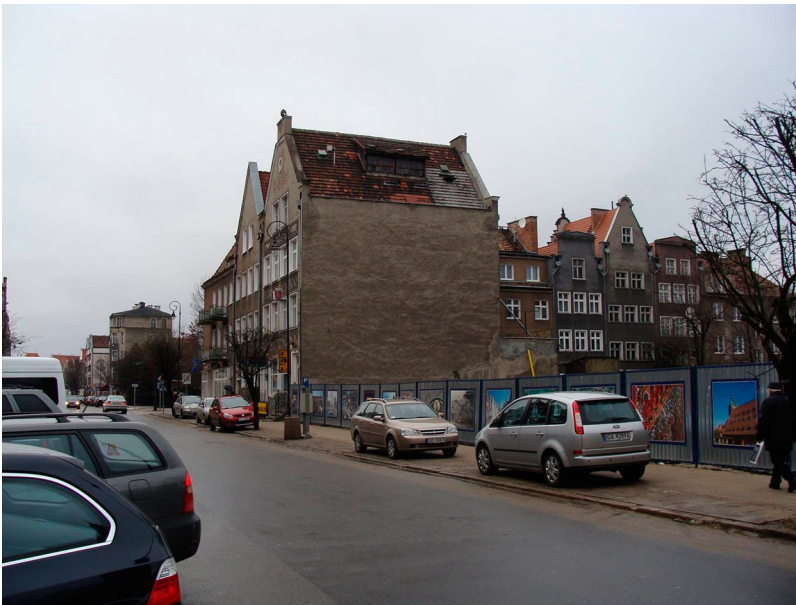
Figure 3. View of the site before the construction of the block. Source: photo by A. Taraszkiewicz, 2010

Despite its extremely prestigious location, the area, degraded by war damage, had been for decades an unpleasant “hole” in the sequence of buildings, waiting for proper use and development, commensurate with its rank in the urban structure (Figure 3). Design work on the complex of new buildings took place in an atmosphere of fairly calm but important debates between the historic monument protection authorities, architects and the public. Community organisations representing the residents saw the new buildings as a reconstruction of pre-war buildings. Following the principles of the Venice Charter, due to the lack of original iconography, the conservation authorities were inclined towards a modern design, with the scale and character of the new building made to fit with the historical context of the place. The architects shared the position of

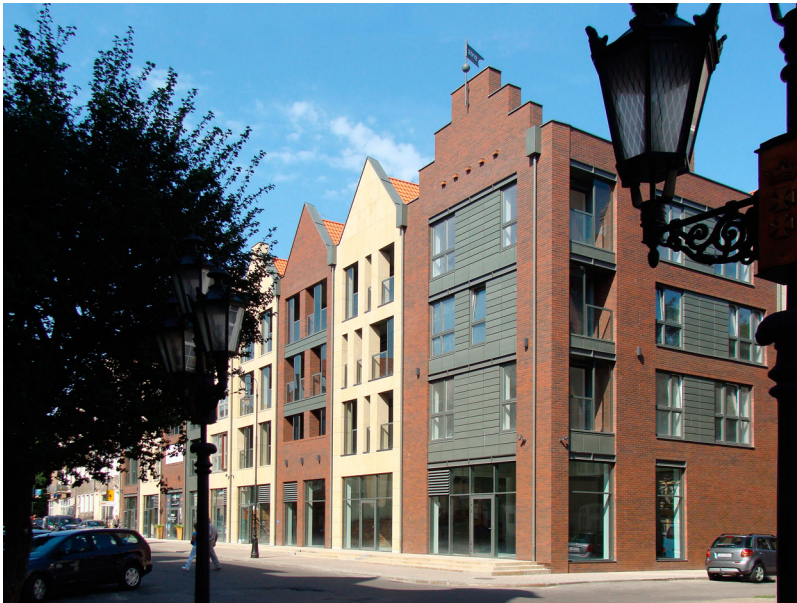
Figure 4. Block of buildings on Szeroka Street, Gdańsk. View after completion. Source: photo by A. Taraszewicz, 2012.

The design of the block refers explicitly to the historical buildings in Gdańsk, but at the same time, it is thoroughly contemporary, with historical references incorporated as neither direct transfers nor borrowings. The contemporary expression of this architecture is determined by the façade expression which is typically modern, drawing on the achievements of the international style, “fresh” architectural details (e.g., minimalist beams or lintels made of rolled c channels) and modern building materials and technologies, e.g., zinc-titanium sheet metal used as façade material (Figure 4).

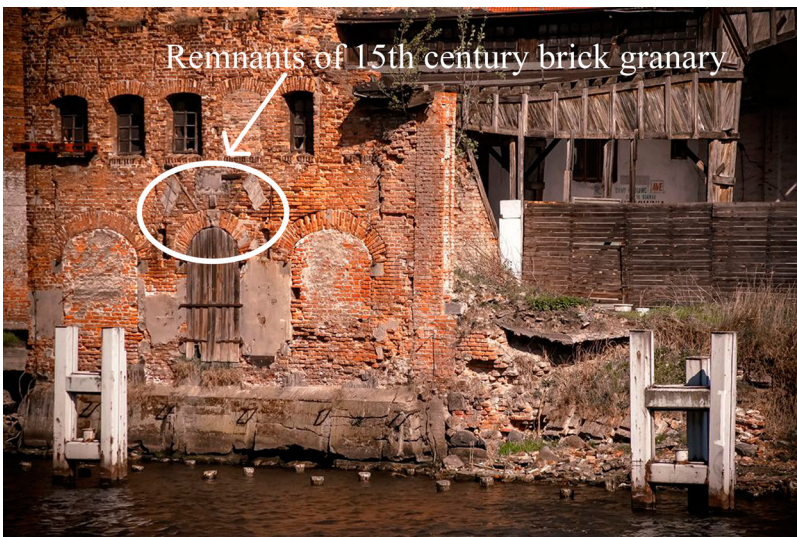
Figure 6. Ruins of the granary Woli Łeb on Wyspa Spichrzów. Source: A. Taraszkiewicz, own materials, 2020

Among the many ruins of granaries found in this area, one of the more interesting was the fifteenth century brick granary known as *Woli Łeb* (Ox's Head). After the war, only part of the front façade survived, decorated with a stone-carved coat of arms (Ox's Head), flags and a cartouche with the Latin inscription, "As it was the Winterfelds' duty to their unknown successors, the monument from the ruins was raised and restored in 1759" (Figure 6).

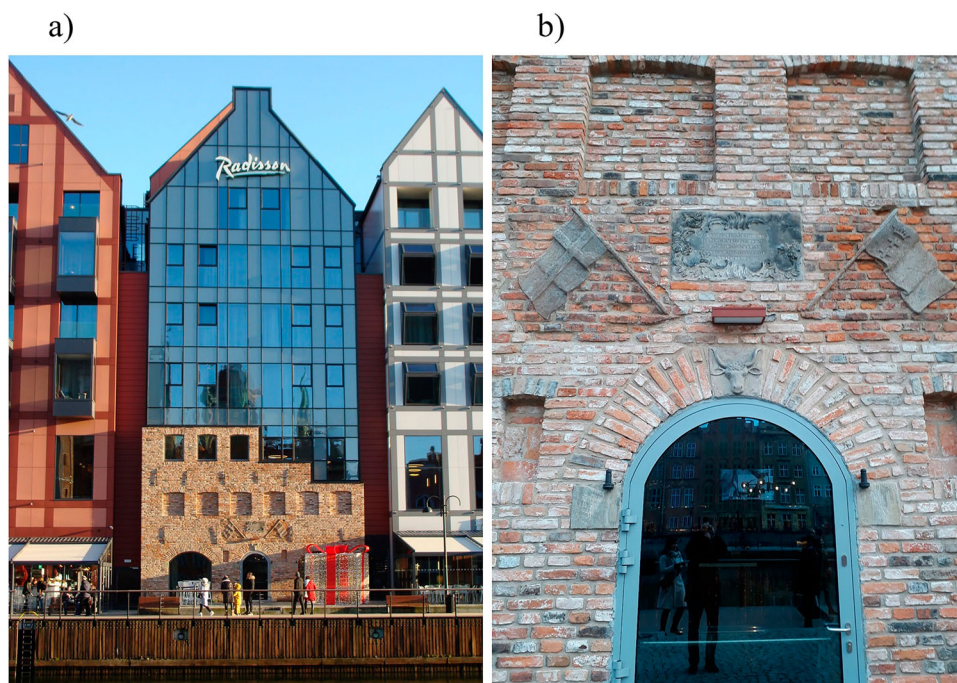
Figure 7. a) Front façade of the Woli Łab granary on Wyspa Spichrzów, Gdańsk, b) Close-up of the relief of the flags and the cartouche. Source: A. Taraszkiewicz, own materials, 2020

Due to its poor technical condition and weak foundations which could not bear the weight of the superstructure planned in the modern design, comparable to the original dimensions of the granary, a rather controversial decision was made to completely dismantle the historical building, a decision to a large extent contrary to the Venice Charter guidelines. Dismantled and inventoried, brick and stone elements and architectural details underwent conservation and were then rebuilt in their original location on a solid, reinforced concrete foundation. Rebuilt in this way, the façade wall could now take the weight of the contemporary five-storey glazed superstructure designed in the aluminium post and beam façade technology. The preserved coat of arms, relief with the flags and the cartouche with the inscription (Figure 7a, b) were set in the axis of the façade, above the entrance on the ground floor.

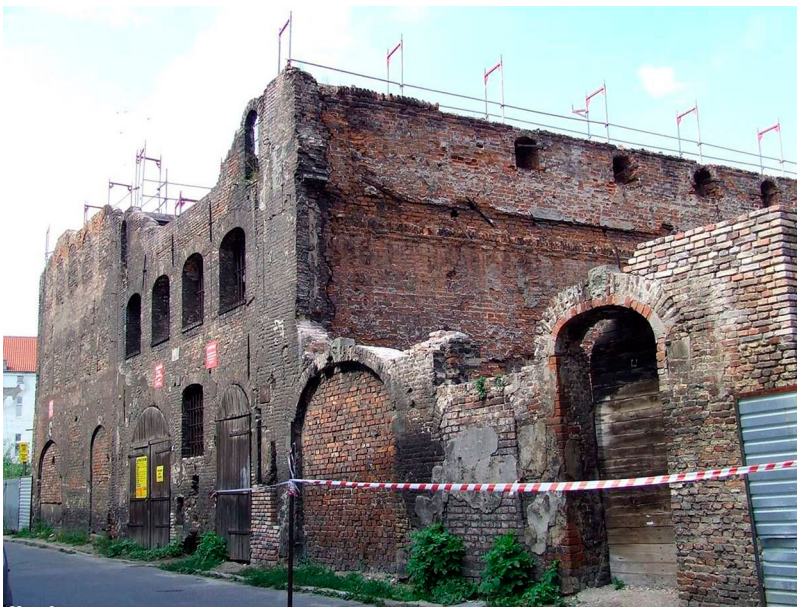
Figure 8. Remnants of the granaries on Żytnia Street. Source: photo. A. Taraszkiewicz, 2007

“Czarny Kogut” (Black Rooster), “Arka Noego” (Noah’s Ark) and “Kuznia” (Smithy) – into the massing, and adapt them to the contemporary function (Figure 8). The way this problem was solved became the main determinant of all the design efforts made in this project.

The historical brick walls were to be dried, cleaned of mould and undergo conservation without complete or even partial dismantling. To avoid burdening the existing remnants of the granaries with the superstructure, reinforced concrete piles and rafter plates (Figure 9) were designed, placed along the walls of the granaries but at a certain distance away from them. All newly designed storeys of the building, rising above the brick remnants, were supported on this new structure. Steel trimmers were placed at the level of the foundations, between the reinforced concrete piles, to strengthen and stabilise the foundations of the granaries which had already been weakened over time.

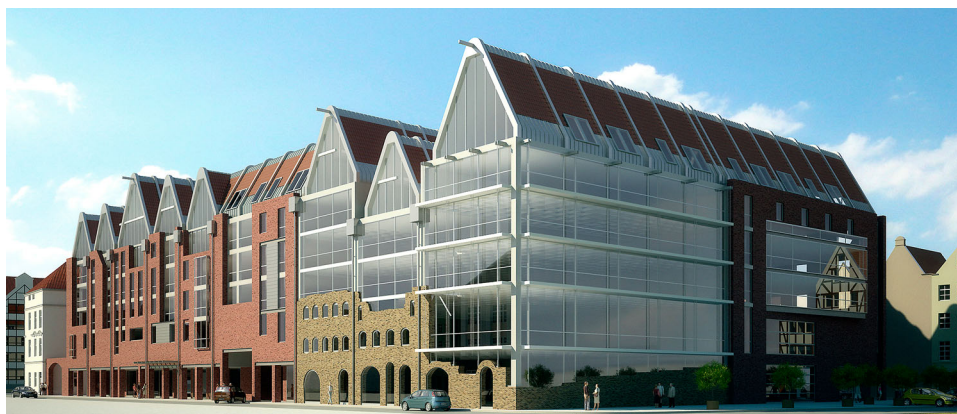
Figure 9. Buildings in the block of Żytnia, Chmielna, Spichrzowa Streets, Gdańsk, computer visualisation. Source: FORT Taraszkiewicz Architekci Sp. z o.o., 2007

In the spirit of the Venice Charter, steps were taken to contrast the historical buildings with contemporary structures. A solution such as this, applied nowadays in many highly developed countries, even to historical buildings of the highest value (De la Torre 2013), seemed to be best suited to this particular case. A strong contrast between what is historical and what is contemporary makes it possible to better highlight the valuable remnants and, at the same time, by emphasising the stylistic and technological differences

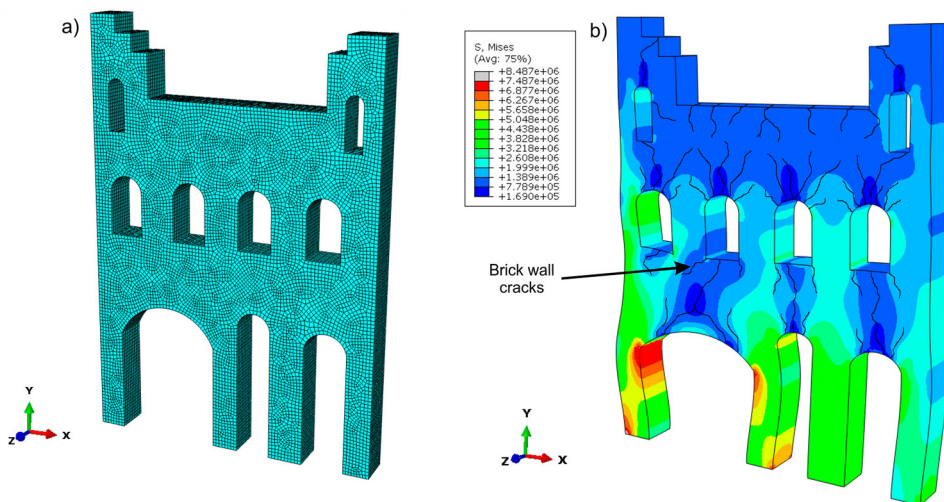
A numerical model of the brick granary walls was developed using the ABAQUS software in order to determine their durability (Figure 10a). The analysis was conducted on a 3D model of a brick wall with dimensions of 850×1200 cm and a thickness equal to 120

Figure 10. a) Numerical model of the brick wall, b) Compression stresses map of brick walls. Source: K. Grębowski, own study, 2020

cm. The wall was divided into 856,898 eight-node cubic solid elements of reduced integration with the linear shape function of the C3D8R type with the total number of nodes equal to 1,287,576. The calculations were carried out for several finite element mesh sizes. The greatest convergence was obtained for the mesh with a 10 mm size (ABAQUS 2013). The overburden load equivalent to the superstructure acting on the existing masonry wall was equal to 185 kN/m^2 . This load was cinematically modeled in the form of equal vertical nodes displacement in the upper element surface. The model took into account the plastic-degradation model of the brick wall with the following parameters: Young's modulus $E = 2600 \text{ MPa}$, Poisson's ratio $\nu = 0.167$, density $\rho = 2000 \text{ kg/m}^3$, dilatation angle $\Psi = 16^\circ$, eccentricity $e = 0.07$, biaxial/uniaxial compression plastic strain ratio: 1.16, shape factor $k_c = 0.667$, viscosity: 0.001, stress $\sigma_c = 8.42 \text{ MPa}$ in elastic strain $\varepsilon = 0.009931$, compressive degradation $d_c = 0.99$ in elastic strain $\varepsilon = 0.009931$, stress $\sigma_t = 0.848 \text{ MPa}$ in crushing strain $\varepsilon_c = 0.00527$, tensile degradation $d_t = 0.97$ in crushing strain $\varepsilon_c = 0.00527$ (FORT, 2007) [30]. The current condition of the brick element was also taken into account by reducing the longitudinal modulus of the elasticity value of the brick. The results obtained during the numerical analysis are presented in Figure 10b in the form of stress maps. It can be seen in this figure that the existing wall fragments are unable to transfer the load of the design's superstructure.

how the granaries on Żytnia Street in Gdańsk were constructed. Based on the obtained results, it was found that the maximum compressive stress $\sigma_{\max} = 8.42$ MPa exceeded the limit of $\sigma_c = 8.12$ MPa, which led to exceeding the ultimate limit state. Compressive stresses resulted in cracks in the wall structure and ultimately its total failure. As a result of the cracks and weakening of the structure, the maximum vertical displacement $u_{\max} = 12.5$ cm exceeded the limit value equal to $u_{gr} = 2.1$ cm, which resulted in exceeding the serviceability limit state (Figure 10b).

With regard to the obtained results, it was concluded that the planned superstructure of the newly designed development cannot in any way be based on the medieval wall (ABAQUS 2013). A reinforcement in the form of a supplementary foundation structure was designed in order to avoid applying load to the existing granary remains (Figure 11a). The brick wall was based on a wide reinforced concrete foundation in the form of a pile cap which itself was based on foundation piles. A steel beam of IPE 300 section was designed to be fitted between the wall and the piles on the pile cap level in order to equally transfer the load to each pair of reinforced concrete piles (Figure 11b). All of the newly designed building storeys at a distance from the brick wall were based on the pile cap structure.

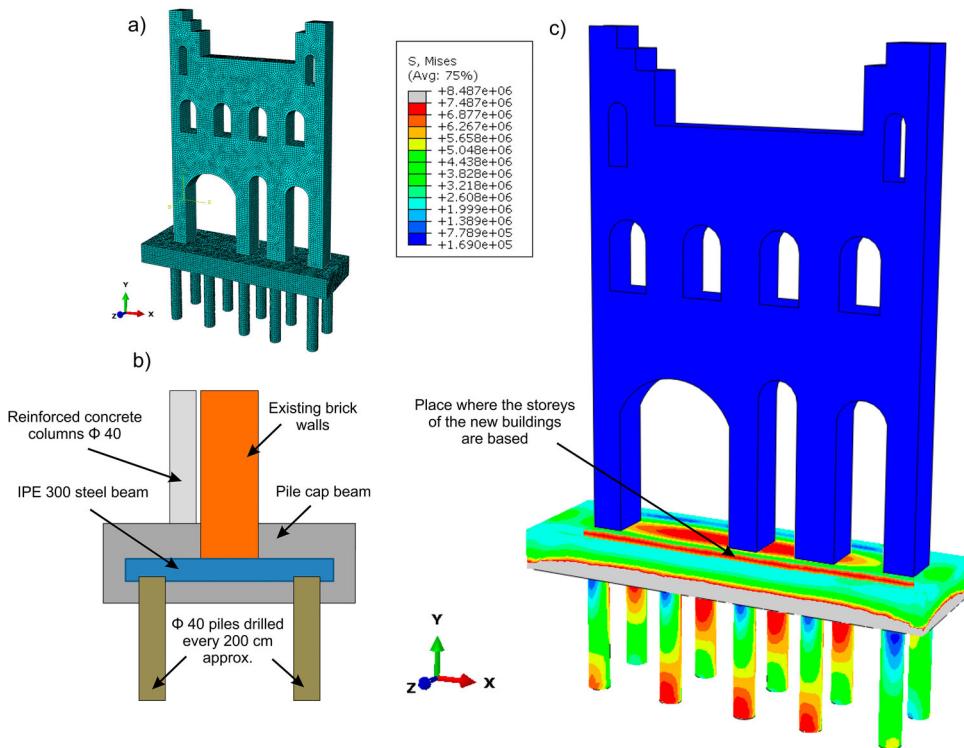
Figure 11. a) Numerical model of the brick wall with the supplementary foundation structure, b) Diagram of the brick wall reinforcement, c) Compression stresses map of brick walls

The numerical model of the brick wall with the reinforcement was performed similarly to the model of the wall without the reinforcement. The initial model was updated with the elements of the supplementary foundation structure. The load was applied to the reinforced concrete pile cap in place of the newly designed building walls setting. The results obtained during the numerical analysis in the form of stress maps are presented in Figure 11c.

A significant horizontal line of stress concentration is visible on the stress map in the place where the new wall is based on the pile cap. As a result, no other stress aside from the dead-load is acting on the brick wall of the granary remains. On the basis of the obtained results, it was concluded that applying the supplementary foundation structure will be safe by basing the walls of the newly designed building on the reinforced concrete pile cap without any interference with the medieval brick structure. The requirements of the ultimate limit state and the serviceability limit state were fully met.
