Properties of Old Concrete Built in the Former Leipziger Palace

Abstract: This research aims to determine the mechanical, chemical, and physical properties of old concrete used in the former Leipziger Palace in Wrocław, Poland. The cylindrical specimens were taken from the basement concrete walls using a concrete core borehole diamond drill machine. The determination of the durability and strength of old concrete was based on specified chosen properties of the old concrete obtained through the following set of tests: measurements of dry density, tests of water absorption, specification of concrete compressive strength and frost resistance, determination of the modulus of elasticity, measurement of the pH value, determination of water-soluble chloride salts and sulphate ions, and X-ray diffraction analyses. Large dispersions of the compressive strength (10.4 MPa to 34.2 MPa), density (2049 kg/m³ to 2205 kg/m³), water absorption (4.72% to 6.55%), and stabilized secant modulus of elasticity (15.25 GPa to 19.96 GPa) were observed. The paper is intended to provide scientists, civil engineers, and designers with guidelines for examining and assessing the long-term durability of old conc

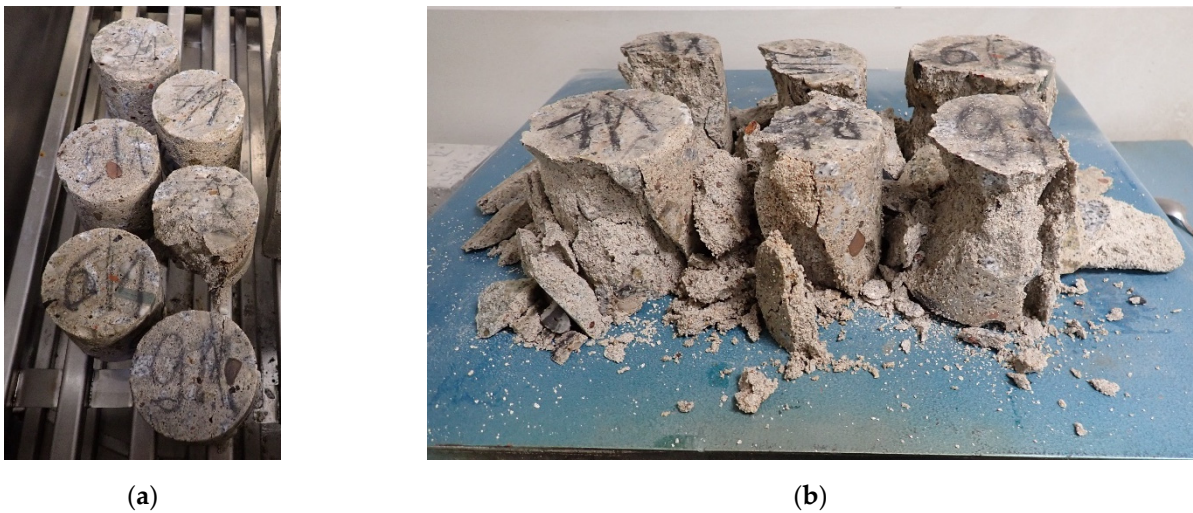
Cylindrical samples were subjected to 50 freezer cycles consisting of freezing at -18 ± 2 °C for 4 h and thawing by total immersion in water at 18 ± 2 °C for 4 h. After 50 freezer cycles (see Figure 7a), the compressive strength tests were performed (see Figure 7b). The compressive strength of the old concrete after 50 freezer cycles varied from 1.7 MPa to 16.1 MPa. The mean value of the compressive strength after 50 freezer cycles was 10.4 ± 2.2 MPa, while the median was 12.1 MPa (see Figure 8). The value of the mean compressive strength after 50 freezer cycles was about 47% lower than the compressive strength of the base samples ($f_{m, is} = 19.7$ MPa). Additionally, two cores showed cracks and visible loosening parts in the concrete from samples (see Figure 7a). The difference between compressive strength, before and after 50 freezer cycles, was considerably higher than 20%, and cracks appeared on the old concrete cores. Therefore, according to PN-B-06250 [60], the old concrete did not have freezing resistance properties.

Figure 7. Frost resistance tests: (a) view of concrete specimens inside the freezing chamber after tests; (b) view of a form of failure concrete specimens.

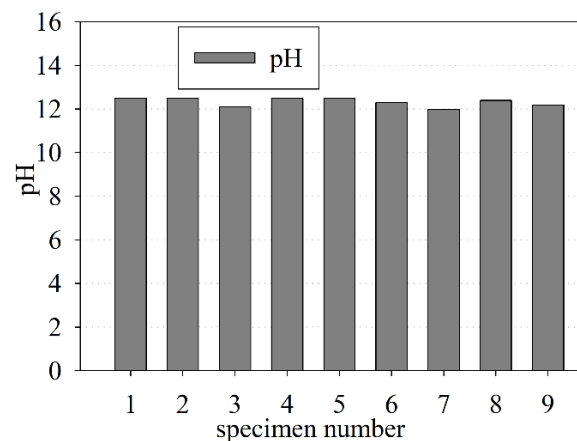
The pH value is an important factor that influences the corrosion rate of reinforcement [75,76]. Freshly made concrete has a pH value that varies from 12.5 to 13.5 [77], while the corrosion of reinforcement generally occurs when the pH value is less than 9 [78]. Under the laboratory tests for the old concrete samples, it was determined that the mean value of the pH was 12.33 ± 0.06 , while the median was 12.40. The pH values for the old concrete ranged from 12.00 to 12.50 (see Figure 10). The pH of the old concrete was in the safety range. One of the concrete cores (which was not subjected to strength tests) included a flat bar-shaped reinforcement, which was in a very good condition, which confirms the results obtained for the safe pH value.

Figure 10. The pH value of the old concrete.
