# A Visual Method of Measuring Railway-Track Weed Infestation Level

**Abstract:** This paper concerns the assessment of railway track surface conditions in relation to the degree of weed infestation. The paper conceptually describes the proposed method using a visual system to analyse weed infestation level. The use of image analysis software for weed detection is also proposed. This new measurement method allows for a mobile assessment of the track's weed infestation status. Validation of the assessment method in real conditions will allow for further expansion of the system using new shades of green from the RAL palette, and will take into account a more extensive and detailed assessment of weed infestation on the track in accordance with applicable railway regulations.

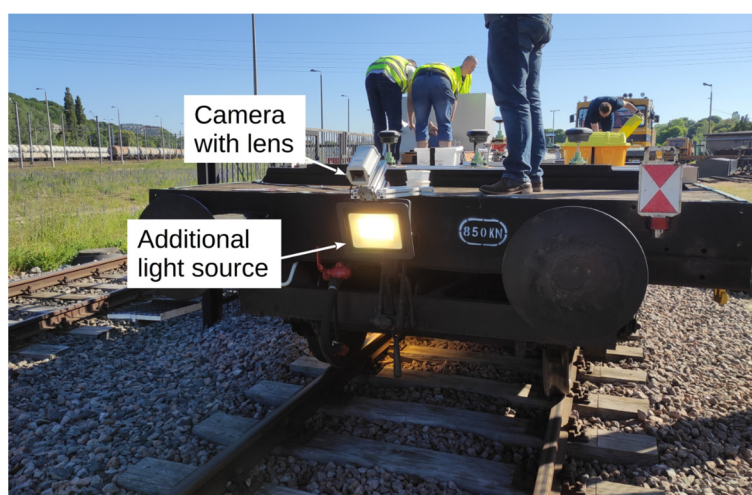
**Figure 2.** Measuring equipment mounted on the flatcar (phot. J. Szmaglinski).

To verify the assumptions of the proposed method, measurements were taken from selected railway line segments which included fragments with different track superstructure weed infestation levels. The measurements were performed in the areas without vegetation and in those where vegetation occurred abundantly. The video camera used for image recording was mounted at the end of the flatcar so that the recorded image covered the entire area of the railway track superstructure. An additional light source was mounted next to the camera to facilitate recording images when the measuring flatcar passed through lower visibility areas, tunnels for instance. A view of the flatcar with the mounted equipment is shown in Figure 2.

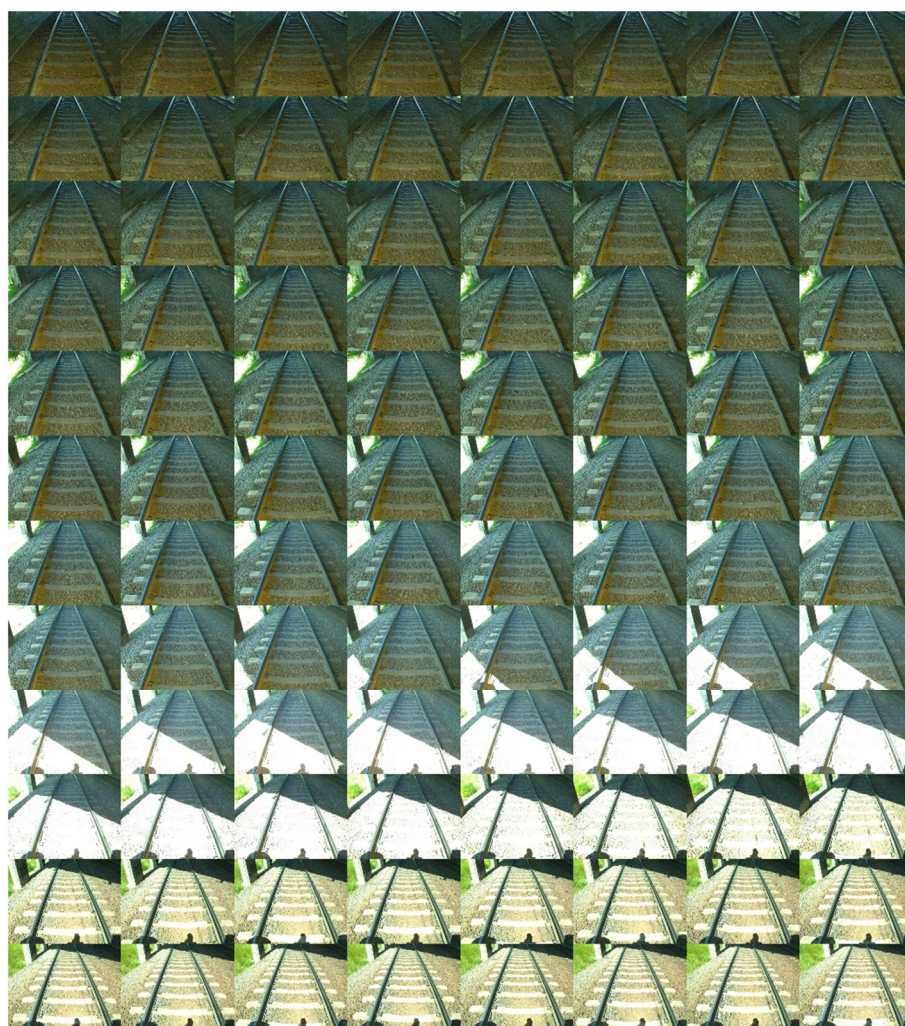
Figure 3 shows the sequence of 96 frames (approx. 2.5 s) recorded while leaving a viaduct under full sunlight. With the use of additional lighting, camera blindness lasted only about 0.3 s (15 frames), so short that it was not a problem for the railway track weed infestation level measuring procedure.

**Figure 3.** Reducing of camera glare effect by using an additional light source.

Weed is rare in tunnels, so the main purpose of using an additional light source was not to illuminate these places for measurement purposes. Additional lighting reduces the effect of camera glare when leaving a darkened area. Because the camera applies automatic selection of exposure parameters, thanks to the additional lighting less time was needed to automatically adjust the recording parameters to meet the changing lighting conditions. It also influenced the possibility of correct level of weed infestation measurement, making such measurement possible immediately after leaving a tunnel, for example. The effect of reducing camera glare is shown in Figure 3.

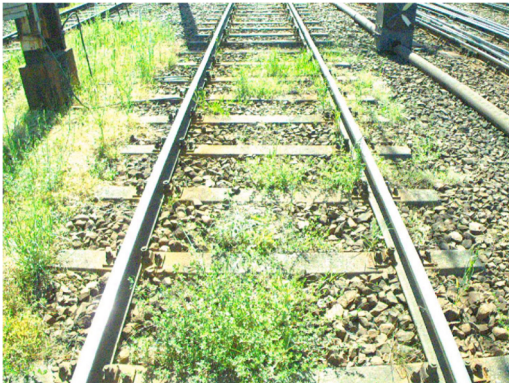
**Table 1.** Image analysis stages of unwanted vegetation detection on railway track.

Source image
II

Comparing with standard of green   129 matches
IV

254 matches in total. The result of the measurement testifies to track superstructure infestation with unwanted vegetation.

As shown in Table 1, the method was successful in detecting unwanted vegetation in the area of the railway track superstructure. The infested areas were detected, and the number of matches indicates the weed infestation intensity in the track superstructure area.
