Communication

A Visual Method of Measuring Railway-Track Weed Infestation Level

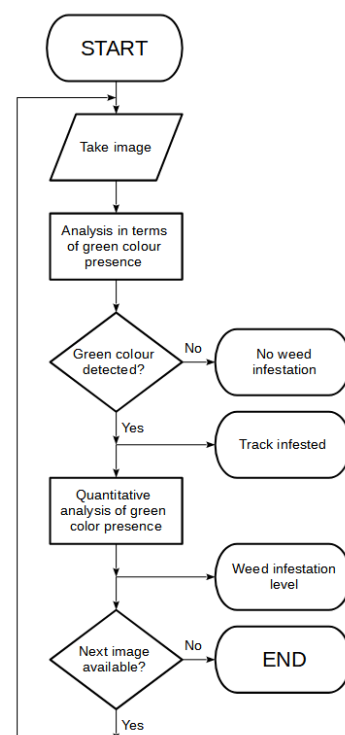
Figure 1. Block diagram of the algorithm measuring the track superstructure weed infestation level.

It is noteworthy that the proposed measurement method can only be applied in the plant vegetation period, i.e., between May and October in the temperate zone in the northern hemisphere. The presence of green colour is a qualitative signal of the occurrence of unwanted vegetation. Determining what percentage of the recorded image is marked green, or how many elements in the image are green, gives the quantitative assessment of the track superstructure weed infestation level. The block diagram of the measurement algorithm is shown in Figure 1.

At first, the recorded frame was cut so that the image contained only the surface area of the railway track. Then the photo was analysed for the presence of green colour. Since individual species of flora may differ greatly by shades of green, it is advisable to perform colour analysis for a number of basic shades. In practice, it turned out sufficient to repeat this analysis three times: for light, normal, and dark shades of green. The detection of green colour showed that weeds were present on the railway track at the place of measurement. The next step in the analysis was the quantification of weed infestation level based on the number of matches to the pattern. The results of the analysis were directly proportional to the area contaminated with undesirable vegetation. The algorithm was performed cyclically for all recorded images.

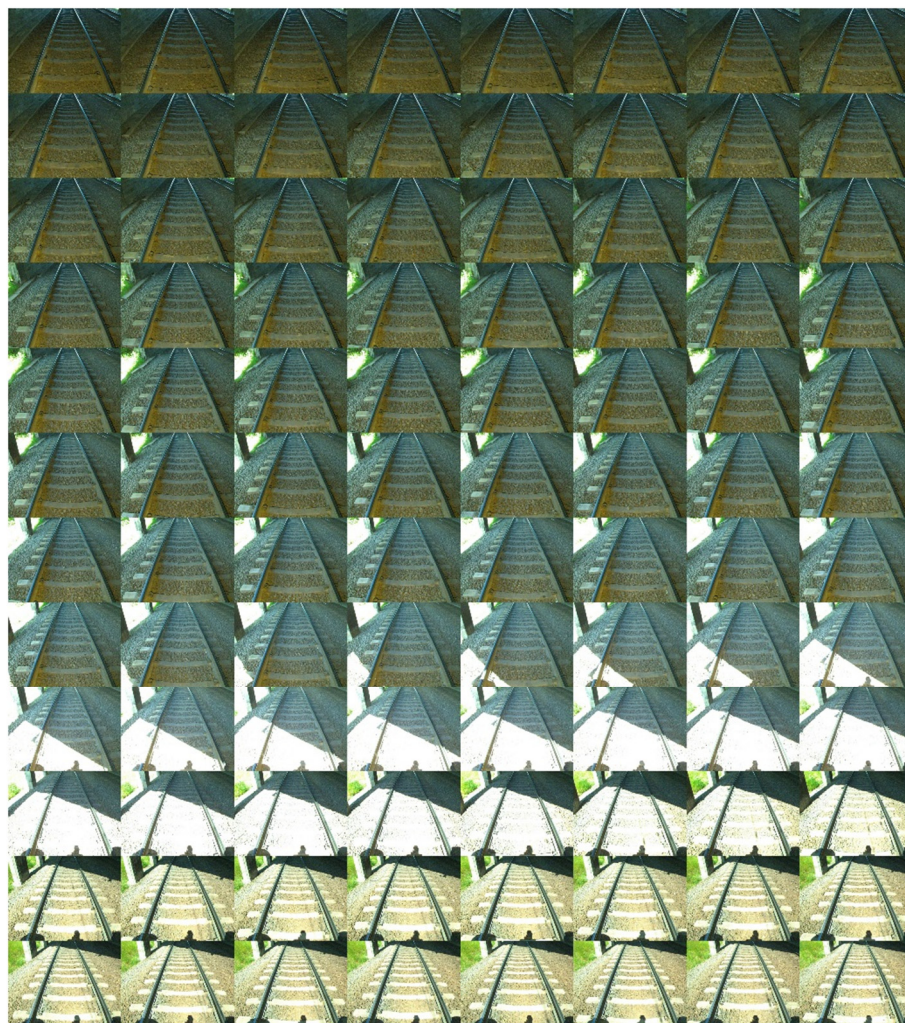
Figure 3. Reducing of camera glare effect by using an additional light source.

Weed is rare in tunnels, so the main purpose of using an additional light source was not to illuminate these places for measurement purposes. Additional lighting reduces the effect of camera glare when leaving a darkened area. Because the camera applies automatic selection of exposure parameters, thanks to the additional lighting less time was needed to automatically adjust the recording parameters to meet the changing lighting conditions. It also influenced the possibility of correct level of weed infestation measurement, making such measurement possible immediately after leaving a tunnel, for example. The effect of reducing camera glare is shown in Figure 3.

Figure 3 shows the sequence of 96 frames (approx. 2.5 s) recorded while leaving a viaduct under full sunlight. With the use of additional lighting, camera blindness lasted only about 0.3 s (15 frames), so short that it was not a problem for the railway track weed infestation level measuring procedure.

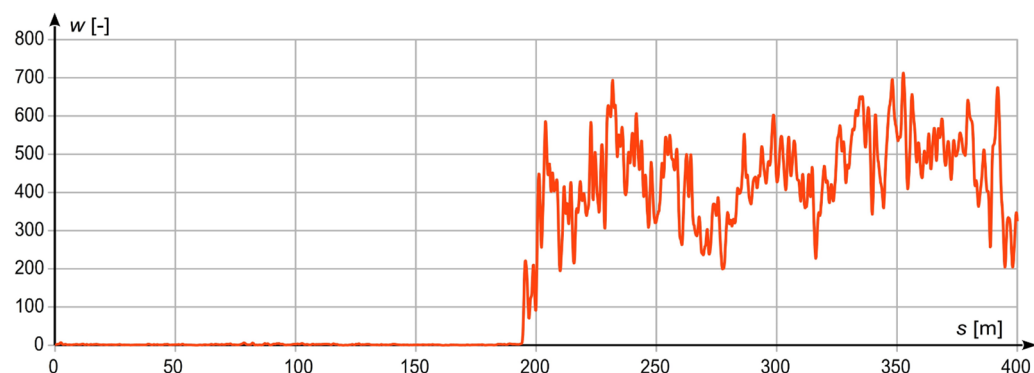
Figure 4. Assessment of the area with unwanted vegetation—case 1.

Case 1, shown in Figure 4, illustrates the measurements taken when passing from a well-maintained section of railway to one with considerable weed infestation. When the measuring flatcar moved through the section without unwanted vegetation, the measurement signal w revealed minor oscillations about zero. After entering the infested section, the signal w increased to an average value of about 500, which testifies to a high level of railway track weed infestation.

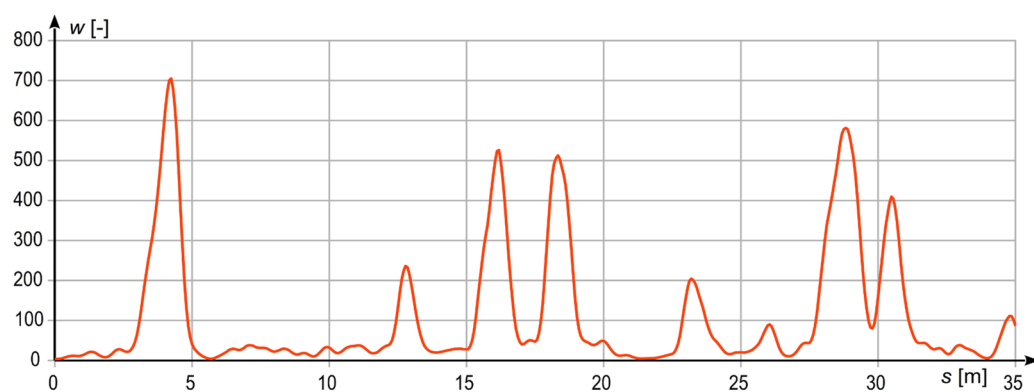
Figure 5. Assessment of the area with unwanted vegetation—case 2.

Case 2, shown in Figure 5, represents a short railway track fragment characterised by moderate maintenance levels and the occurrence of isolated spots of high weed infestation. The signal w changed value from 20–30 up to as much as 700 in the most infested places.

Despite the abovementioned minor drawback, the presented results confirm high usability of the system for assessing railway-track weed infestation level. The results shown in Figure 5, especially, reveal the system's great potential for assessing places of unwanted vegetation occurrence in both qualitative and quantitative terms. Based on the level of signal w , the intensity of required sprayings can be assessed for a given area, which will enable control of the emission of harmful substances into the environment, decreasing application levels to the minimum required to remove unwanted vegetation from the railway track superstructure.
