Article

Influence of a Lighting Column in the Working Width of a W-Beam Barrier on TB51 Crash Test

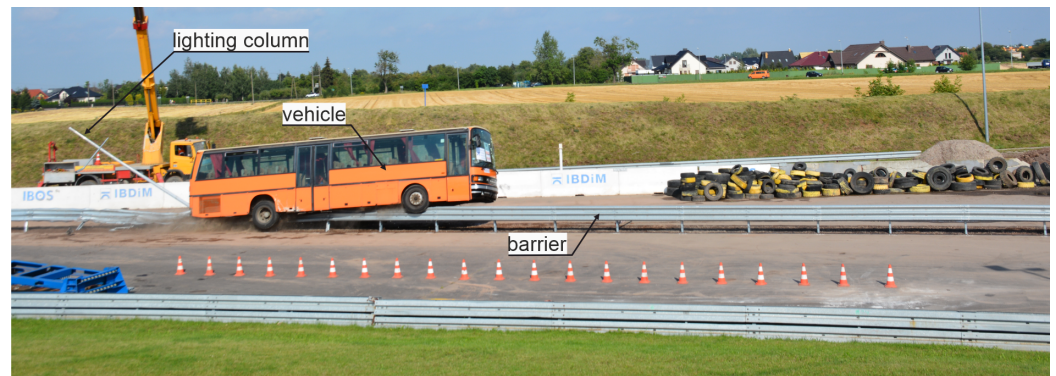
Figure 1. Exemplary view of the bus during the analyzed crash test.

This study analyzes the effect of the installation of a lighting column in the working width of a W-beam RSB on the results of the TB51 crash test, as in Figure 1. This research is important as it will shed light onto the mechanisms and interactions that occur in the barrier–column–vehicle system during an accident. This will allow the verification of whether two road safety devices that are safe separately will also work together to achieve an appropriate level of safety. The TB51 crash test was selected as it involves a 13-tonne bus, which can inflict serious damage to the barrier during the impact. Moreover, this particular impact can have extremely tragic consequences, as there may be many fatalities and seriously injured persons. The W-beam barrier was chosen as it is one of the most frequently used types of barriers on roads in the EU. That barrier successfully passed full-scale crash tests according to EN 1317 [14]; hence, it has appropriate certificates for use on European roads. Similarly, the lighting column was positively tested in accordance with the EN 12767 standard [32]. However, the tests for both systems were conducted separately. Hence, the research aimed to evaluate the safety of the combination of those two road safety systems: the W-beam barrier and the lighting column. The other objectives of this study were as follows:

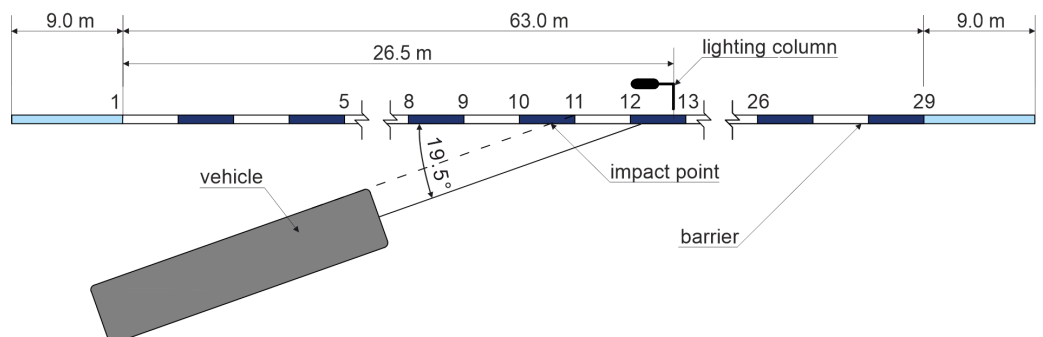
Figure 2. Scheme of the test setup.

The full-scale crash test was conducted on 10 August 2017 at the testing grounds of the Research Institute for Protective Systems (IBOS) [33]. The experiment was carried out by the Research Institute for Roads and Bridges (IBDiM) [34]. This institute is certified by the Polish Center for Accreditation to, among others, perform crash tests according to the EN1317 standard [14]. The setup of the test is presented in Figure 2. The total length of the system was 81 m, where there was 63 m of straight section and 9 m at each end of the barrier.

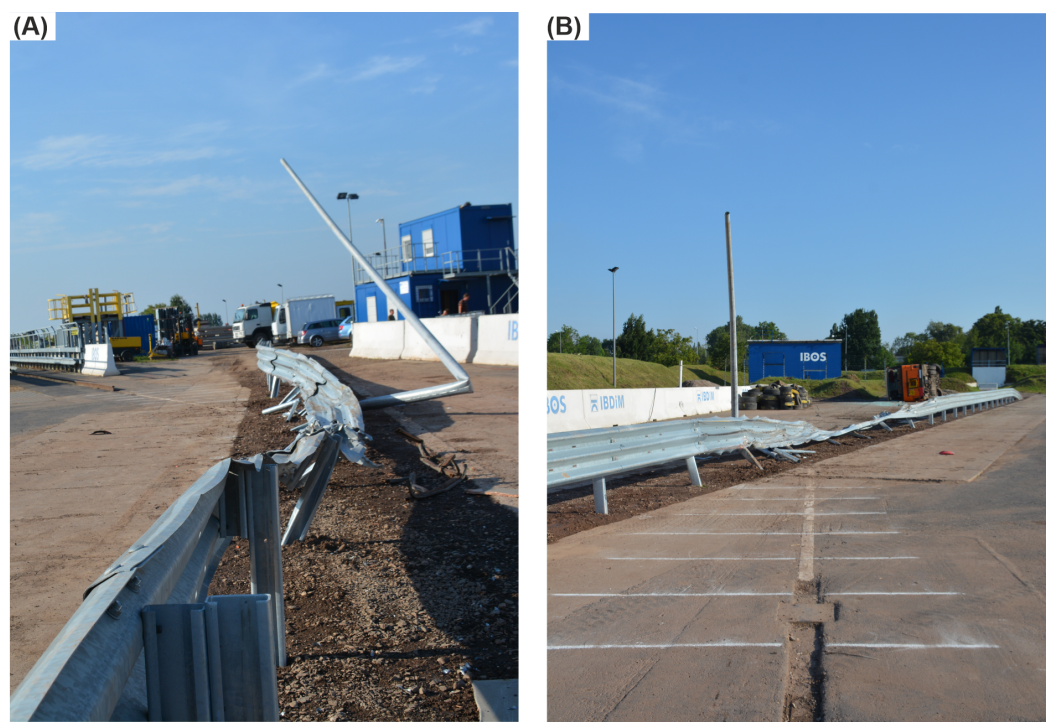
Figure 8. Test site after the collision with (A) a view from behind the barrier on the vehicle approach track and (B) a view from the approach track on the impact point.

The impact speed of the bus in the full-scale crash test was 73.2 km/h, and the angle equaled 19.5° , thus generating the vehicle's kinetic energy of 298.7 kJ. During the experiment, the vehicle hit the barrier 10 cm before the post No. 11 and remained in contact with the guardrail. After passing the post No. 14, the bus ran over the barrier and rode along the barrier's top up to the post No. 16. After reaching this post, the bus left the barrier on the side opposite to the in-run. At the height of the Post 29, the vehicle overturned to its left side, which can be seen in Figure 8B. In addition, damage to the protective system and the lighting column is presented in Figure 8A.

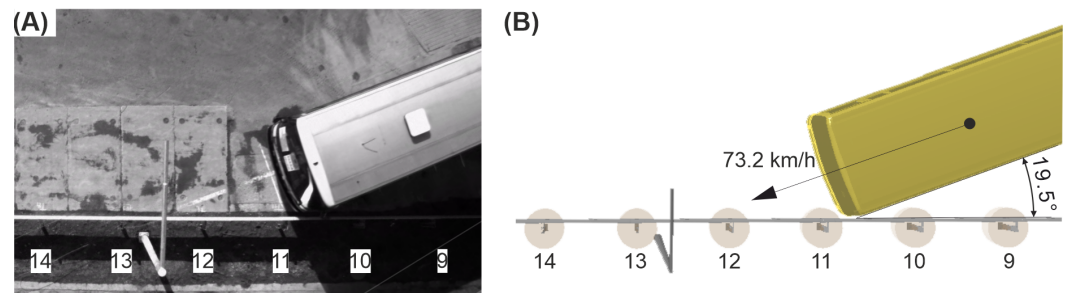
Figure 9. Impact conditions of the vehicle in (A) the full-scale crash test and in (B) the simulation.

in the experiment; hence, the bus in the simulation hit the barrier 10 cm before Post 11. A comparison of the impact conditions between the experiment and the simulation is also presented in Figure 9.

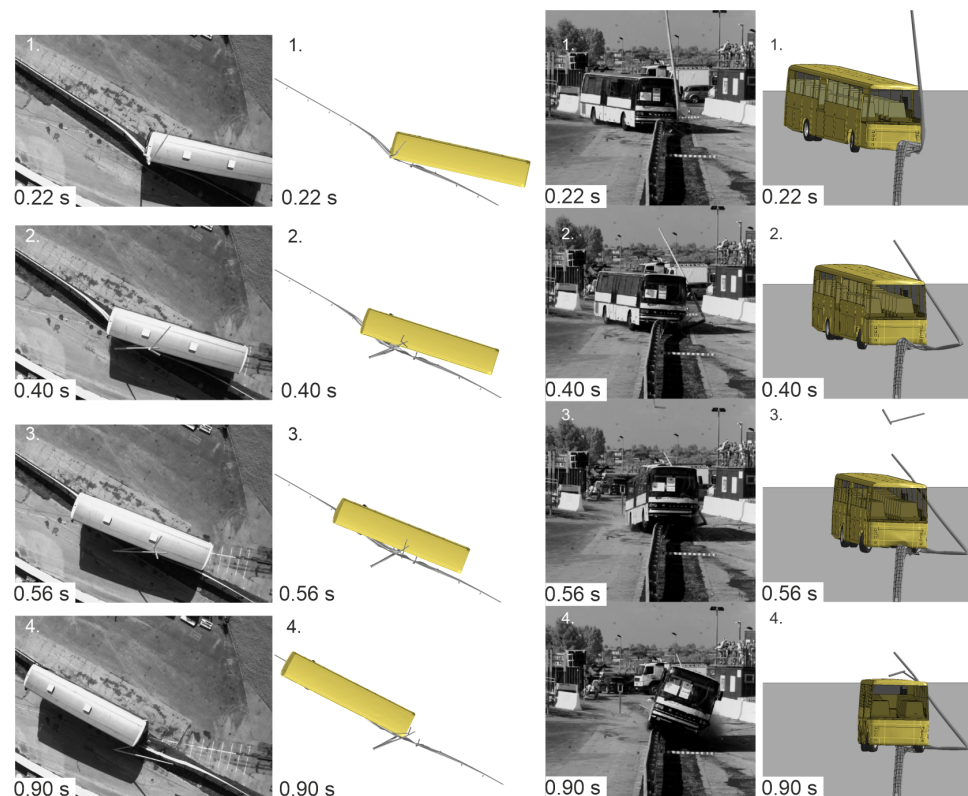
Figure 10. Vehicle trajectories of the full-scale crash test and the numerical simulation.

The results of the numerical simulation were compared with the corresponding experiment. A visual representation of the vehicle trajectories for both cases is presented in Figure 10. During the initial phase, the bus in the simulation and the experiment followed a similar path. Differences were observed in the latter parts of the test. The vehicle in the experiment hit the barrier and swung to its other side, as in Figure 10(2). As seen, the left side of the vehicle crossed the face of the barrier, and eventually, the whole bus followed and fully crossed over to the other side of the protective system (see Figure 10(4)). The wheels on the right side of the bus then caught the barrier, resulting in the bus rollover. A difference in the vehicle course was observed in the simulation where the center of the vehicle's chassis did not cross the face of the barrier. Hence, as a consequence, the vehicle hung on the barrier, as seen in Figure 10(3). The simulation ended with the bus's undercarriage hanging on the protective barrier, as in Figure 10(4). Nevertheless, in both, the experiment and the simulation, the analyzed road safety barrier did not stop the vehicle from crossing over the traffic lane.

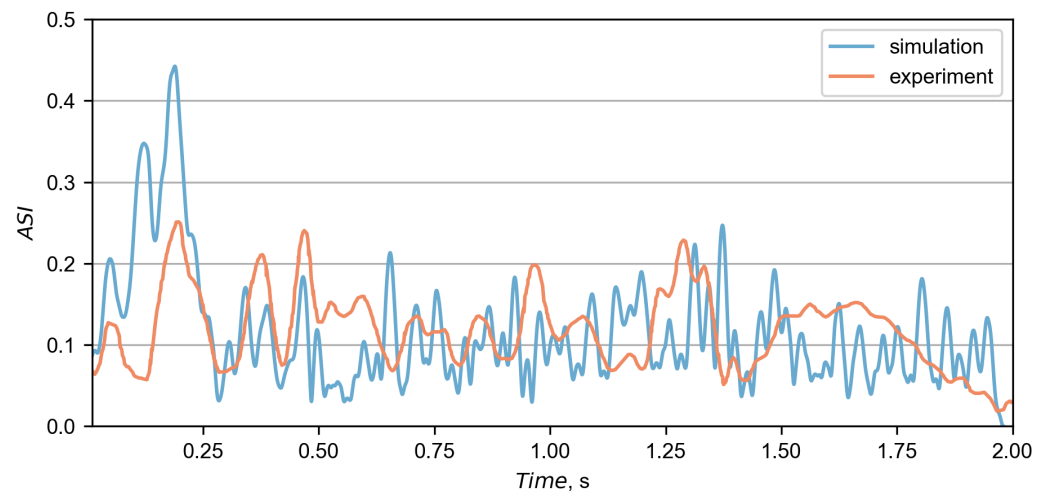
Figure 11. The comparison between the ASI calculated at the driver seat in the simulation and the experiment.

The calculated ASI curves were based on accelerations from the driver seat and are presented in Figure 11. The similarity between the curves was calculated based on the MPC and ANOVA metrics, as proposed in the technical report [41]. Residuals of ASI curves with their corresponding distributions are presented in Figure 12. A summary of the metrics is in Table 2, where all criteria were fulfilled, indicating a good overall correlation between curves. The maximum ASI in the experiment was 0.25 and occurred 0.196 s after the initial impact. In the simulation, the maximum ASI was higher and exited 0.44 at 0.189 s.

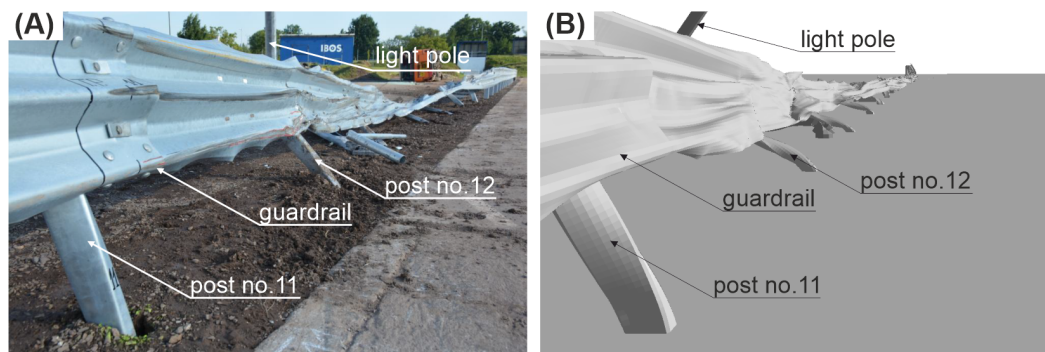
Figure 14. View of the damaged barrier. (A) Experiment; (B) simulation.

As a result of the impact in the full-scale crash test, the system was damaged between Posts 11 and 19. For the simulation, the damage was between Posts 10 and 25. The guardrail was locally torn in the experiment at Posts 12, 15, 16, and 18. For the simulation, the guardrail was severely damaged at Posts 12, 15, 18, 19, and 20. In the full-scale

crash test, Posts 11, 12, and 17 were bent, the posts between 13 to 16 were bent to the ground, and the posts from 1 to 11 were only twisted. For the simulation case, Posts 10, 11, 12, and 24 were bent, Posts 13 to 23 were bent to the ground, and the posts from 1 to 9 and No. 25 were only twisted. The lighting column for both the experiment and the simulation was damaged near the foundation and was broken at one third of its height.

A view of the damage of the system can be seen in Figure 14.

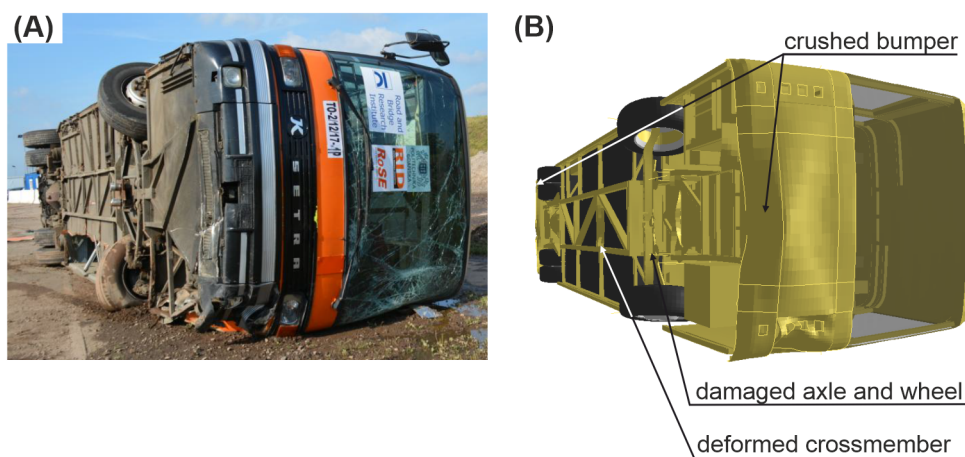
Figure 15. View of the damaged vehicle. (A) Experiment; (B) simulation.

In the experiment, the rear window of the vehicle was broken, the front windshield was severely cracked, and the front bumper was crushed. Moreover, the left-front wheel of the vehicle was broken. The left side of the vehicle was damaged due to the contact with the guardrail. In the simulation, the left side of the vehicle was also damaged. Additionally, the front and rear bumpers were crushed due to the impact. Moreover, the cross-member of the chassis frame was damaged and the front axle was bent near the left-front wheel.

A comparison of vehicle's damage between the full-scale crash test and simulation is presented in Figure 15.

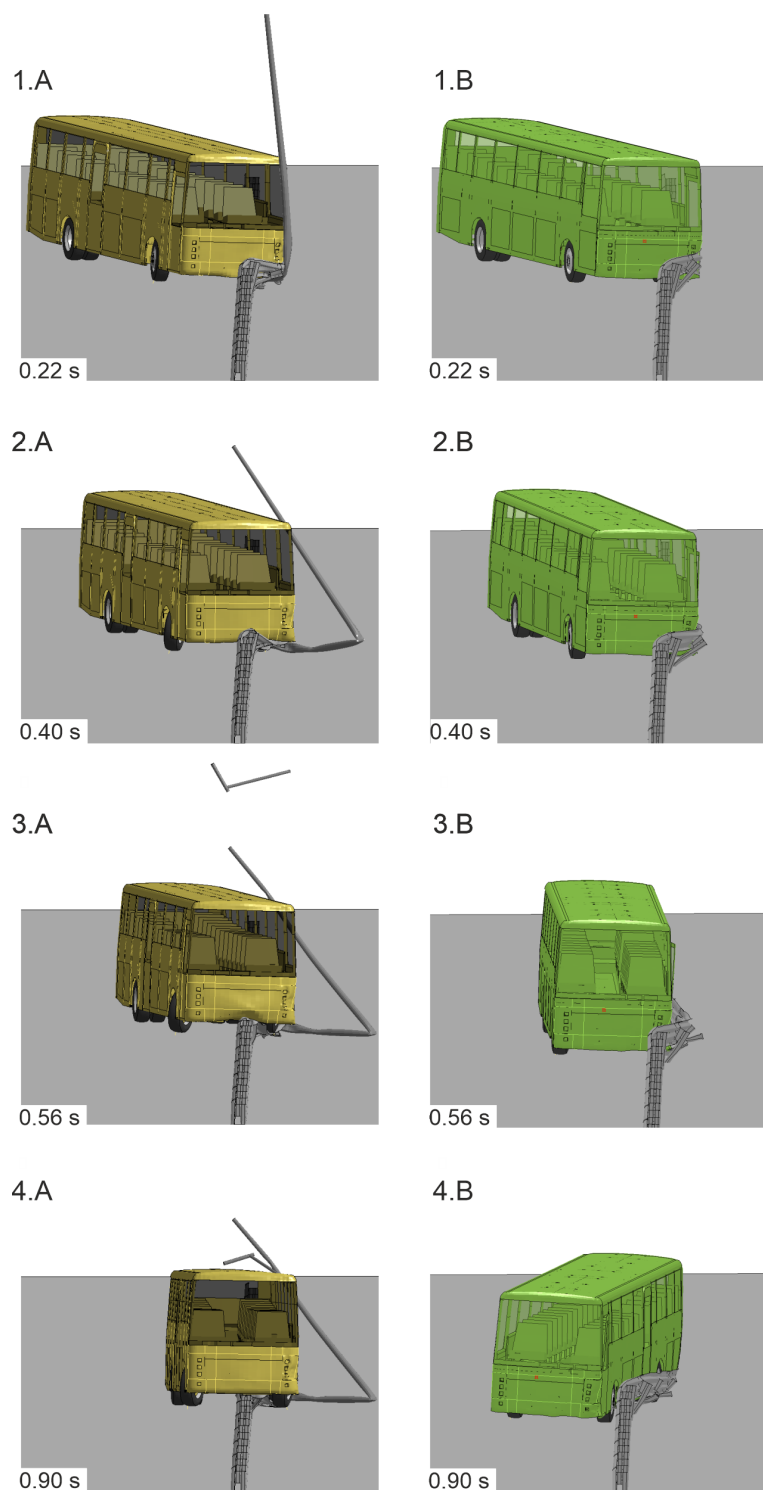
Figure 16. Vehicle trajectories of numerical simulations of (A) the barrier without an obstacle (Case No. 1) and (B) the barrier with a lighting column within its working width (Case No. 2).

Numerical simulations considered two cases, where Case No. 1 had the lighting column installed within the working width of the H2/W4/A W-beam RSB and Case No. 2 considered the barrier itself, without any obstacles. All of the modeling details were the same in both simulations, i.e., the model of the vehicle and the model of the barrier remained unchanged. Both cases had the same impact conditions, i.e., the impact speed of 70.6 km/h, the impact angle of 20.3°, and the impact location of 10 cm before Post No. 11. The course of the vehicles' trajectories in both simulations is presented in Figure 16.

The trajectory of the vehicle in Case No. 1 was described in Section 3. In simulation Case No. 2, 0.08 s after the impact, the barrier guardrail flattened on the left-front side of the vehicle body and the vehicle began to slide and redirect along the guardrail. At 0.14 s after the impact, Spacer No. 12 was detached from the guardrail, and then, two more spacers (Nos. 13 and 14) also detached from the guardrail consequently. At 0.54 s after the impact, the rear of the bus hit the guardrail at the height of Post No. 10 (see Figure 16(3.B)). The rear of the vehicle was also caught by the barrier, and the guardrail properly redirected the vehicle; at 1.30 s after the impact,

the vehicle eventually left the barrier. The calculated working width was 1.37 m, and the dynamic deflection was 1.03 m. The difference between the working width from the simulation and the value from its certificate was less than 10 cm. The maximum roll angle of the vehicle in the simulation Case No. 2 was 2.01°, and it was 3.95° less than in Case No. 1. A comparative analysis of the vehicle trajectories for both simulation cases is summarized in Table 3, where the time 0.0 s is the time of vehicle impact and the time 2.0 s indicates the end of the simulation.

Time Intervals, s	Comparison between Simulations	
	Case No 1	Case No 2
0.0 *–0.13	Similar Course	
0.14–0.25	The guardrail made contact with the lighting column, which prevented the connection between the post and the guardrail from breaking (see Figures 16(1.A) and 20A).	Post No. 12 was detached from the guardrail (see Figures 16(1.B) and 20B).

0.26–0.39	Post No. 13 did not detach from the guardrail, and the system was pressed to the ground by the vehicle chassis (see Figure 16(2.A)).	Another post (No. 13) was detached from the guardrail. The guardrail flattened against the vehicle body and began to redirect the vehicle (see Figure 16(2.B)).

0.40–0.63	After sliding underneath the vehicle chassis, the guardrail was shaped into a flat surface parallel to the ground, which acted as a ramp, which allowed the vehicle to run over the barrier (see Figure 16(3.A)).	Post No. 14 disconnected from the guardrail, and the guardrail continued to effectively redirect the vehicle (see Figure 16(3.B)).

0.63–0.85	The left-front wheel of the vehicle crossed to the other side of the barrier, and the vehicle chassis landed on the top of the guardrail. The system underneath the bus almost completely laid down on the ground (see Figures 16(4.A) and 19A).	The bus was moving parallel to the line of the barrier. Post No. 12, 13, and 14 were disconnected from the system (see Figures 16(4.B) and 19B).

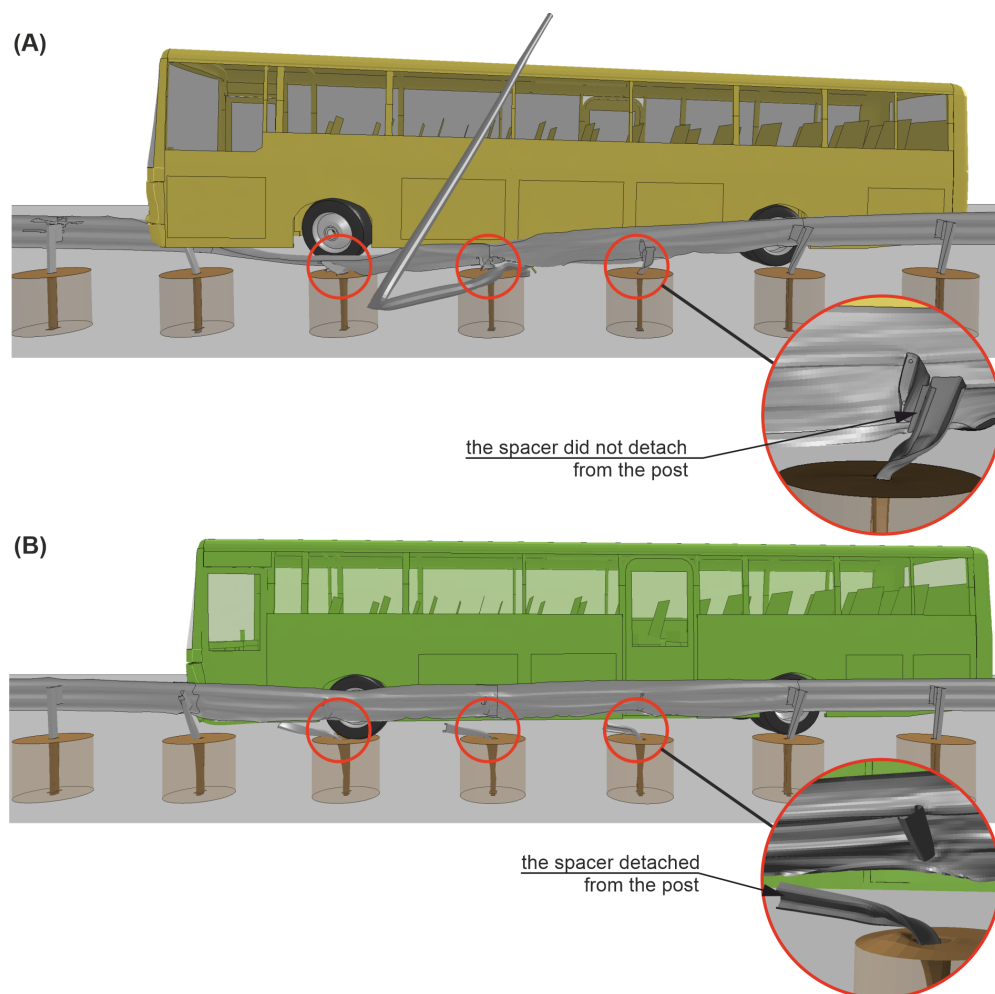
Figure 19. Side views of the H2/W4/B road safety barrier during simulations (time = 0.5 s) for (A) Case No. 1 and (B) Case No. 2. Note that the surface and soil cylinders are set transparent for clarity.

In Figures 19 and 20, there is a comparison between Case No. 1 and Case No. 2 at crucial moments in the simulation. It was observed that Post Nos. 11, 12, and 13 in Case No. 1 (see Figure 19A) did not detach from the guardrail, in contrast to the ones in Case No. 2 (see Figure 19B). This difference seems to be crucial from the point of view of the correct operation of the system. The experiment additionally confirmed the simulation results, where also no detachment of the posts from the system was observed. The comparison of the damaged barrier in the experiment and corresponding simulation is presented in Figure 21.

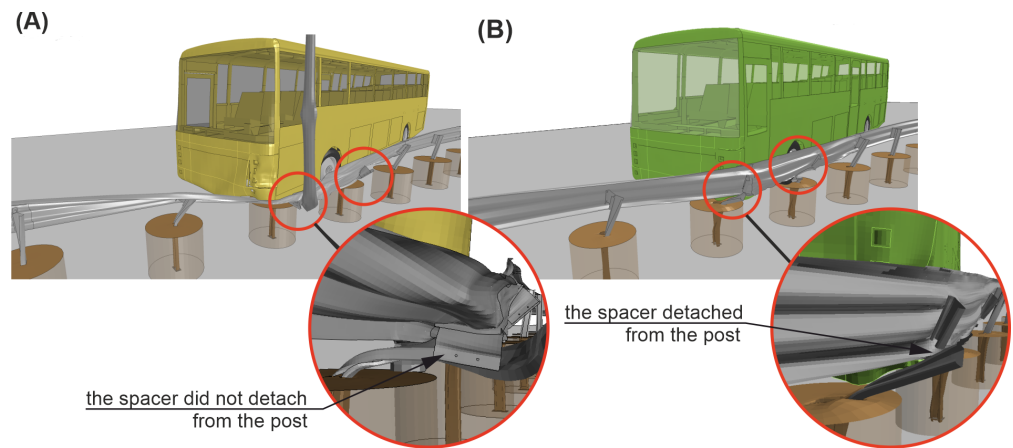
Figure 20. Isometric views of simulations (time = 0.3 s) for Cases (A) No. 1 and (B) No. 2. Note that the surface and soil cylinders are set transparent for clarity.

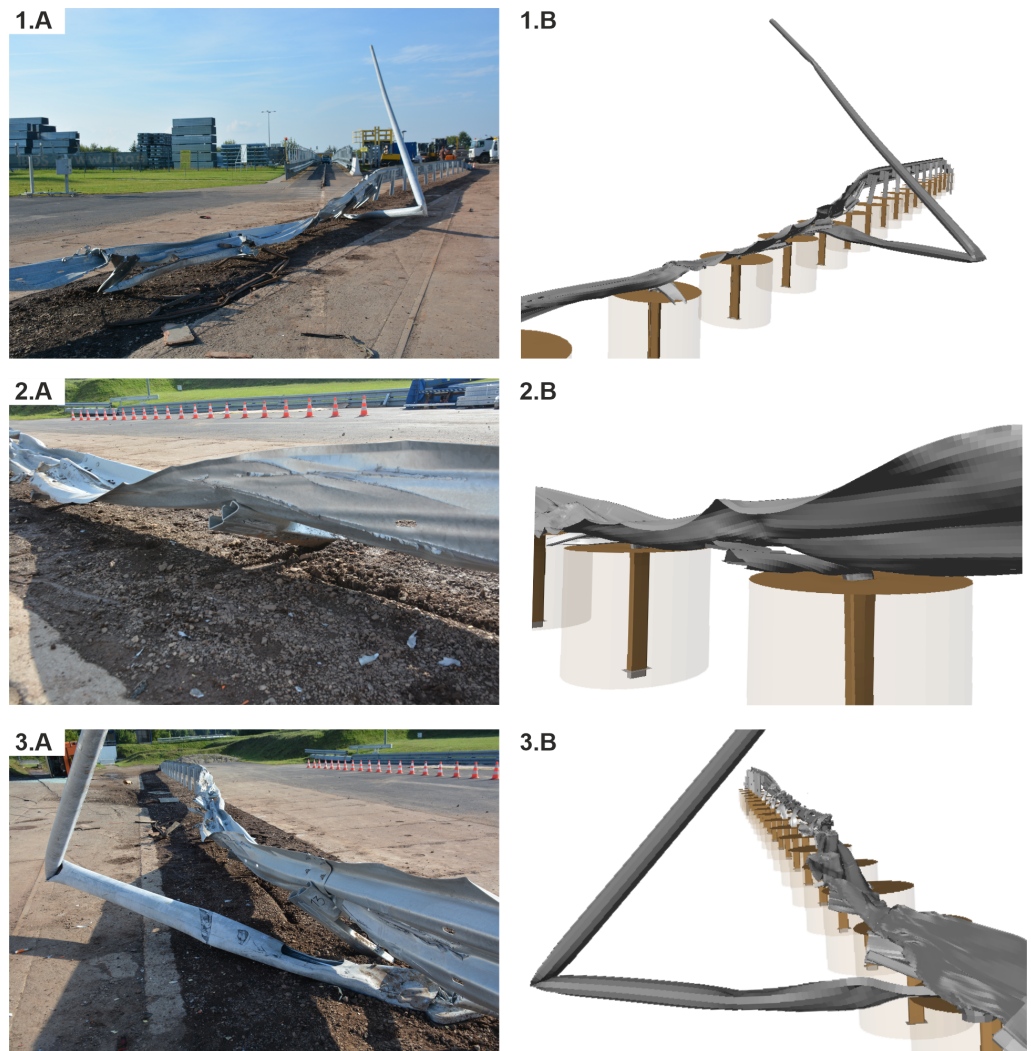
Figure 21. Views of the damaged H2/W4/A road safety barrier in (A) the experiment and in (B) the simulation. Note that the surface and soil cylinders are set transparent for clarity.
