Article

Influence of a Lighting Column in the Working Width of a W-Beam Barrier on TB51 Crash Test

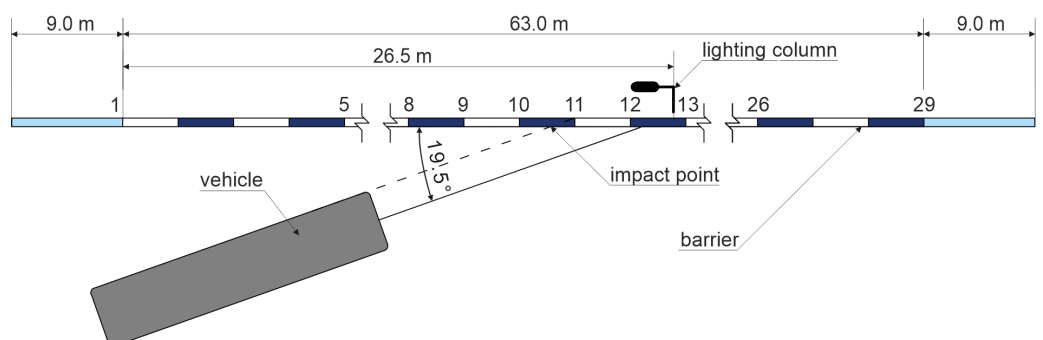
Figure 2. Scheme of the test setup.

The full-scale crash test was conducted on 10 August 2017 at the testing grounds of the Research Institute for Protective Systems (IBOS) [33]. The experiment was carried out by the Research Institute for Roads and Bridges (IBDiM) [34]. This institute is certified by the Polish Center for Accreditation to, among others, perform crash tests according to the EN1317 standard [14]. The setup of the test is presented in Figure 2. The total length of the system was 81 m, where there was 63 m of straight section and 9 m at each end of the barrier.

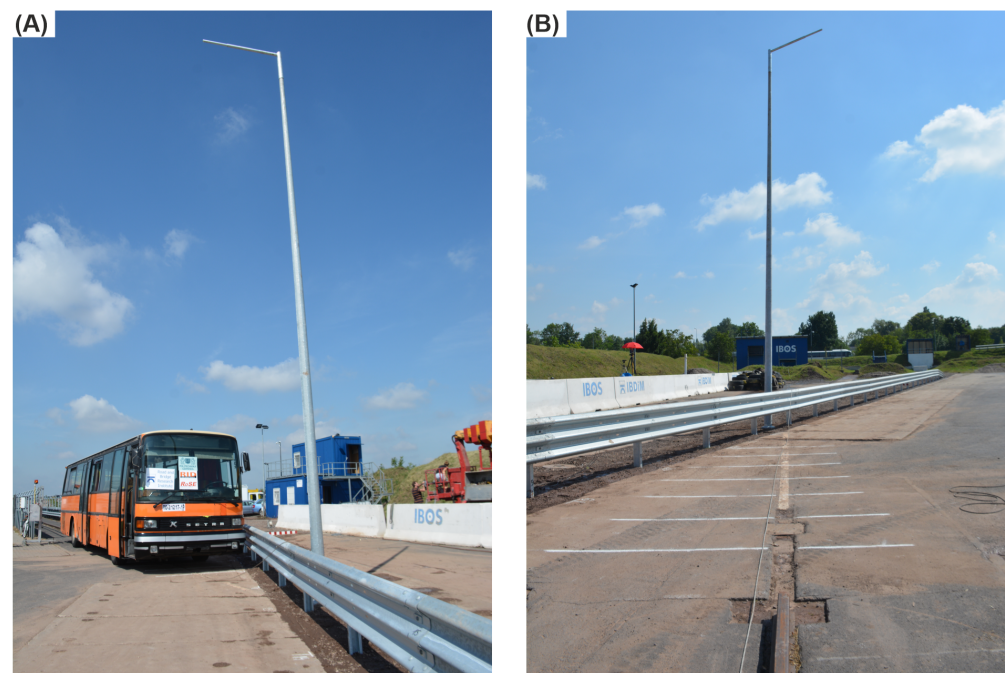
Figure 4. Test site before the collision, with (A) a view of the run-up track with the bus and the impact point and (B) a view of the impact point from the point of view of the run-up track.

The analyzed crash test also considered the lighting column in the working width of the barrier. This column was the 100HE3 class according to the EN 12767 standard [32]. Without a foundation, the column was 10 m long and weighted 87 kg. It was mounted 1.75 m behind the 12th post of the barrier (see Figure 4), and its axis was distanced at 0.60 m from the face of the system. The foundation was made of a 150 × 30 × 30 cm reinforced concrete cube, weighing approximately 225 kg.

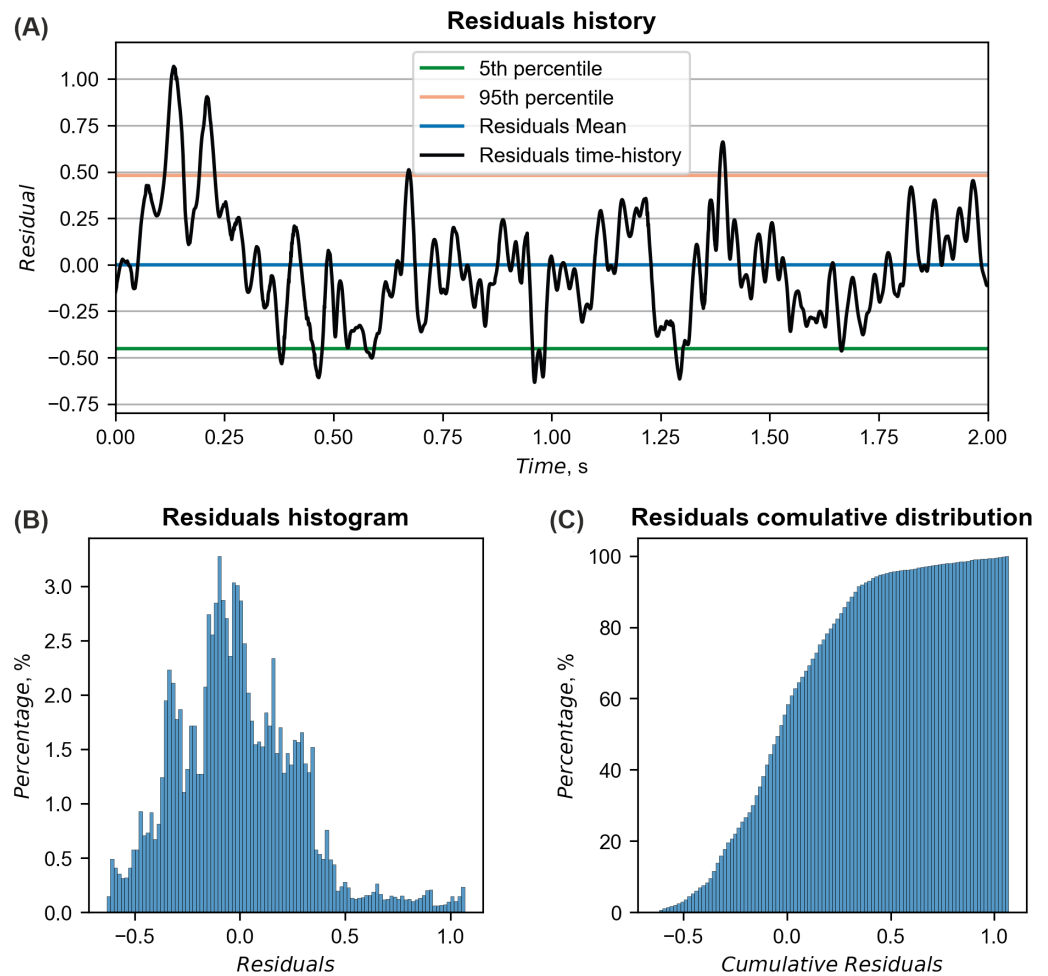
Figure 12. Residuals (A) history, (B) histogram, and (C) cumulative distribution of ASI curves.

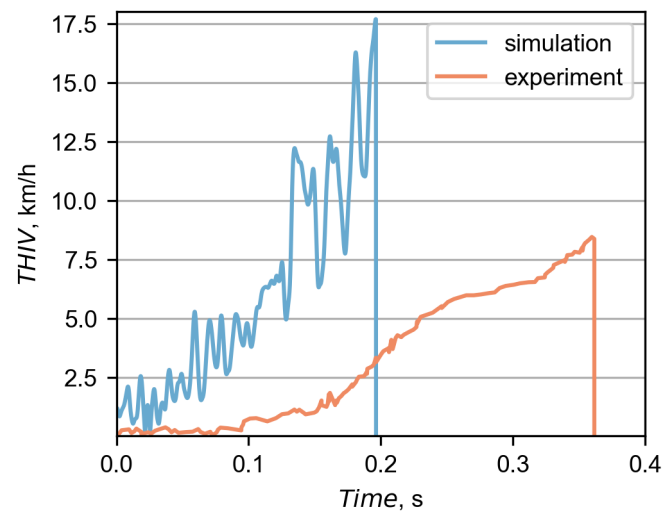
Figure 13. The comparison between the THIV calculated at the driver seat in the simulation and the experiment.

In Figure 13, there is a comparison between the experimental and the simulation THIV curves. For both cases, the THIV was based on accelerations from the driver seat. However, as seen in Figure 13, there are significant differences between those curves. Discrepancies are mainly due to the different rate at which the vehicle changed its direction after hitting the barrier. This is because the THIV index directly depends on the yaw velocity. In both cases, the barrier initiated the redirection of the bus. However, in the simulation, the redirection occurred faster and was more abrupt. In the experiment, the bus maintained its initial moving direction for longer. Additionally, the discrepancy may be due to the fact that in the simulation, the bus hanged on the barrier, and in the experiment, the bus completely ran over to the other side of the barrier.

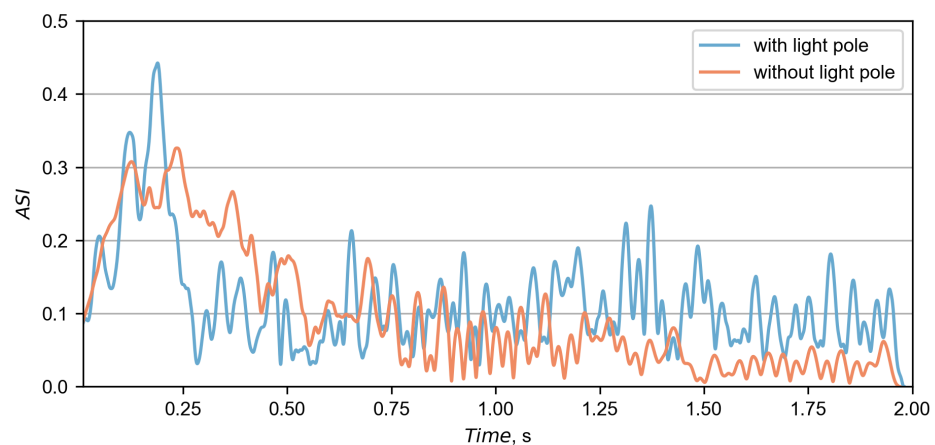
Figure 17. The comparison between the ASI calculated at the driver seat in both simulations.

The results of the ASI and THIV for both simulations were calculated based on accelerations from the driver seat. Their corresponding curves are presented in Figures 17 and 18. In Case No. 2, the maximum ASI equaled 0.33 and was 25% lower than in Case No. 1. The time of the maximum ASI in Case No. 2 was at 0.235 s after the impact, which was 0.046 s later than in Case No. 1. The maximum THIV in Case No. 2 was 16.06 km/h at the time of 0.196 s, which is 9% less and 0.006 s earlier, compared to the other case.

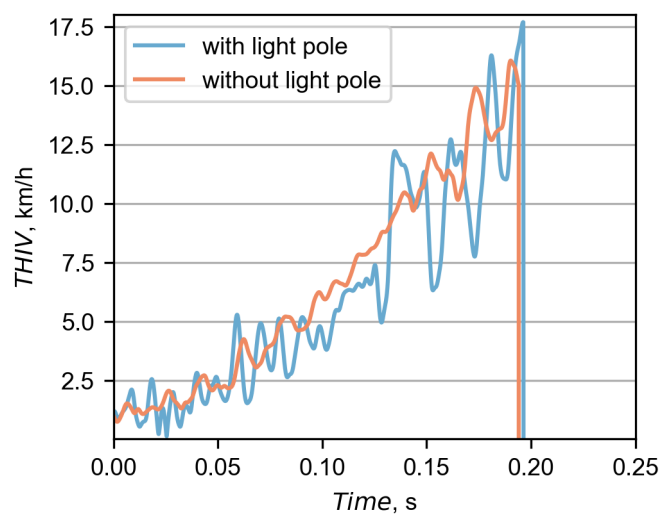
Figure 18. The comparison between the THIV calculated at the driver seat in both simulations.
