Experimental ultimate strength assessment of stiffened plates subjected to marine immersed corrosion

Krzysztof Woloszyk^a, Yordan Garbatov^{b,*}, Jakub Kowalski^a

ABSTRACT

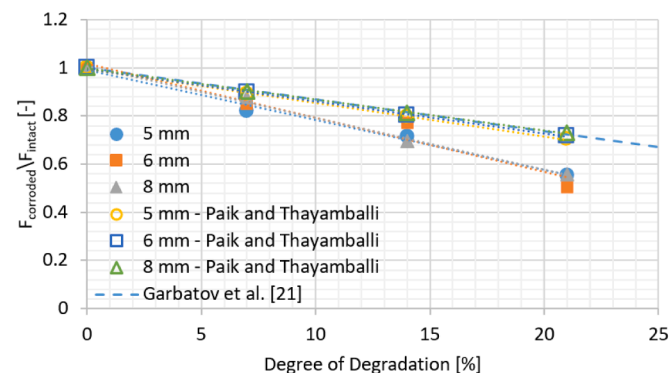
Additionally, the strength reduction was significantly higher when compared to the specimens corroded electrochemically (Garbatov et al., 2017) (see Fig. 5). The curve presented in Fig. 5 has been established as the regression from experimental points. For that case, the thickness

Fig. 5. Relative strength reduction vs degradation level.

variations were not that high, like in current investigations, leading to a decrease of strength of about 30% for a similar degradation level. In fact, for that degradation level, the results were closed to values obtained from the empirical formulation of Paik and Thayamballi (1997).

ultimate strength significantly decreases with corrosion development. It is observed that the reduction in the strength is very similar for different thicknesses and follows a linear trend. In the case of the mean value thickness reduction of 21%, the approximately 46% strength reduction has been observed.

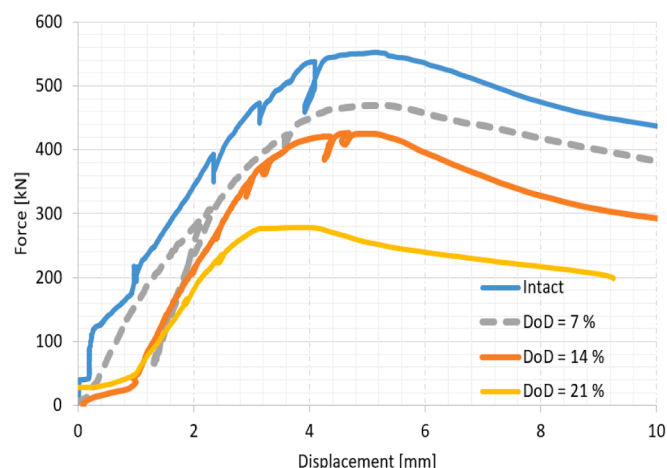
Fig. 7 shows the force-displacement curves for specimens of an initial thickness of 6 mm. Apart from the initial scatter caused by the initial readjustment of the specimens in the supports (specimens with 14 and 21% of corrosion loss), the force-displacement relationship is quite similar regardless of the degradation level. The ultimate strength is

Fig. 7. Force-displacement curves for 6 mm specimens.

It could be noted in Figs. 6–8 that force-displacement curves are not continuous in some places. Notably, before reaching ultimate strength, force and displacement dropped and increased again. This may be caused by several reasons, including localised failure and readjustment of the specimen (Woloszyk et al., 2021c), and losing the welding integrity during the incremental loading (see Fig. 9).

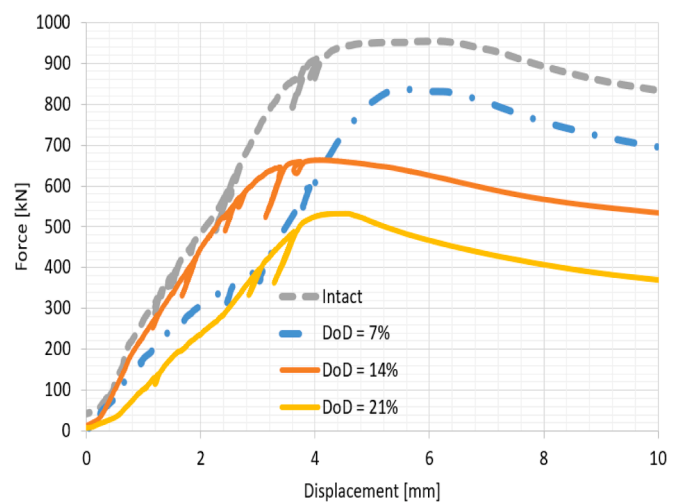
The force-displacement curves for 8 mm specimens are presented in Fig. 8. It is noted that the initial stiffness of the specimen was lower with the corrosion degradation growth, which can be seen in terms of the initial slope of the force-displacement relationship. The only irregular behaviour is noted for a specimen with a *DoD* level of 7%, where some severe reduction in the strength in pre-collapse behaviour occurred. Nevertheless, both pre-and post-collapse behaviours were somewhat similar and were not strongly dependent on the corrosion *DoD*. The point of ultimate strength has been reached between 4 mm and 6 mm of the longitudinal displacement.

Fig. 8. Force-displacement curves for 8 mm specimens.

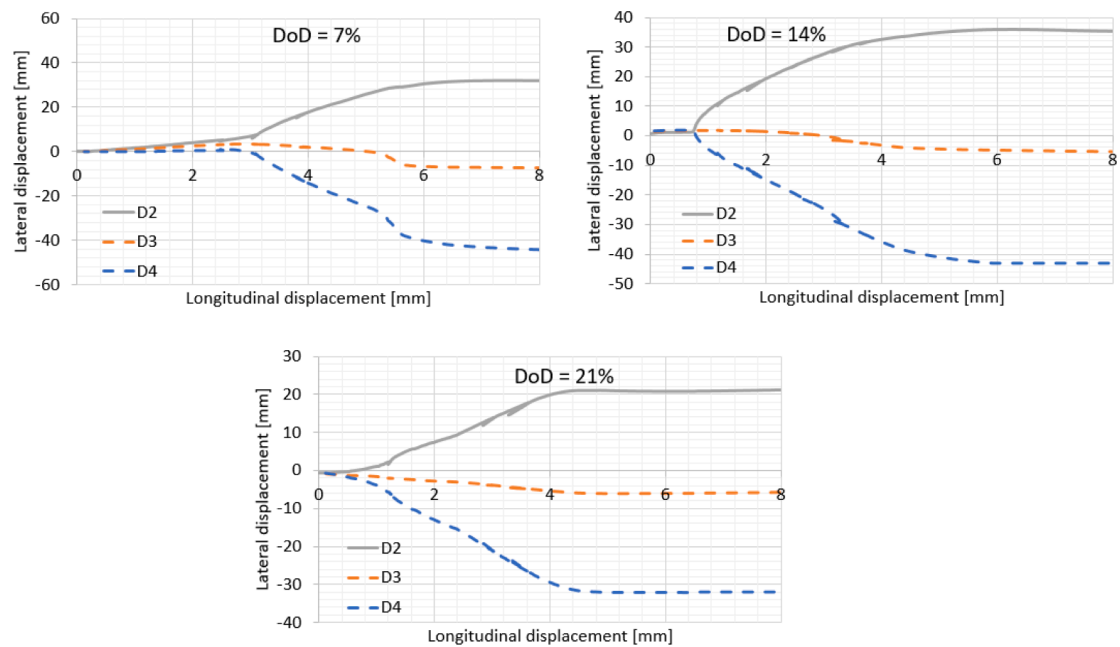
The lateral displacements for 8 mm specimens are presented in Fig. 15. In this case, the local plate buckling was observed after some increments of the loading application. 3, 1 and 0.2 mm of longitudinal displacement were observed for 7, 14 and 21% of DoD, respectively. This behaviour is quite understandable since with the corrosion development, the plate slenderness increase, leading to the structure being more prone to buckling. The rest of the observations is somewhat like other specimens. The side-way deflections increase up to the moment when ultimate strength is reached, and then, there are relatively constant.

Fig. 15. Lateral displacements in corroded specimens of 8 mm: 7% of DoD (left, top), 14% of DoD (right, top) and 21% of DoD (bottom).

Figs. 13–15 show the lateral displacements for each specimen separately from gauges D2 – D4. As indicated before, the role of gauges D1 and D5 is only to monitor the clamping supports of the specimens; thus, the results from those measurements are not given herein.
