Effectiveness of various types of coating materials applied in reinforced concrete exposed to freeze–thaw cycles and chlorides

Ginneth Patricia Millán Ramírez

, Hubert Byliński & Maciej Niedostatkiwicz

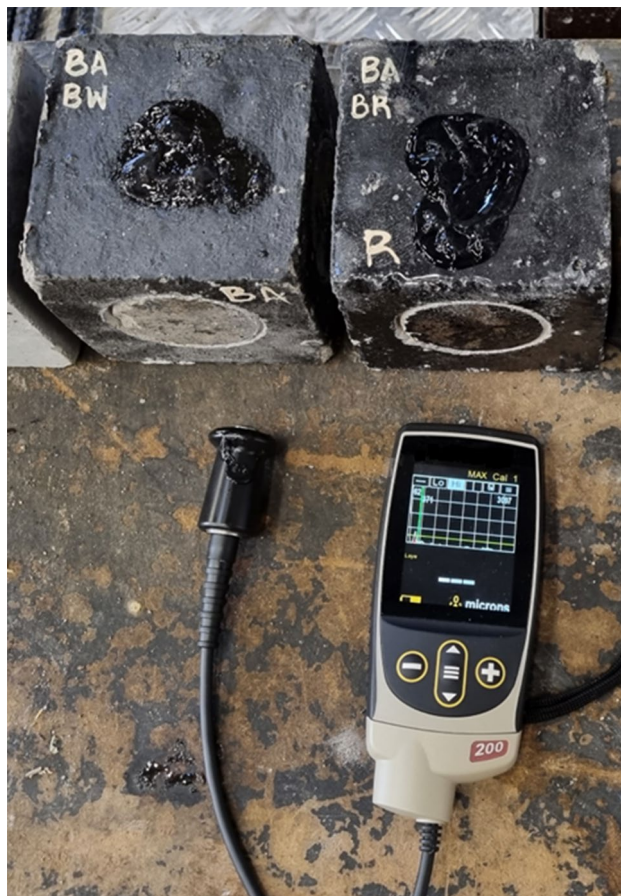
Figure 3. Measurement of coating material thickness.

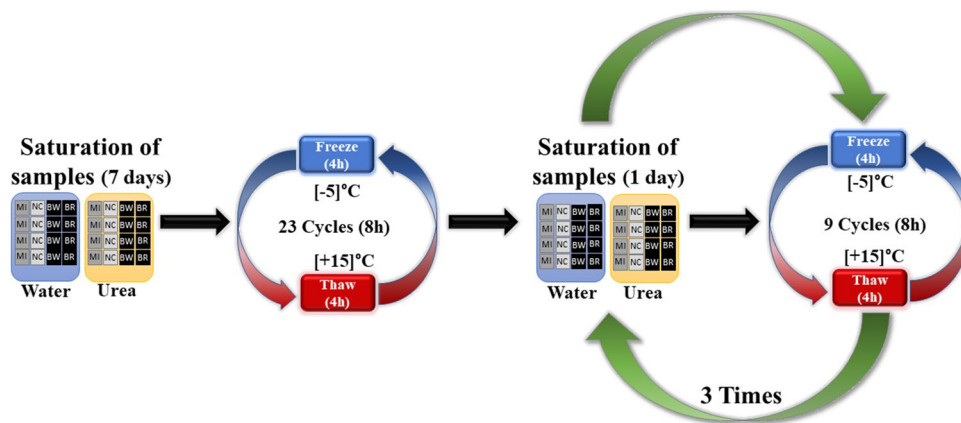
Figure 4. Aging process description. Freeze–thaw cycles and saturation of concrete samples.

Aging process. An accelerated aging test was conducted using a Tropol K-012 frost resistance test chamber, which is commonly employed for assessing the frost resistance of building materials. The specimens were subjected to cyclical freezing in air and thawing in water, while an electronic programmer monitored the cycles.

To simulate freeze–thaw conditions in the laboratory, the test was performed at temperatures ranging between $[-5]$ and $[+15]$ °C. Two solutions were employed to simulate contaminated environments: regular water and urea solution with a concentration of 7%. The aging process, as depicted in Fig. 4, was applied to the samples. Furthermore, each specimen was coated with one of the four materials assessed in this research: BW, BR, MI, and EP. Additionally, a control sample without protection (NC) was included for comparison with the protected samples. After 50 freeze–thaw cycles and a 10-day saturation period, the absorption rate, pull-off adhesion strength, and chloride permeability of each sample were measured.
