Effect of wet Hydrogen Sulfide on Carbon Steels Degradation in Refinery Based on Case Study

Abstract

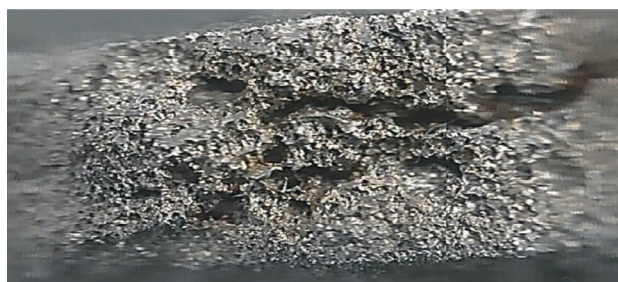
Fig. 1 Image of the corrosion coupon surface after exposition in the aqueous environment with H₂S

Mechanism wet H₂S can be observed in four different forms: blistering, hydrogen-induced cracking (HIC) and stress-oriented hydrogen-induced cracking (SOHIC) and sulfide corrosion cracking (SSC). Hydrogen blisters may be formed as a surface bulge, and HIC-, SOHIC- and SSC-based cracking processes may occur at many different depths by interconnecting cracks caused by hydrogen blisters. SOHIC is potentially more damaging appearing as arrays of cracks stacked on the top of each other. The SSC is defined as cracking of metal under combined action of tensile stress and corrosion described above. Example of HIC/SOHIC degradation by Wet H₂S is shown in Fig. 1
